**Report: TAB Report**  
**Function: Test, Adjust, & Balance**  
**Date: 05/12/2025**  
**Completed By: National TAB**

## 05-05-25 CAVA DENVER, CO (STAPLETON)

<b>Section</b>	<b>Page #</b>
Summary	3
Remarks	4
Balance Schedule	12
Checklists	13
AHU/RTU	38
FAN - Exhaust	46
Kitchen Hood Type I	49
GRD Layout	51

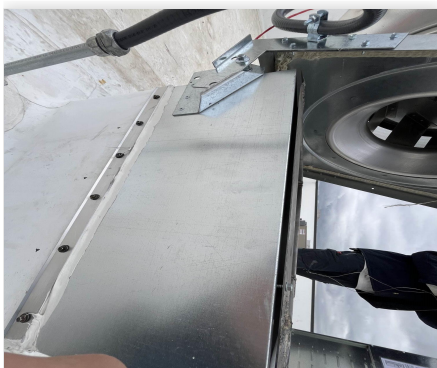
**Issue Name :** KEF gap between duct and curb.  
**Description :** There is a gap between the exhaust duct flange and the curb; its location will not cause airflow issues but it is recommended to fire caulk it to prevent insects from getting inside.  
**Created By :** National TAB                      **Assigned To :** National TAB - Will Turnbough  
**Status :** Open  
**Priority :** Low                                      **Asset Tag :** KEF1  
**Originated Date :** 05/08/2025 - Cody Collett - National TAB
