Sierra Grill

CheckList Information

Name :	Duct Integrity Test Sierra Grill	Status :	NotSubmitted
Assigned Organization :	All State Fire Midwest	Asset :	
Requesting Organization :	All State Fire Midwest

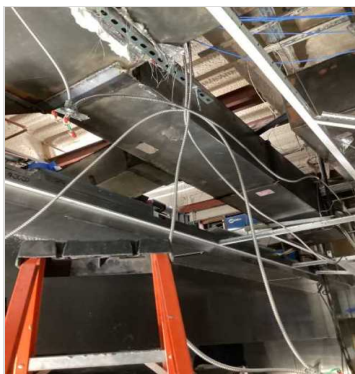
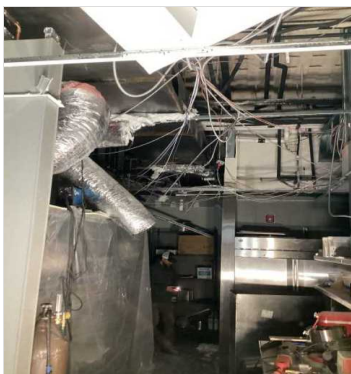
Pressurized UV sensitive water test using a water jet through custom welded ductwork. Hood 1, Hood 2 and common duct from exhaust hood to previously tested vertical duct. Vertical exhaust ductwork previously inspected and approved by city of Lenexa and was excluded from this test.

Hood 1 and Hood 2 exhaust duct risers, junctions and common duct free of visible leaks?	Yes
---	-----

All State recommends that all ductwork associated with water wash self cleaning hoods be manufactured from stainless steel rather than black iron to avoid corrosion and rust that may affect future duct integrity.

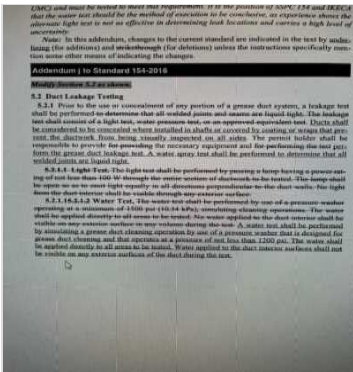
ASHRAEDuctTest.jpg

Does the ductwork supporting hoods 1 and 2, pass NFPA 17, 17a, 96 and ASHRAE 154 requirements at the time of testing?	Pass
---	------

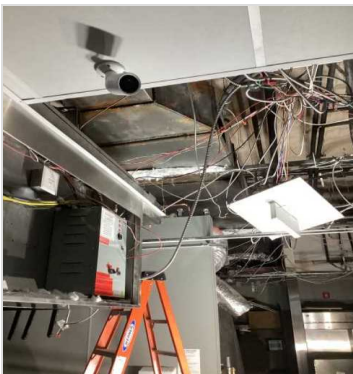
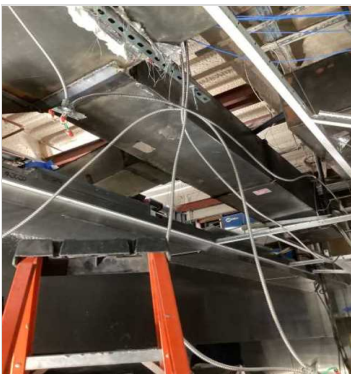
Pressurized UV sensitive water test using a water jet through custom welded ductwork. Hood 3 is designed for solid fuel cooking and is a dedicated exhaust duct. Hood 3 was tested from the exhaust duct collar to previously tested vertical duct. Vertical ductwork previously inspected and approved by the city of Lenexa and was excluded from this test.

Hood 3 exhaust duct riser and connection to main duct work free of visible leaks? Yes

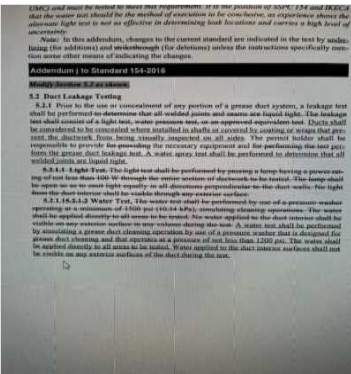
ASHRAEDuctTest.jpg

Does the ductwork supporting hood 3 meet NFPA 17, 17a, 96 and ASHRAE 154 requirements at the time of testing? Pass
