**Report: TAB Report**  
**Function: Test, Adjust, & Balance**  
**Date: 12/04/2024**  
**Completed By: National TAB**

## 11-25-24 CHIPOTLE #5115 CALIFORNIA, MD

Chipotle Mexican Grill  
610 Newport Center Drive, Suite 1100  
Newport Beach, CA 92660

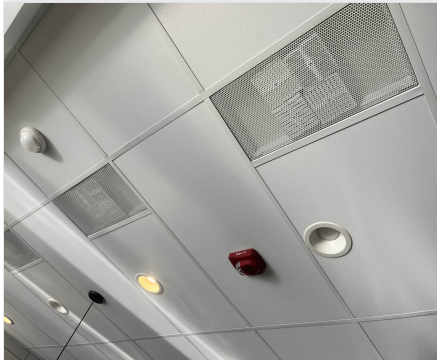
**Issue Name :** 4-way deflectors for serving line diffusers are not removed  
**Description :** The serving line diffusers still have the 4-way deflectors installed. Recommend having them removed.  
**Created By :** National TAB                      **Assigned To :** National TAB - David Annan  
**Status :** Open  
**Priority :** Medium                                      **Asset Tag :**  
**Originated Date :** 12/03/2024 - David Annan - National TAB

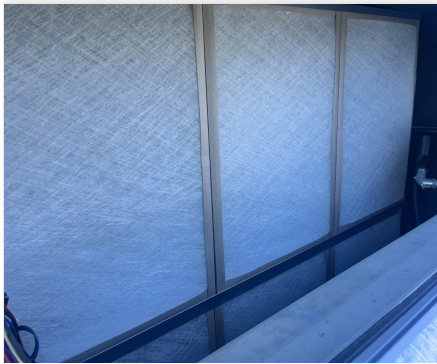
**Issue Name :** Construction filters are still installed  
**Description :** Both RTUs still have construction filters installed. Recommend that pleated filters with a MERV rating of atleast 8 be installed prior to the stores opening.  
**Created By :** National TAB                      **Assigned To :** National TAB - David Annan  
**Status :** Open  
**Priority :** Medium                                      **Asset Tag :**  
**Originated Date :** 12/03/2024 - David Annan - National TAB

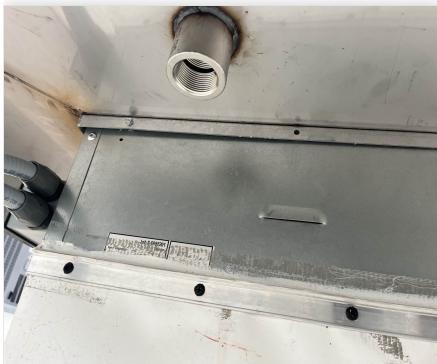
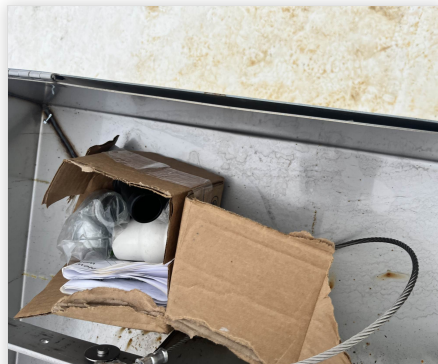
**Issue Name :** KEF: Grease drain is not installed  
**Description :** The grease drain is not installed under the Viroguard outlet. Recommend that the drain be installed prior to stores opening.  
**Created By :** National TAB                      **Assigned To :** National TAB - David Annan  
**Status :** Open  
**Priority :** Medium                                      **Asset Tag :**  
**Originated Date :** 12/03/2024 - David Annan - National TAB

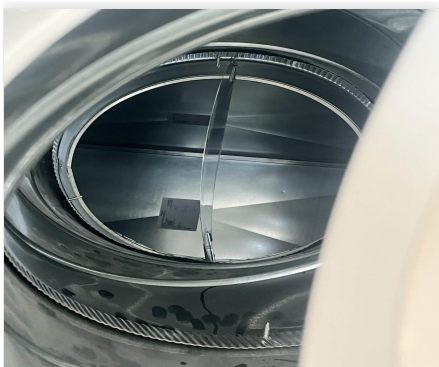
**Issue Name :** RTU-2: Diffuser balance cannot be complete  
**Description :** RTU-2 mains dinning diffusers are not easily accessible and there are long screws restricting the dampers from closing. Unable to complete the diffuser balance. Recommend that internal OBDs be installed as stated in the plans.  
**Created By :** National TAB                      **Assigned To :** National TAB - David Annan  
**Status :** Open  
**Priority :** High                                      **Asset Tag :**  
**Originated Date :** 12/03/2024 - David Annan - National TAB

Notes:  
Dampers were inaccessible and screws were preventing the dampers side wall diffusers from closing.

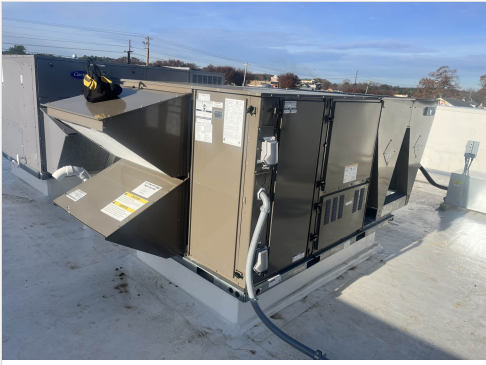
## Unit Data - PHOTO LOG

Asset: RTU1

Unit Data		
	Design	Actual
MFG	York	York
Serial Num	-	N2G2679021
Model Num	ZJ150	ZJ150E18R4D5ECA1R1
Type	RTU	RTU
Configuration	Vertical	Vertical
Num OA Filters 1	-	1
OA Filter Size 1	-	29x21
Num Final Filter 1	-	4
Final Filter Size 1	-	20X25X2

General	
	Actual
Fan Rotation Correct	Yes
Unit Filters Clean	Construction Filters
Condensate Drain Installed	Yes

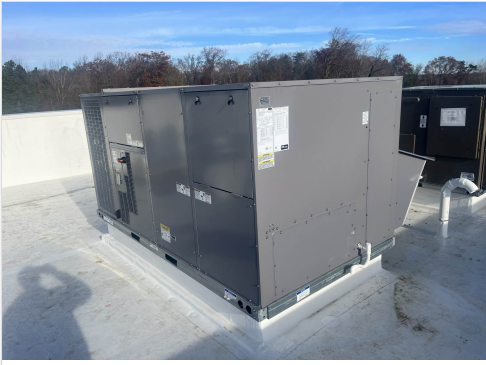
## Unit Data - PHOTO LOG

Asset: RTU2

Unit Data		
	Design	Actual
MFG	Carrier	Carrier
Serial Num	-	5023P05519
Model Num	48FC_M16	50FC-M16B3Q5A6W4C0
Type	RTU	RTU
Configuration	Vertical	Vertical
Num OA Filters 1	-	2
OA Filter Size 1	-	25X23
Num Final Filter 1	-	6
Final Filter Size 1	-	18X14X2

General	
	Actual
Fan Rotation Correct	Yes
Unit Filters Clean	Construction Filters
Condensate Drain Installed	Yes

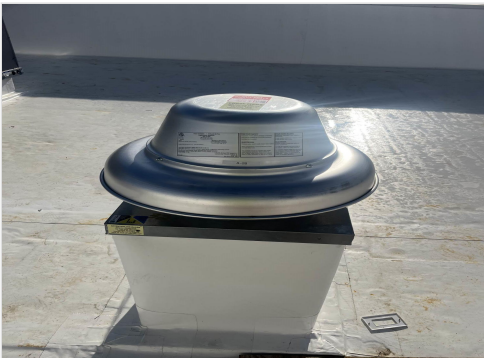
### Unit Data - PHOTO LOG

Asset: EF2

Unit Data		
	Design	Actual
MFG	CaptiveAire	CaptiveAire
Model Num	DR12HFA	DR12HFA
Serial Num	-	6899284
Type	Downblast	Downblast
Configuration	Vertical	Vertical

Balance schedule on MSET calls for Exhaust to be 150 CFM. Unit was balance to 150 CFM to provide a positive building pressure to the store.

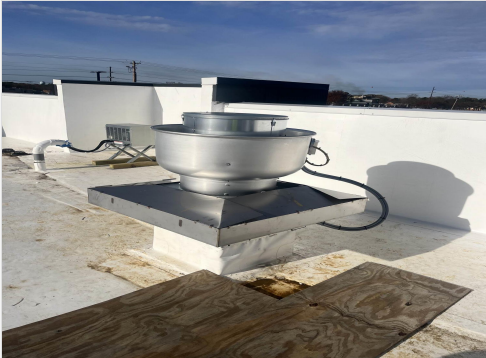
### Unit Data - PHOTO LOG

Asset: KEF1

Unit Data		
	Design	Actual
MFG	CaptiveAire	CaptiveAire
Model Num	DU85HFA	DU85HFA
Serial Num	-	6899284
Type	Upblast	Upblast
Configuration	Vertical	Vertical

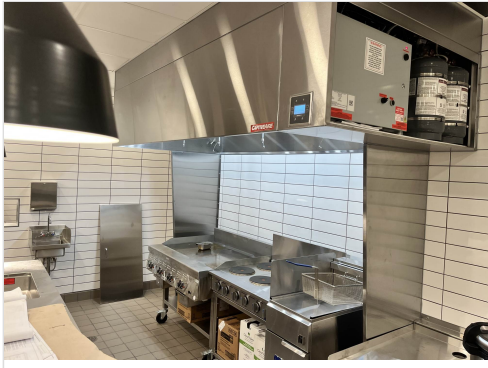
## Unit Data - PHOTO LOG

Asset: HD1

Unit Data		
	Design	Actual
MFG	CaptiveAire	CaptiveAire
Model Num	5424 ND-2	5424 ND-2
Job / Serial Num	-	6899284
Type	Type 1 Canopy Hood	Type I
Hood length	153"	112"
Hood Width	54"	54"
