**Report By:**

**National TAB  
1329 E. KEMPER ROAD  
SUITE 4210  
CINCINNATI, OH 45246**

**Report: FINAL TAB REPORT  
Function: Test, Adjust, & Balance  
Date: 10/11/2022**

**PROJECT  
10-10 SWEETGREEN #DAL -  
SOUTHLAKE, TX**

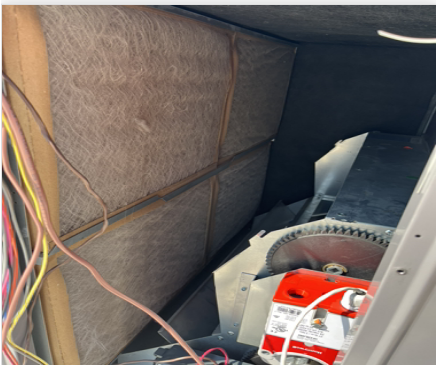
FuselTf825840916db495...

Issue Name : RTU-3 has construction filters  
Description : Recommend replacing with final filters  
Created By : National TAB      Assigned To : National TAB - Will Turnbough  
Status : Open  
Originated Date : 10/10/2022 - Tyler Youells - National TAB

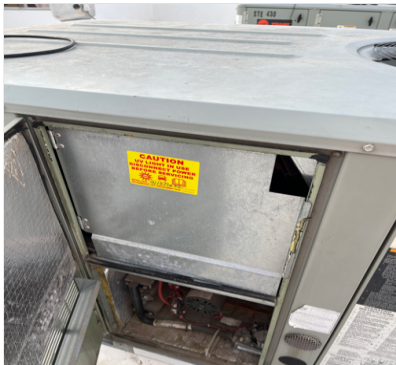
FuseITbb17dd633b8149d...

Is a UV warning sticker installed?

YES

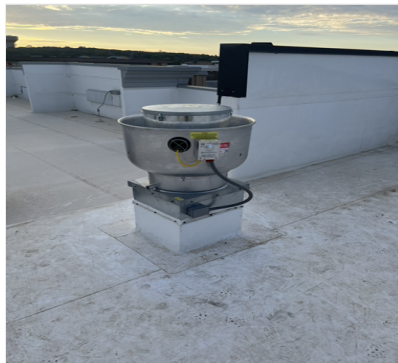
FuseIT41a9a2498afe483...

Identify where the exhaust air is discharged and take pictures

Exhausts out of Ef-1

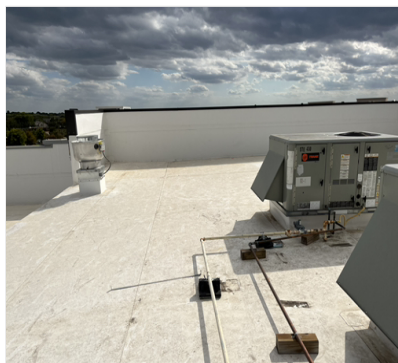
FuseIT0034127f93ee4b7...

Are there any outside air intakes nearby that would be able to re-entrain the exhaust smoke? Take pictures

No closest is OA intake of Rtu-1 which is 10+ feet
