Report: TAB Report
Function: Test, Adjust, & Balance
Date: 03/12/2026
Completed By: National TAB

PROJECT
05-18-26 QT #1010 CHARLOTTE, NC

Project: 05-18-26 QT #1010 CHARLOTTE, NC

Project Summary

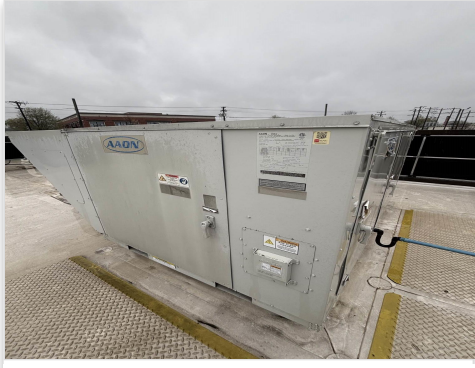
Unit Data - PHOTO LOG

Asset: RT-1

AREA:SALES FLOOR

Unit Data	
	Actual
MFG	AAON
Serial Num	202001-ANEK19589
Model Num	RN-8-0-EA0A-152
Num OA Filters 1	1
OA Filter Size 1	45X24
Num Final Filter 1	2
Final Filter Size 1	56X45

Test Data		
	Design	Actual
SF CFM	4200	4313
SF RPM	-	DD
OA CFM (Hoods On)	800	769
OA CFM (Hoods Off)	350	355
RL Voltage	-	207/208/209
RL Amperage	-	6.4/6.2/5.8
VFD Max SetPt	-	36Hz
VFD Min SetPt	-	24Hz
OA Damper Position (Hoods On)	-	46%
OA Damper Position (Hoods Off)	-	25%

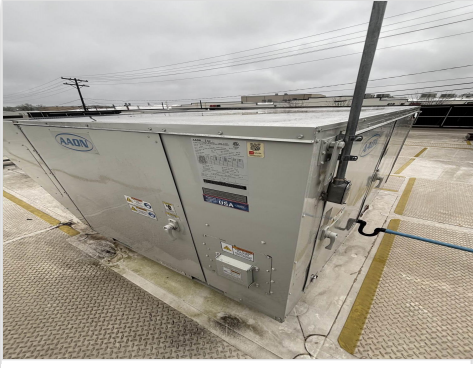
Unit Data - PHOTO LOG

Asset: RT-2

AREA: SALES FLOOR

Unit Data	
	Actual
MFG	AAON
Serial Num	202001-ANEK19588
Model Num	RN-013-8-0-EA0A-152
Num OA Filters 1	1
OA Filter Size 1	45X24
Num Final Filter 1	2
Final Filter Size 1	56X45

Test Data		
	Design	Actual
SF CFM	4200	4282
SF RPM	-	DD
OA CFM (Hoods On)	800	834
OA CFM (Hoods Off)	350	358
RL Voltage	-	209/210/208
RL Amperage	-	5.4/5.2/5.7
VFD Max SetPt	-	34Hz
VFD Min SetPt	-	24Hz
OA Damper Position (Hoods On)	-	46%
OA Damper Position (Hoods Off)	-	26%

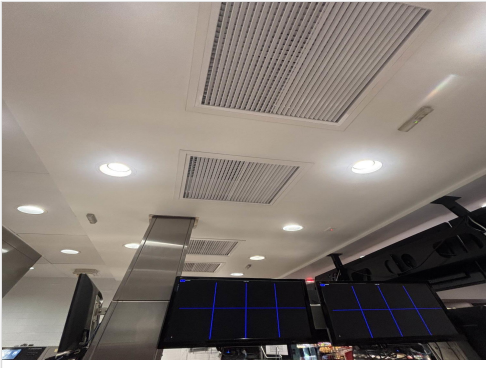
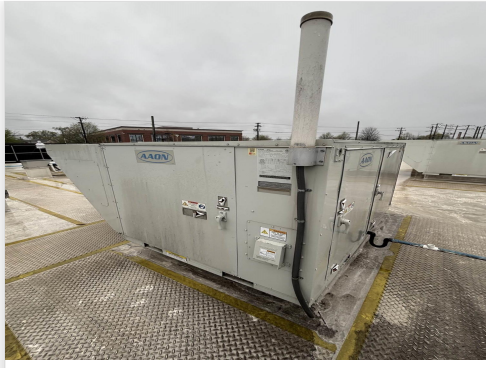
Unit Data - PHOTO LOG

Asset: RT-3

AREA:BOH/KITCHEN

Unit Data	
	Actual
MFG	AAON
Serial Num	202001-ANEK19587
Model Num	RN-013-8-0-EA0A-152
Num OA Filters 1	1
OA Filter Size 1	45X24
Num Final Filter 1	2
Final Filter Size 1	56X45

Test Data		
	Design	Actual
SF CFM	4200	4195
SF RPM	-	DD
OA CFM (Hoods On)	800	753
OA CFM (Hoods Off)	350	341
RL Voltage	-	208/207/209
RL Amperage	-	8.0/8.2/8.5
VFD Max SetPt	-	40.2Hz
VFD Min SetPt	-	24Hz
OA Damper Position (Hoods On)	-	46%
OA Damper Position (Hoods Off)	-	23%

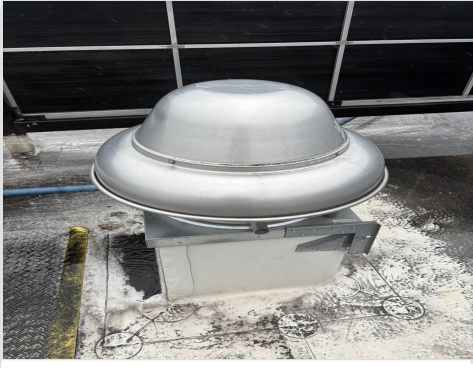
Unit Data - PHOTO LOG

Asset: EF1

AREA:RESTROOMS/JANITOR

Design	Actual
MFG	NA	CAPTIVEAIRE
Model Num	NA	DR50HFA
Serial Num	-	4103395
Type	-	DOWNBLAST
Configuration	-	VERTICAL

Design	Actual
CFM	750	715
Fan RPM	-	DD
Fan Rotation	-	CORRECT
Motor RPM	-	DD
System SetPt	-	SPEED CONTROLLER / MEDIUM SPEED
RL Voltage	-	109
RL Amperage	-	6.2
Total ESP	-	0.52"
Fan Inlet SP	-	-0.52"
Fan Discharge SP	-	ATM

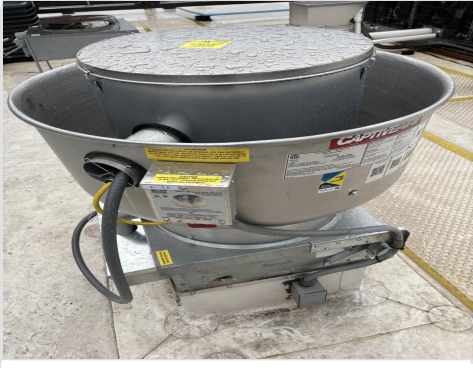
Unit Data - PHOTO LOG

Asset: EF3

AREA: KITCHEN HD

Unit Data		
	Design	Actual
MFG	NA	CAPTIVEAIRE
Model Num	NA	DU50HFA
Serial Num	-	8309100
Type	UPBLAST	UPBLAST
Configuration	VERTICAL	VERTICAL

Test Data		
	Design	Actual
CFM	1350	1360
Fan RPM	-	DD
Fan Rotation	-	CORRECT
Motor RPM	-	DD
System SetPt	-	HMI / 54.5Hz
RL Voltage	-	210
RL Amperage	-	2.5
Total ESP	-	0.46"
Fan Inlet SP	-	-0.46"
Fan Discharge SP	-	ATM
