Report: TAB REPORT
Function: Test, Adjust, & Balance
Date: 12/10/2024
Completed By: National TAB

PROJECT
12-09-24 CULVERS PRINCETON, MN

Project: 12-09-24 CULVERS PRINCETON, MN

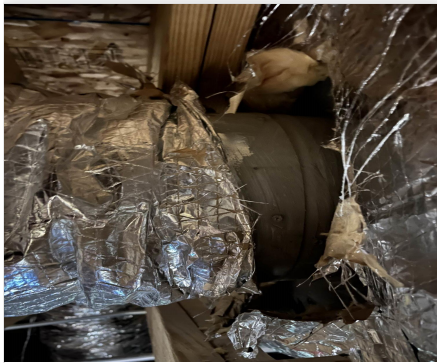
Issue Name : RTU-2: Missing Dampers
Description : Kitchen unit is missing dampers on several diffusers. Where necessary, flex was banded with drawband to reduce airflow. See issue regarding smoke capture; diffusers not balanced to design.
Created By : National TAB **Assigned To :** National TAB - Dan Hertenstein
Status : Open
Priority : High **Asset Tag :**
Originated Date : 12/10/2024 - Michael McDonnell - National TAB

- Notes:
- [1] UNIT LABEL FLA 27.0 BASED ON UNIT VOLTAGE OF 184. WITHIN MOTOR SF.
 - [2] UNIT IS MISSING DAMPERS ON SEVERAL DIFFUSERS.
 - [3] DIFFUSERS BALANCED FOR HOOD CAPTURE.

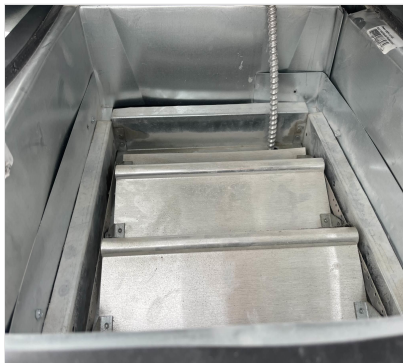
For restroom fan(s) is the back draft damper installed and can it fully open?
