Report: TAB REPORT
Function: Test, Adjust, & Balance
Date: 12/10/2024
Completed By: National TAB

PROJECT
12-09-24 CULVERS PRINCETON, MN

Project: 12-09-24 CULVERS PRINCETON, MN

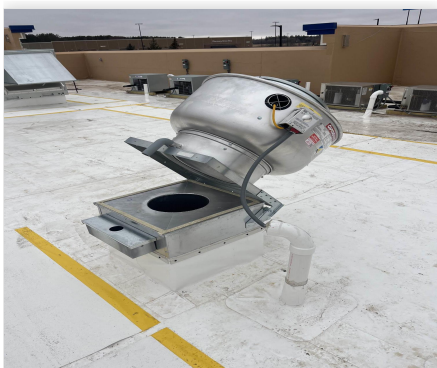
Issue Name : PRV-2: Electrical Conduit Length
Description : When fan is leaned back, electrical conduit is completely tight and prevents fan from fully Leaning back. This will likely lead to damage when fans are cleaned. Recommend conduit is lengthened.
Created By : National TAB **Assigned To :** National TAB - Dan Hertenstein
Status : Open
Priority : Medium **Asset Tag :**
Originated Date : 12/09/2024 - Michael McDonnell - National TAB

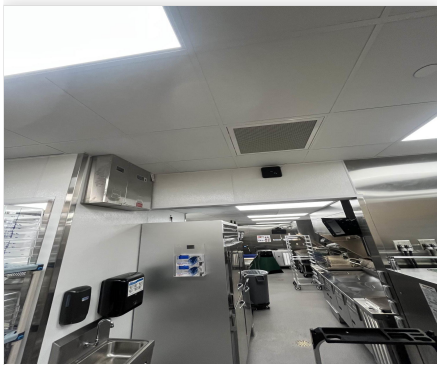
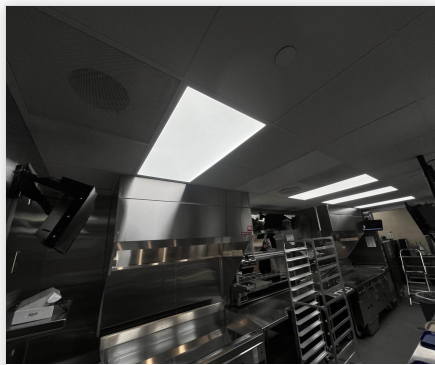
Issue Name : RTU-2: Diffuser / Return Locations
Description : Cookline Diffuser 1-7 is not in correct position per plans. It's important cookline diffusers are installed per plan for hood capture. Additionally, a return is out of location and positioned immediately to right of hood. Recommend diffusers and grilles are installed per plan.
Created By : National TAB **Assigned To :** National TAB - Dan Hertenstein
Status : Open
Priority : Medium **Asset Tag :**
Originated Date : 12/09/2024 - Michael McDonnell - National TAB

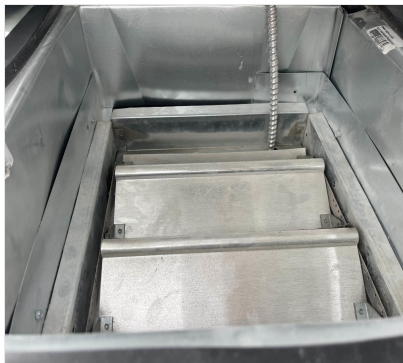
PRV-3 (griddle) conduit needs to be lengthened, see issue.

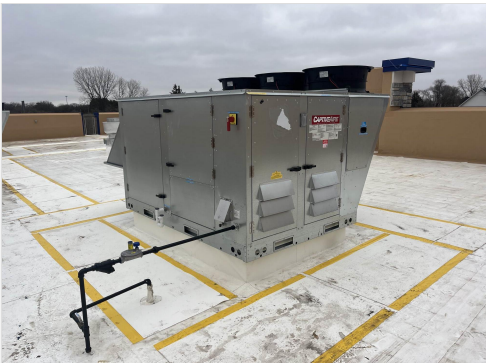
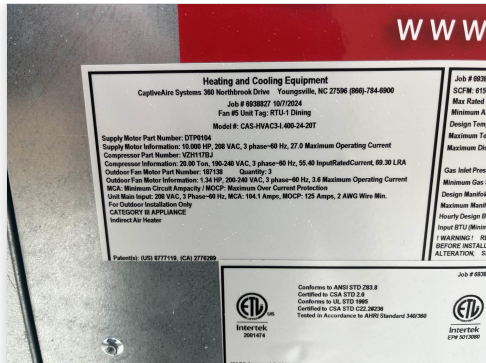
Asset: RTU1

Test Data		
	Design	Actual
SF CFM	6150	6167
SF RPM	-	1641
RA CFM	4400	-
OA CFM	1750	-
RL Voltage	-	183V @VFD
RL Amperage	-	22.6 @VFD
SF Rotation	-	CCW, CORRECT
SF System SetPt	-	56.1 HZ
RA Damper Position	-	MECHANICALLY LINKED
Min OA Damper Position	-	-
Min OA Damper Type	-	ECONOMIZER

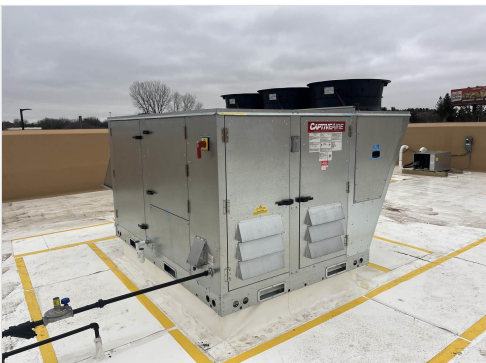
Asset: RTU2

Unit Data		
	Design	Actual
MFG	CAPTIVEAIRE	CAPTIVEAIRE
Serial Num	-	6938827
Model Num	CAS-HVAC1.300-24-20T	CAS-HVAC1.300-24-20T
Type	RTU	DOAS
Configuration	VERTICAL	VERTICAL
Num OA Filters 1	-	4
OA Filter Size 1	-	16X25X2
Num Final Filter 1	-	8
Final Filter Size 1	-	20X25X2

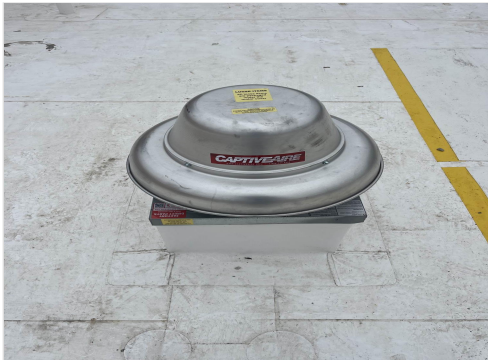
Asset: PRV1

Test Data		
	Design	Actual
CFM	375	372
Fan RPM	1369	988
Fan Rotation	-	CCW, CORRECT
Motor RPM	-	988
System SetPt	-	46%
RL Voltage	-	NR [1]
RL Amperage	-	NR [1]
Total ESP	0.50"	0.18"
Fan Inlet SP	-	-0.18"
Fan Discharge SP	-	ATM

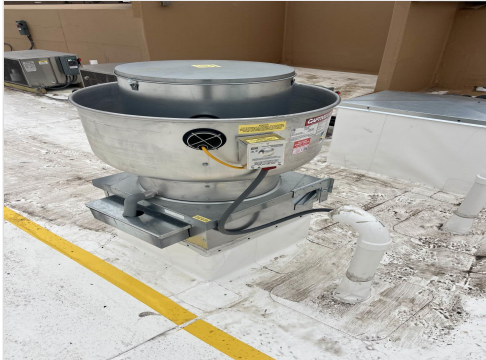
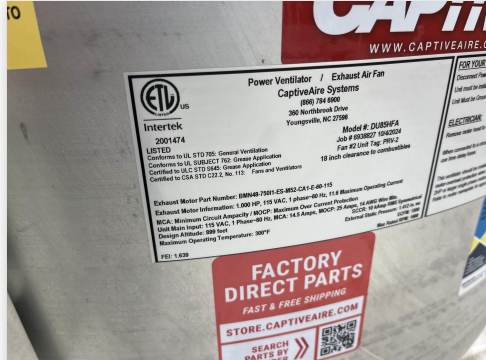
Asset: PRV2

Test Data		
	Design	Actual
CFM	1500	1559
Fan RPM	1406	1176
Fan Rotation	-	CCW, CORRECT
Motor RPM	-	1176
System SetPt	-	59%
RL Voltage	-	117
RL Amperage	-	3.4
Total ESP	1.412	0.81"
Fan Inlet SP	-	-0.81"
Fan Discharge SP	-	ATM

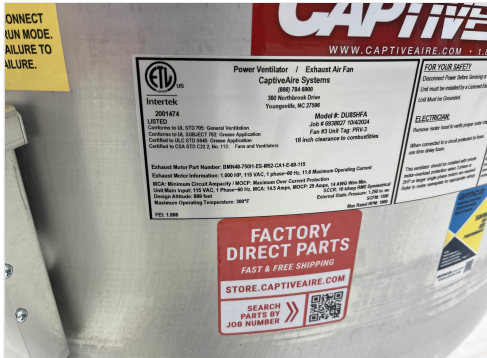
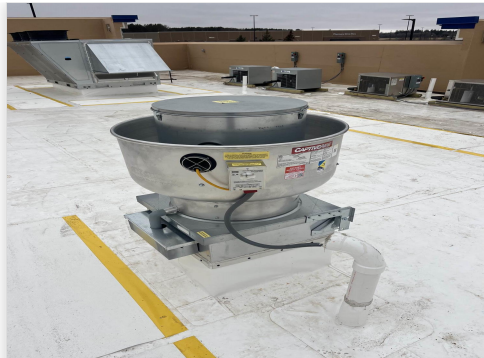
Asset: PRV3

Test Data		
	Design	Actual
CFM	1500	1542
Fan RPM	1348	1238
Fan Rotation	-	CCW, CORRECT
Motor RPM	-	1238
System SetPt	-	62%
RL Voltage	-	117
RL Amperage	-	3.5
Total ESP	1.25"	1.04"
Fan Inlet SP	-	-1.04"
Fan Discharge SP	-	ATM

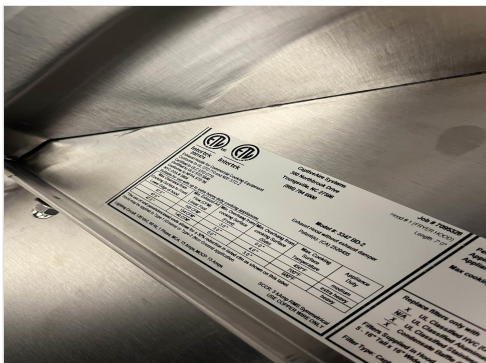
Asset: HD1

Test Data Exhaust		
	Design	Actual
Filter Type	SOLO FILTER	SOLO FILTER
Filter Size 1	16X16	16X16
Filter Qty 1	5	5
Filter AK factor size 1	1.53	1.53
Filter Total AK Area	7.65	7.65
Filter1 FPM	-	208
Filter2 FPM	-	210
Filter3 FPM	-	195
Filter4 FPM	-	200
Filter5 FPM	-	206
Filter Ave FPM(corr)	-	203.80
CFM	1500	1559

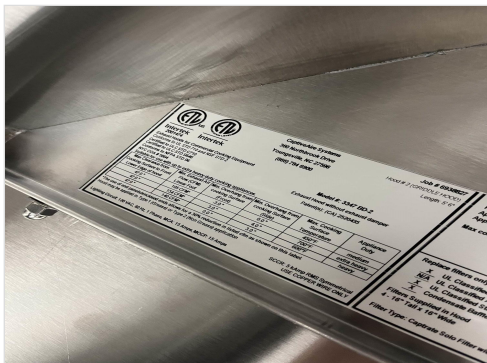
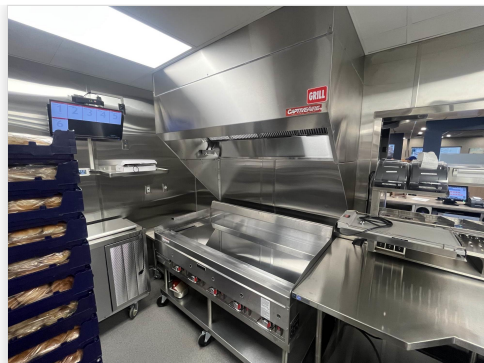
Asset: HD2

Test Data Exhaust		
	Design	Actual
Filter Type	SOLO FILTER	SOLO FILTER
Filter Size 1	16X16	16X16
Filter Qty 1	4	4
Filter AK factor size 1	1.53	1.53
Filter Total AK Area	6.12	6.12
Filter1 FPM	-	253
Filter2 FPM	-	243
Filter3 FPM	-	257
Filter4 FPM	-	255
Filter Ave FPM(corr)	-	252
CFM	1500	1542
