**Report: TAB REPORT**  
**Function: Test, Adjust, & Balance**  
**Date: 12/10/2024**  
**Completed By: National TAB**

**PROJECT**  
**12-09-24 CULVERS PRINCETON, MN**

200 19th Ave N

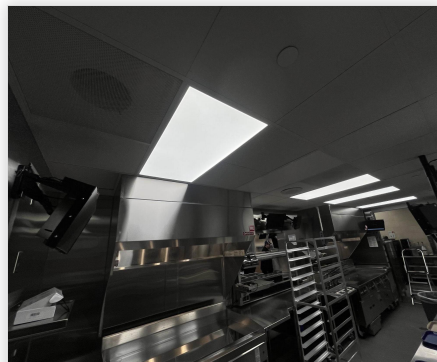
**Issue Name :** RTU-2: Cookline Diffusers  
**Description :** Cookline Diffuser 1-7 is not in correct position per plans. It's important cookline diffusers are installed per plan for hood capture. Several kitchen diffusers are also missing dampers. MC came to install missing dampers, but only brought 2 dampers. Several still missing. Additionally, return in incorrect location per plans.

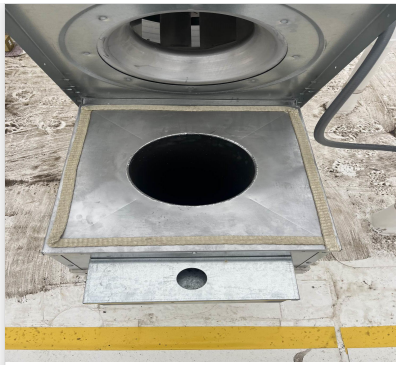
<b>Lean fan back. Is grease duct installation adequate and is duct ran all the way to the base of the fan?</b>	Pass
--	------

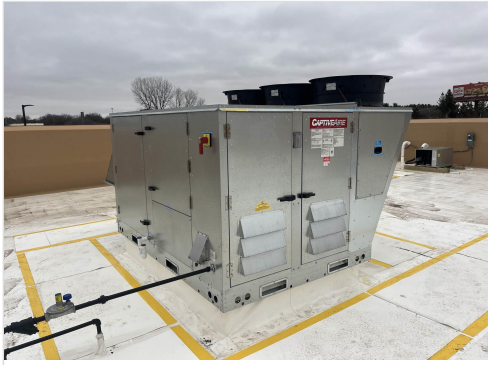
- Notes:
- [1] UNIT LABEL FLA 27.0 BASED ON UNIT VOLTAGE OF 184. WITHIN MOTOR SF.
  - [2] UNIT IS MISSING DAMPERS ON SEVERAL DIFFUSERS.
  - [3] DIFFUSERS BALANCED FOR HOOD CAPTURE.

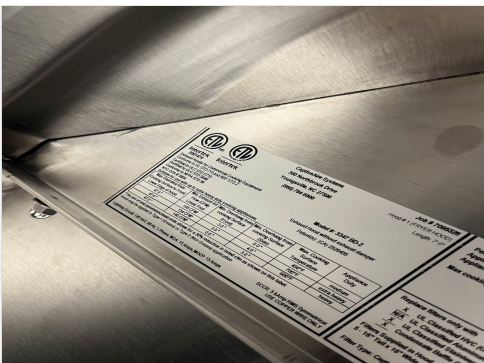
HD-1: 90%-smoke escaping on ends of hood HD-2: 100%
