Report: TAB Report
Function: Test, Adjust, & Balance
Date: 12/31/2025
Completed By: National TAB

PROJECT
02-02-26 QT #0436 PEORIA, AZ

Project: 02-02-26 QT #0436 PEORIA, AZ

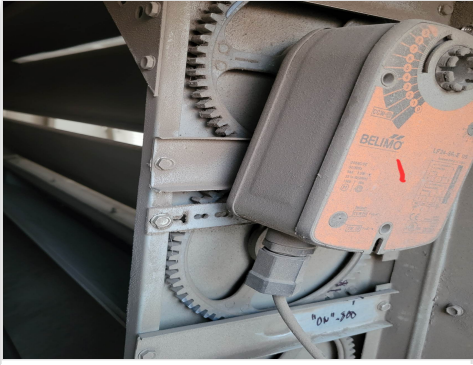
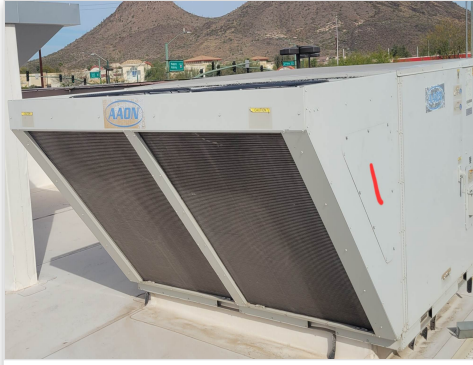
Asset: RT-1

Test Data		
	Design	Actual
SF CFM	4200	4454
SF RPM	-	30 HZ
OA CFM (Hoods On)	800	866
OA CFM (Hoods Off)	350	351
RL Voltage	-	54.8
RL Amperage	-	7.7
VFD Max SetPt	-	50.0
VFD Min SetPt	-	24.0
OA Damper Position (Hoods On)	-	40.0
OA Damper Position (Hoods Off)	-	10.0

Performance Data		
	Design	Actual
MA Plenum SP	-	-0.28"
Fan Suction SP	-	-0.43"
Fan Discharge SP	-	0.25"
Total ESP	-	0.53"
Fan Total SP	-	0.68"

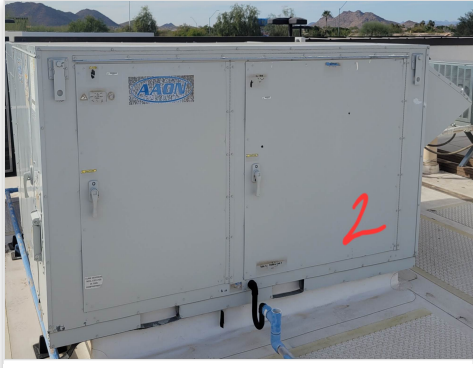
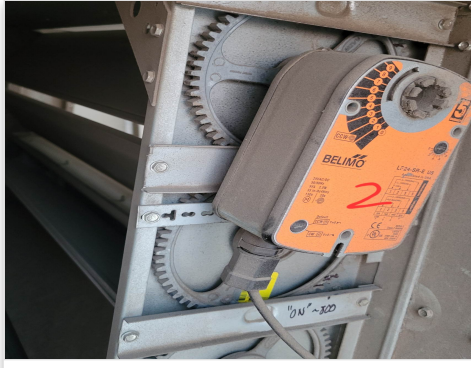
Asset: RT-2

Test Data		
	Design	Actual
SF CFM	4200	4519
SF RPM	-	30 HZ
OA CFM (Hoods On)	800	880
OA CFM (Hoods Off)	350	358
RL Voltage	-	54.9
RL Amperage	-	7.85
VFD Max SetPt	-	50.0
VFD Min SetPt	-	24.0
OA Damper Position (Hoods On)	-	40.0
OA Damper Position (Hoods Off)	-	10.0

Performance Data		
	Design	Actual
MA Plenum SP	-	-0.29"
Fan Suction SP	-	-0.43"
Fan Discharge SP	-	0.21"
Total ESP	-	0.50"
Fan Total SP	-	0.64"

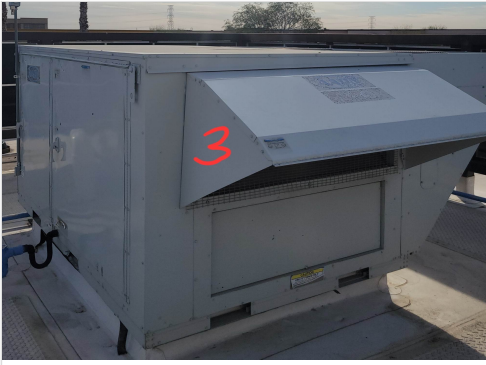
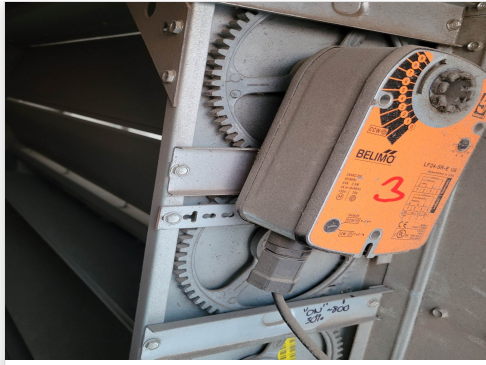
Asset: RT-3

Test Data		
	Design	Actual
SF CFM	4200	4245
SF RPM	-	39 HZ
OA CFM (Hoods On)	800	846
OA CFM (Hoods Off)	350	358
RL Voltage	-	108.8
RL Amperage	-	7.55
VFD Max SetPt	-	65.0
VFD Min SetPt	-	24.0
OA Damper Position (Hoods On)	-	30.0
OA Damper Position (Hoods Off)	-	8.0

Performance Data		
	Design	Actual
MA Plenum SP	-	-0.45"
Fan Suction SP	-	-0.63"
Fan Discharge SP	-	0.50"
Total ESP	-	0.95"
Fan Total SP	-	1.13"

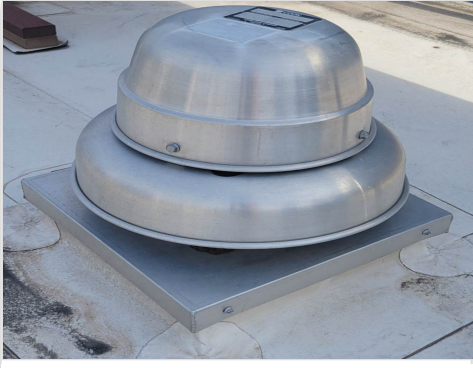
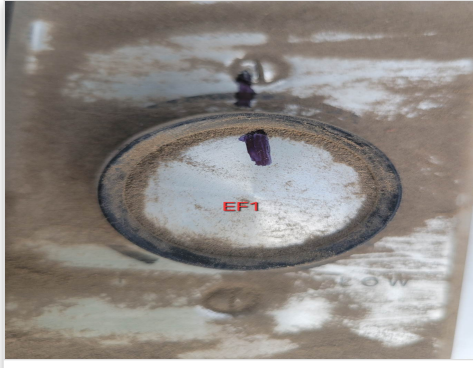
Asset: EF1

Test Data		
	Design	Actual
CFM	225	216
Fan RPM	-	N/A
Fan Rotation	-	CCW
Motor RPM	-	N/A
System SetPt	-	MED
RL Voltage	-	N/A
RL Amperage	-	0.43
Total ESP	-	0.55"
Fan Inlet SP	-	-0.55"
Fan Discharge SP	-	ATMS

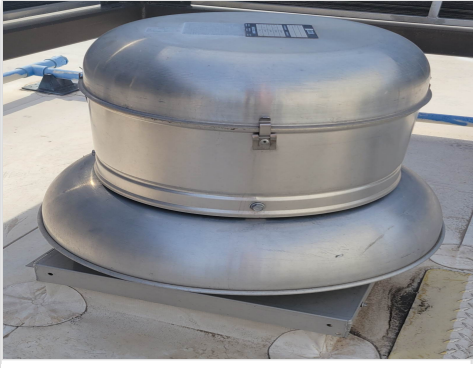
Asset: EF2

Test Data		
	Design	Actual
CFM	525	537
Fan RPM	-	N/A
Fan Rotation	-	CCW
Motor RPM	-	N/A
System SetPt	-	MED
RL Voltage	-	N/A
RL Amperage	-	0.3
Total ESP	-	0.26"
Fan Inlet SP	-	-0.26"
Fan Discharge SP	-	ATMS

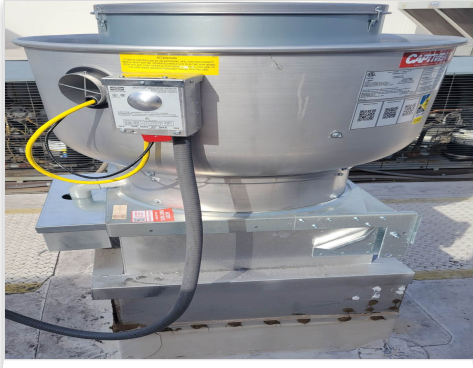
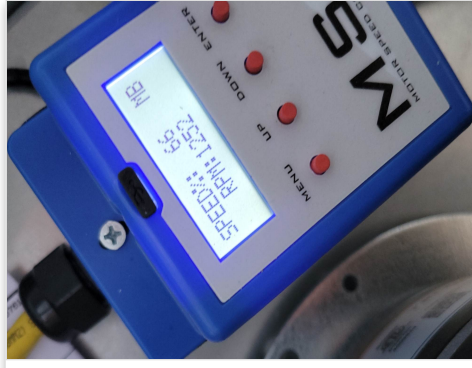
Asset: EF3

Design	Actual
CFM	1350	1373
Fan RPM	-	1252
Fan Rotation	-	CCW
Motor RPM	-	1252
System SetPt	-	52.8 HZ - 66%
RL Voltage	-	211.5
RL Amperage	-	2.43
Total ESP	0.75"	0.67"
Fan Inlet SP	-	-0.67"
Fan Discharge SP	-	ATMS

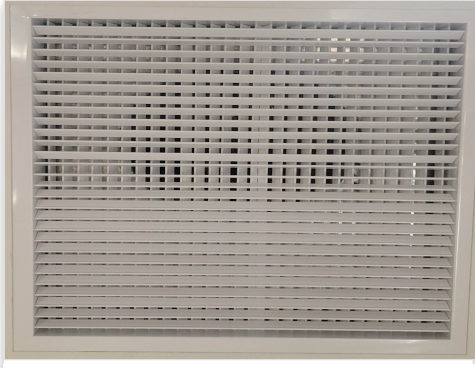
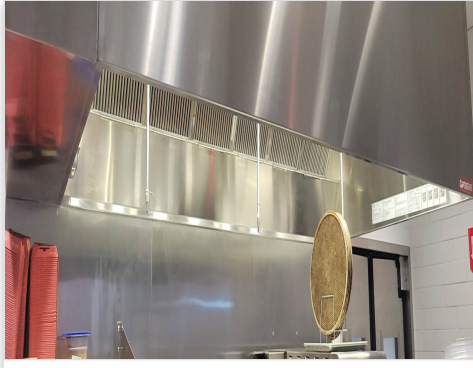
Asset: HD1

Test Data Exhaust		
	Design	Actual
Filter Type	CAPTRATE SOLO FILTER	CAPTRATE SOLO
Filter Size 1	20X16	16X20
Filter Qty 1	6	6
Filter AK factor size 1	2.08	2.08
Filter Total AK Area	12.48	12.48
Filter1 FPM	-	110
Filter2 FPM	-	112
Filter3 FPM	-	109
Filter4 FPM	-	118
Filter5 FPM	-	110
Filter6 FPM	-	103
Filter Ave FPM(corr)	-	110
CFM	1350	1373

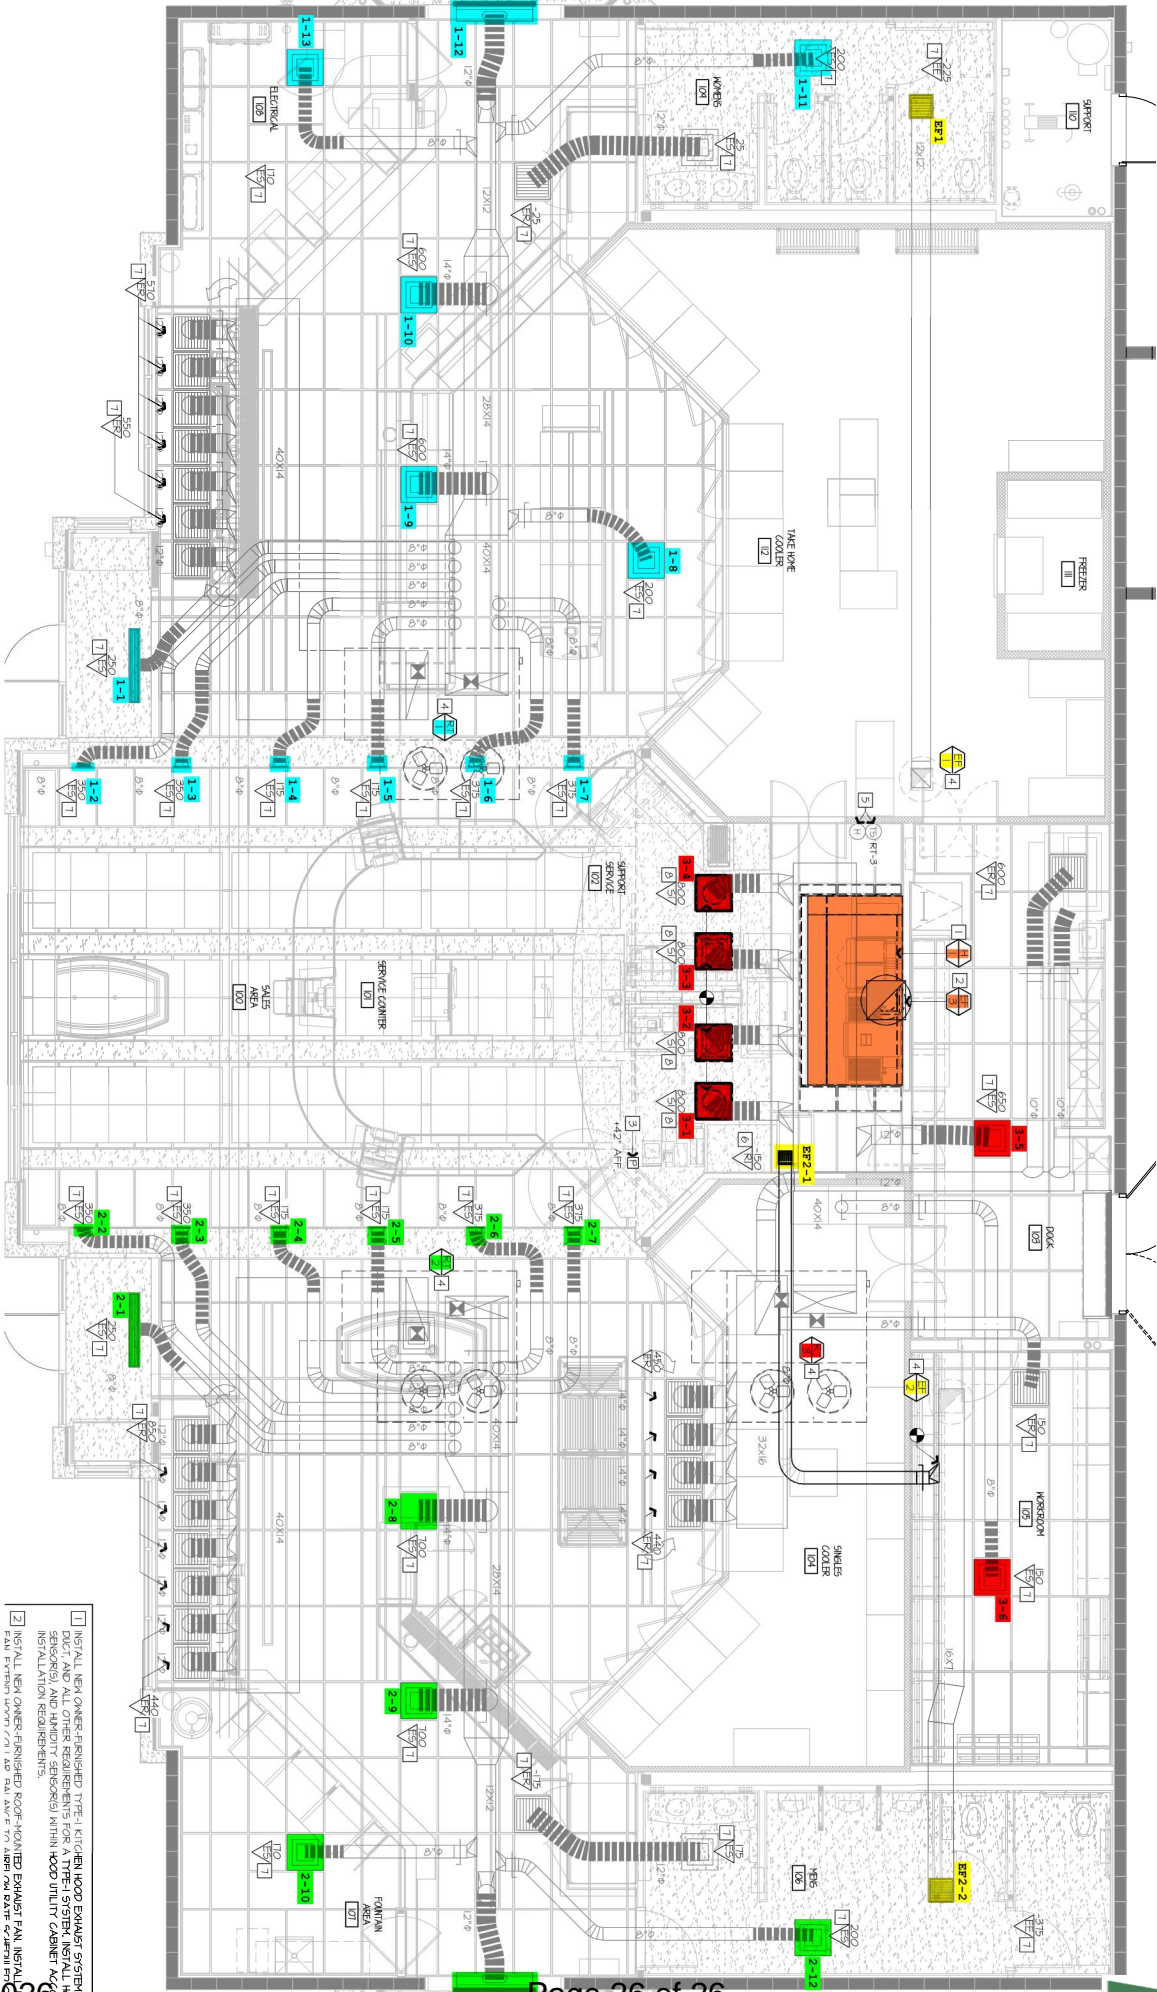
- 1 INSTALL NEW OWNER-FINISHED TYPE-I KITCHEN HOOD EXHAUST SYSTEM FREE SUPPLY DUCT AND ALL OTHER REQUIREMENTS FOR A TYPE-I SYSTEM INSTALL HOOD CONTROLS TO INSTALLATION REQUIREMENTS.
- 2 INSTALL NEW OWNER-FINISHED SCOFF-MOUNTED EXHAUST FAN INSTALL SUPPLY DUCT AND ALL OTHER REQUIREMENTS FOR A TYPE-I SYSTEM INSTALL HOOD CONTROLS TO INSTALLATION REQUIREMENTS.
