**Report: TAB Report**  
**Function: Test, Adjust, & Balance**  
**Date: 11/21/2025**  
**Completed By: National TAB**

**PROJECT**  
**11-10-25 QT #0465 PHOENIX, AZ**

Project: 11-10-25 QT #0465 PHOENIX, AZ

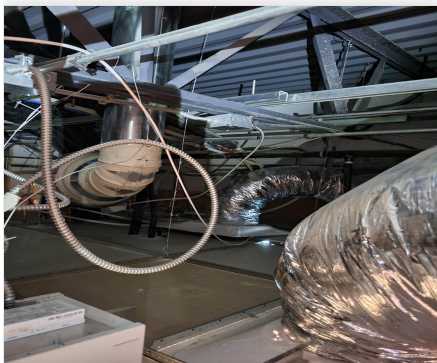
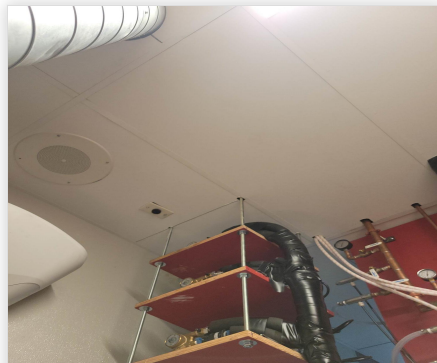
Project Issue File Details

**Issue Name :** DIFFUSER LYING ON TOP OF CEILING  
**Description :** Diffuser is not in use, should be conditioning the humid area behind the soda machines. Recommend reopening damper for duct and replacing where it should be.  
**Created By :** National TAB                      **Assigned To :** National TAB - Dan Hertenstein  
**Status :** Open  
**Priority :** Low                                      **Asset Tag :** SGRD5  
**Originated Date :** 11/23/2025 - Christine Weale - National TAB

Notes:  
RECOMMEND REPLACING SGRD-5 AND REOPENING DAMPER TO CONDITION BEHIND SODA MACHINES AND EVEN OUT AIR FLOW.

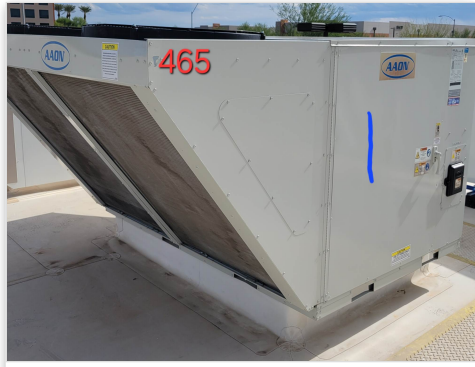
**Unit Data - PHOTO LOG**

Asset: RT-1

Unit Data	
	Actual
MFG	AAON
Serial Num	202303-ANEK25718
Model Num	RN-013-8-0-EA0A-152
Num OA Filters 1	1
OA Filter Size 1	45X22
Num Final Filter 1	2
Final Filter Size 1	46X19.5X2

Test Data		
	Design	Actual
SF CFM	4200	4612
SF RPM	-	43.8 HZ
OA CFM (Hoods On)	800	853
OA CFM (Hoods Off)	350	378
RL Voltage	-	143
RL Amperage	-	6.95
VFD Max SetPt	-	73
VFD Min SetPt	-	24
OA Damper Position (Hoods On)	-	46.0
OA Damper Position (Hoods Off)	-	0.0

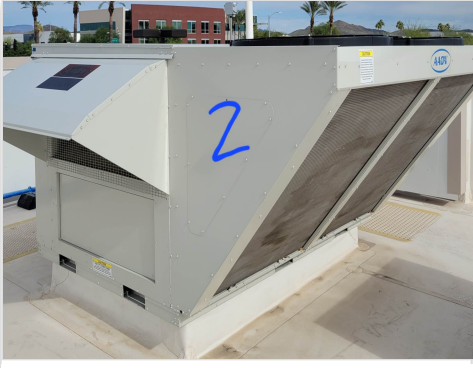
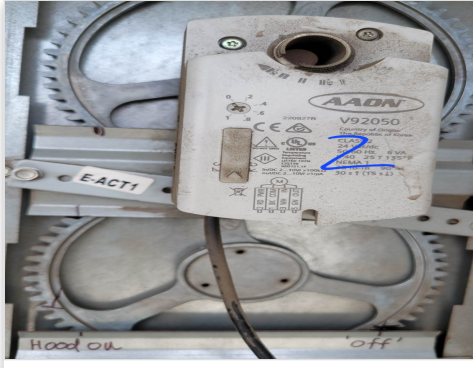
Unit Data - PHOTO LOG

Asset: RT-2

Unit Data	
	Actual
MFG	AAON
Serial Num	202303-ANEK25719
Model Num	RN-013-8-0-EA0A-152
Num OA Filters 1	1
OA Filter Size 1	45X22
Num Final Filter 1	2
Final Filter Size 1	46X19.5X2

Test Data		
	Design	Actual
SF CFM	4200	4572
SF RPM	-	49.8 HZ
OA CFM (Hoods On)	800	866
OA CFM (Hoods Off)	350	358
RL Voltage	-	181.6
RL Amperage	-	8.65
VFD Max SetPt	-	83.0
VFD Min SetPt	-	24.0
OA Damper Position (Hoods On)	-	46.0
OA Damper Position (Hoods Off)	-	0.0

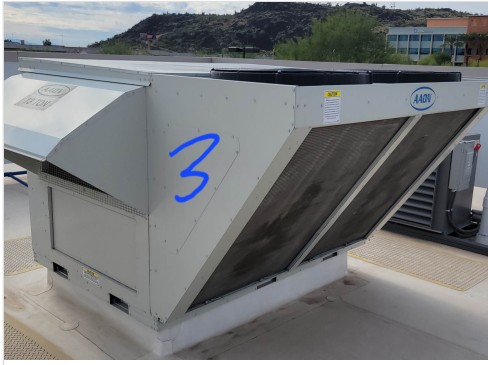
# Unit Data - PHOTO LOG

Asset: RT-3

Unit Data	
	Actual
MFG	AAON
Serial Num	202303-ANEK25717
Model Num	RN-013-8-0-EA0A-152
Num OA Filters 1	1
OA Filter Size 1	45X22
Num Final Filter 1	2
Final Filter Size 1	46X19.5X2

Notes:  
DAMPERS INACCESSIBLE, SEE 'REMARKS'.

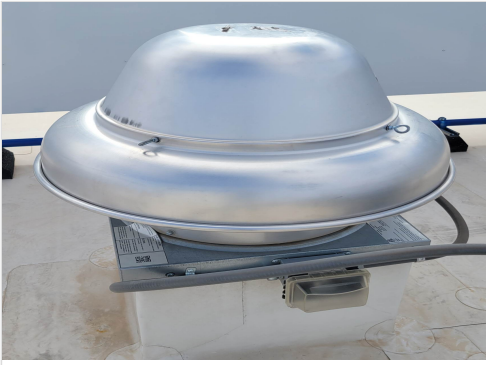
## Unit Data - PHOTO LOG

Asset: EF1

Unit Data		
	Design	Actual
MFG	NA	CAPTIVEAIRE
Model Num	NA	DR50HFA
Serial Num	-	5920923
Type	-	DOWNBLAST
Configuration	-	VERTICAL

Test Data		
	Design	Actual
CFM	750	834
Fan RPM	-	N/A
Fan Rotation	-	CCW
Motor RPM	-	N/A
System SetPt	-	LOW
RL Voltage	-	N/A
RL Amperage	-	7.51
Total ESP	-	0.17"
Fan Inlet SP	-	-0.17"
Fan Discharge SP	-	ATMS

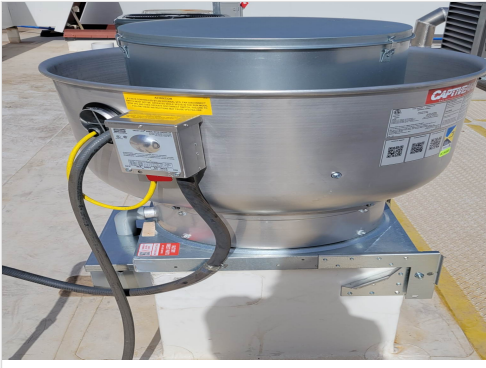
**Unit Data - PHOTO LOG**

Asset: EF3

Unit Data		
	Design	Actual
MFG	NA	CAPTIVEAIRE
Model Num	NA	DU50HFA
Serial Num	-	7644877
Type	UPBLAST	UPBLAST
Configuration	VERTICAL	VERTICAL

Test Data		
	Design	Actual
CFM	1350	1408
Fan RPM	-	1217
Fan Rotation	-	CCW
Motor RPM	-	1217
System SetPt	-	51.8 HZ
RL Voltage	-	216.2
RL Amperage	-	1.93
Total ESP	-	0.66"
Fan Inlet SP	-	-0.66"
Fan Discharge SP	-	ATMS

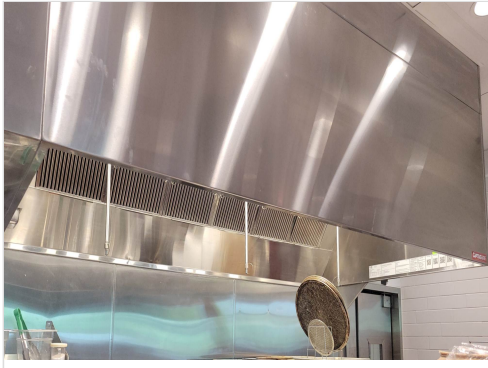
## Unit Data - PHOTO LOG

Asset: HD1

Unit Data		
	Design	Actual
MFG	CAPTIVEAIRE	CAPTIVEAIRE
Model Num	6030 ND-2-F	6030 ND-2-F
Job / Serial Num	-	7644877
Type	TYPE I CANOPY	TYPE I CANOPY
Hood length	-	108"
Hood Width	-	60"

Test Data Exhaust		
	Design	Actual
Filter Type	-	CAPTRATE SOLO
Filter Size 1	-	16X20
Filter Qty 1	-	6
Filter AK factor size 1	-	2.08
Filter Total AK Area	-	12.48
Filter1 FPM	-	110
Filter2 FPM	-	123
Filter3 FPM	-	117
Filter4 FPM	-	112
Filter5 FPM	-	106
Filter6 FPM	-	109
Filter Ave FPM(corr)	-	113
CFM	1350	1408
