Report: TAB Report
Function: Test, Adjust, & Balance
Date: 11/21/2025
Completed By: National TAB

PROJECT
11-10-25 QT #0465 PHOENIX, AZ

Project: 11-10-25 QT #0465 PHOENIX, AZ

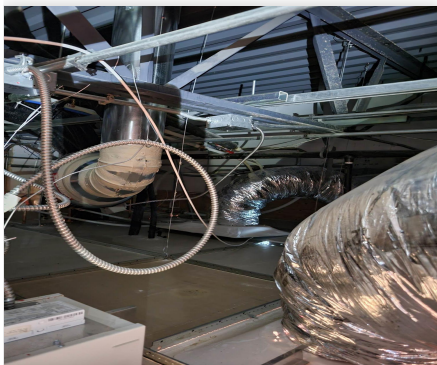
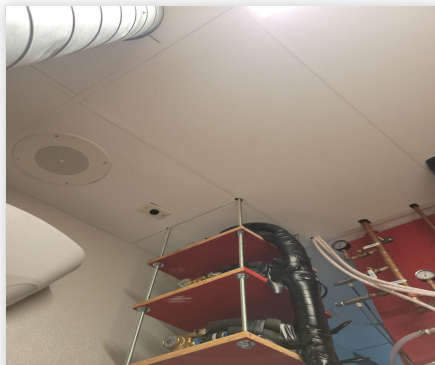
Issue Name : DIFFUSER LYING ON TOP OF CEILING
Description : Diffuser is not in use, should be conditioning the humid area behind the soda machines. Recommend reopening damper for duct and replacing where it should be.
Created By : National TAB **Assigned To :** National TAB - Dan Hertenstein
Status : Open
Priority : Low **Asset Tag :** SGRD5
Originated Date : 11/23/2025 - Christine Weale - National TAB

Notes:
RECOMMEND REPLACING SGRD-5 AND REOPENING DAMPER TO CONDITION BEHIND SODA MACHINES AND EVEN OUT AIR FLOW.

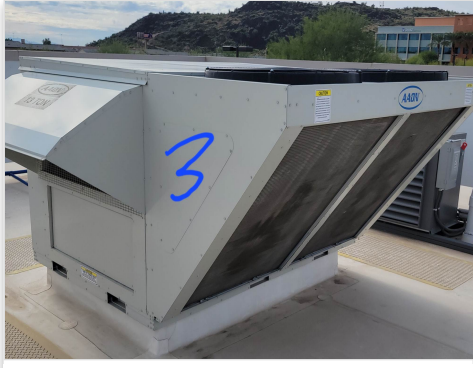
Asset: RT-3

Unit Data	
	Actual
MFG	AAON
Serial Num	202303-ANEK25717
Model Num	RN-013-8-0-EA0A-152
Num OA Filters 1	1
OA Filter Size 1	45X22
Num Final Filter 1	2
Final Filter Size 1	46X19.5X2

Test Data		
	Design	Actual
SF CFM	4200	4497
SF RPM	-	46.2 HZ
OA CFM (Hoods On)	800	853
OA CFM (Hoods Off)	350	358
RL Voltage	-	158.8
RL Amperage	-	7.7
VFD Max SetPt	-	77.0
VFD Min SetPt	-	24.0
OA Damper Position (Hoods On)	-	46.0
OA Damper Position (Hoods Off)	-	0.0

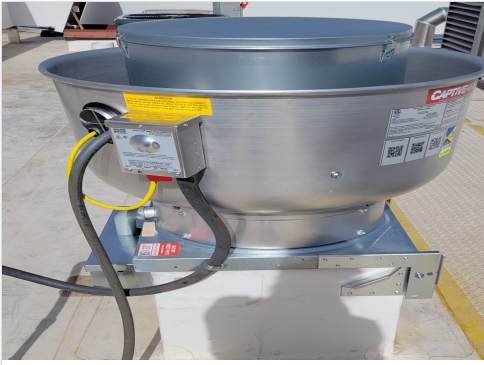
Asset: EF3

Unit Data		
	Design	Actual
MFG	NA	CAPTIVEAIRE
Model Num	NA	DU50HFA
Serial Num	-	7644877
Type	UPBLAST	UPBLAST
Configuration	VERTICAL	VERTICAL

Test Data		
	Design	Actual
CFM	1350	1408
Fan RPM	-	1217
Fan Rotation	-	CCW
Motor RPM	-	1217
System SetPt	-	51.8 HZ
RL Voltage	-	216.2
RL Amperage	-	1.93
Total ESP	-	0.66"
Fan Inlet SP	-	-0.66"
Fan Discharge SP	-	ATMS
