Report: TAB Report
Function: Test, Adjust, & Balance
Date: 11/21/2025
Completed By: National TAB

PROJECT
11-10-25 QT #0465 PHOENIX, AZ

Project: 11-10-25 QT #0465 PHOENIX, AZ

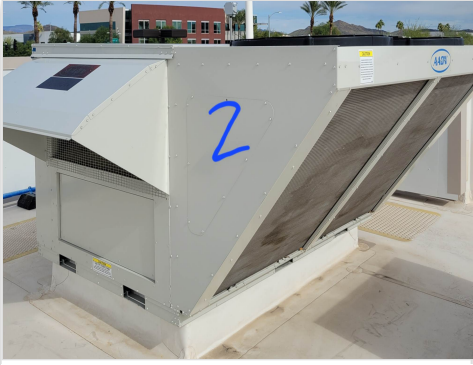
Unit Data - PHOTO LOG

Unit Data	
	Actual
MFG	AAON
Serial Num	202303-ANEK25719
Model Num	RN-013-8-0-EA0A-152
Num OA Filters 1	1
OA Filter Size 1	45X22
Num Final Filter 1	2
Final Filter Size 1	46X19.5X2

Test Data		
	Design	Actual
SF CFM	4200	4572
SF RPM	-	49.8 HZ
OA CFM (Hoods On)	800	866
OA CFM (Hoods Off)	350	358
RL Voltage	-	181.6
RL Amperage	-	8.65
VFD Max SetPt	-	83.0
VFD Min SetPt	-	24.0
OA Damper Position (Hoods On)	-	46.0
OA Damper Position (Hoods Off)	-	0.0

Notes:
RECOMMEND REPLACING SGRD-5 AND REOPENING DAMPER TO CONDITION BEHIND SODA MACHINES AND EVEN OUT AIR FLOW.

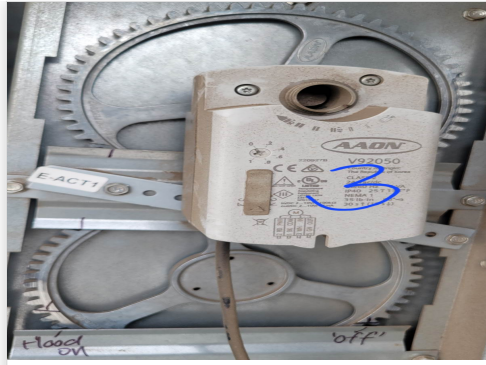
Unit Data - PHOTO LOG

Unit Data	
	Actual
MFG	AAON
Serial Num	202303-ANEK25717
Model Num	RN-013-8-0-EA0A-152
Num OA Filters 1	1
OA Filter Size 1	45X22
Num Final Filter 1	2
Final Filter Size 1	46X19.5X2

Notes:
DAMPERS INACCESSIBLE, SEE 'REMARKS'.

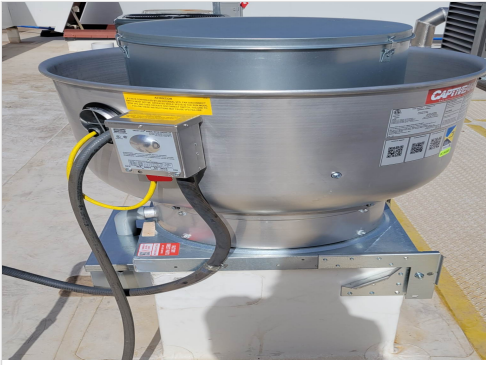
Unit Data - PHOTO LOG

Unit Data		
	Design	Actual
MFG	NA	CAPTIVEAIRE
Model Num	NA	DU50HFA
Serial Num	-	7644877
Type	UPBLAST	UPBLAST
Configuration	VERTICAL	VERTICAL

Test Data		
	Design	Actual
CFM	1350	1408
Fan RPM	-	1217
Fan Rotation	-	CCW
Motor RPM	-	1217
System SetPt	-	51.8 HZ
RL Voltage	-	216.2
RL Amperage	-	1.93
Total ESP	-	0.66"
Fan Inlet SP	-	-0.66"
Fan Discharge SP	-	ATMS
