Report: Report
Function: Test, Adjust, & Balance
Date: 12/29/2023

PROJECT
11-13-23 PENN STATION - OXFORD, OH

SDV Job #: 6340295 - SDV for Job 6113273

Region Job #: 6113273
Region Job Name: Penn Station V2B-6L (Oxford, OH)

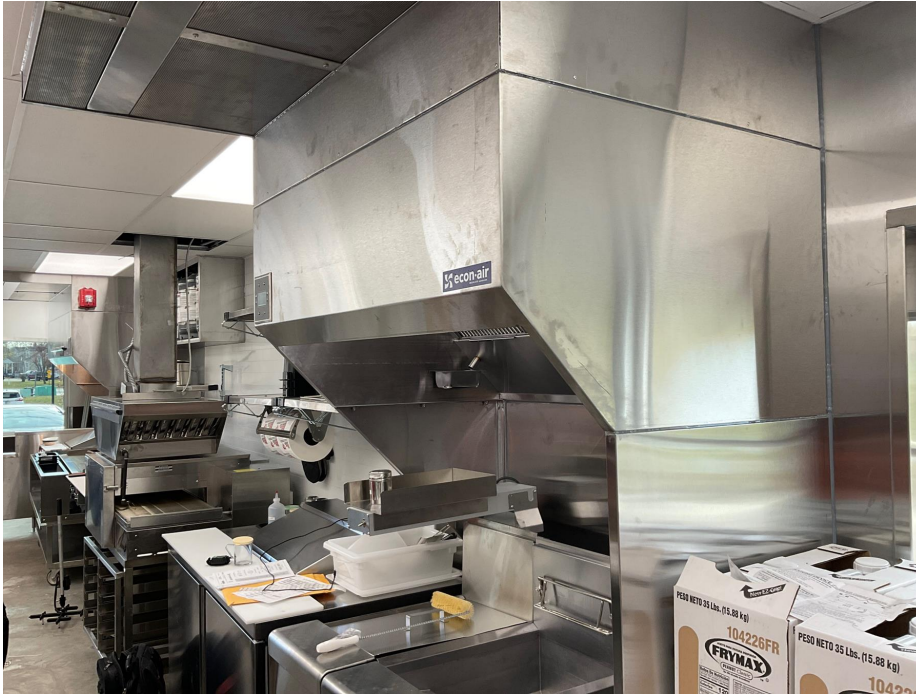
Hood 3 (HD3-Fry) (HD3-Fry)

Model:	3650ELPX-2	Length:	4' 2.00"		
Exhaust CFM:	Design = 833	Initial = 1150	Final = 807	(96.9% of design)

Hung Using appropriate material to safely secure hood.	Design: Yes	Actual: Yes
COOKING EQUIPMENT ON AND OPERATING	Design: Yes	Actual: Yes
COOKING EQUIPMENT INSTALLED AS CLOSE TO BACK WALL AS POSSIBLE	Design: Yes	Actual: Yes
END PANELS INSTALLED CORRECTLY	Design: Yes	Actual: Yes
Smoke Test Performed on all Hoods? Upload Video	Design: Yes	Actual: Yes

Front Lower Edge of Hood is within 6'6" - 7' - 0" (78" - 84") Appliance From Floor (AFF)	Design: Yes	Actual: Yes
--	--------------------	--------------------

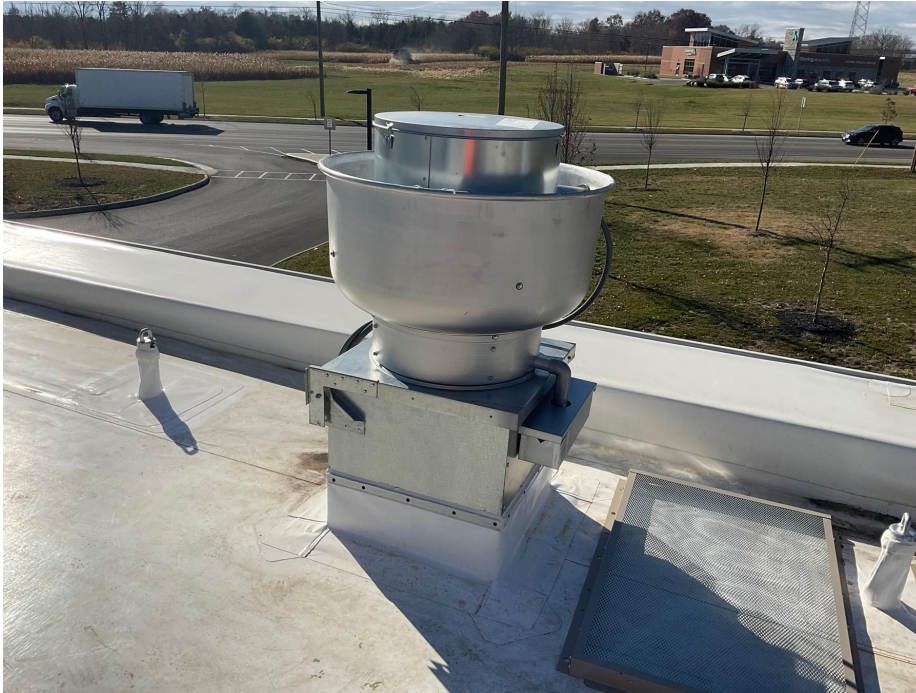
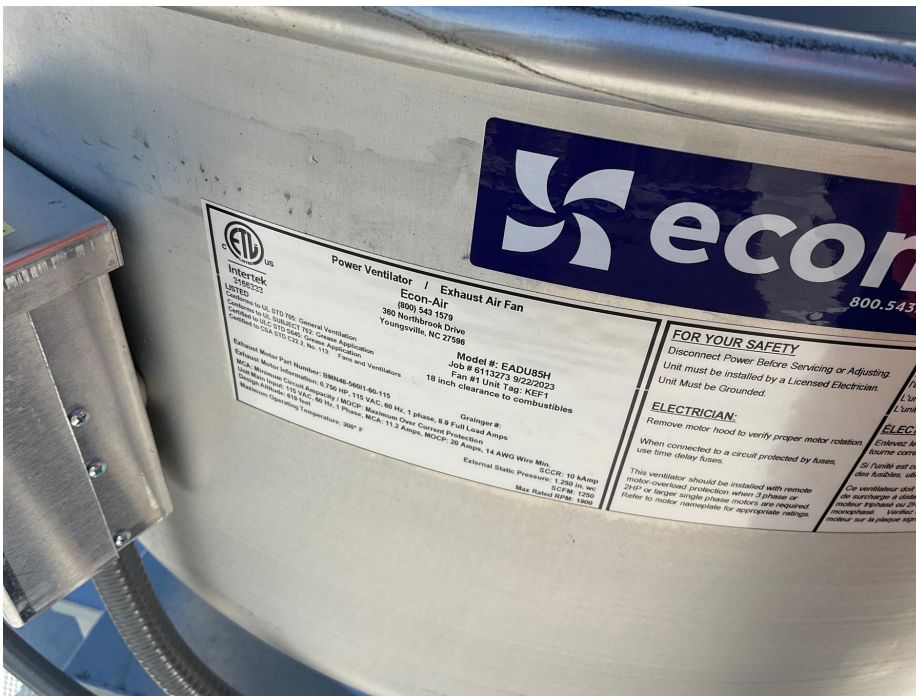
Fan 1 - EADU85H (KEF1) (KEF1)

Exhaust CFM: Design = 1250 Actual = 1165 (93.2% of design)

Record the ECM Speed		Actual: 56
VOLTS	Design: 115	Actual: 122
HP	Design: 0.75	Actual: 0.75
HUB SET SCREW TIGHT	Design: Yes	Actual: Yes
FAN LEVEL	Design: Yes	Actual: Yes
ROTATION	Design: Correct	Actual: Correct
FAN VIBRATION	Design: Good	Actual: Good
RPM - DESIGN	Design: 1278	Actual: 1008
RPM - MAX	Design: 1900	Actual: N/A
RPM - MAX RECOMMENDED	Design: 1600	Actual: N/A
FLA	Design: 8.9	Actual: 3.5
OVERLOAD SET POINT	N/A	
PHASE	Design: 1	Actual: 1
Unit within five miles from the coast?		Actual: No
INSPECT ALL EXTERIOR SIDES OF UNIT. ANY VISIBLE DAMAGE	Design: No	Actual: No
SPEED CONTROL VOLTAGE	Design: 65	Actual: N/A

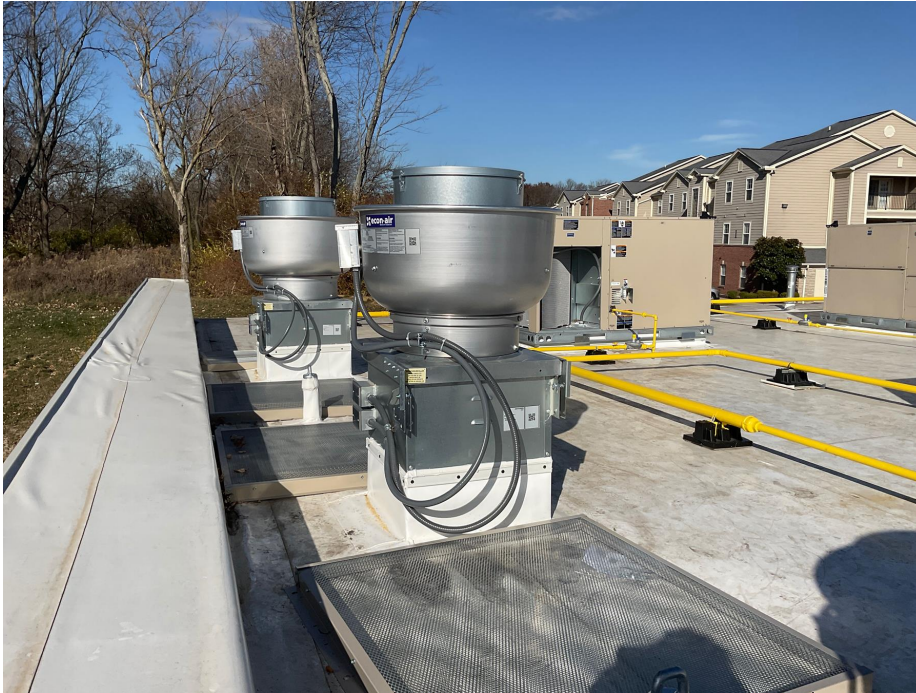
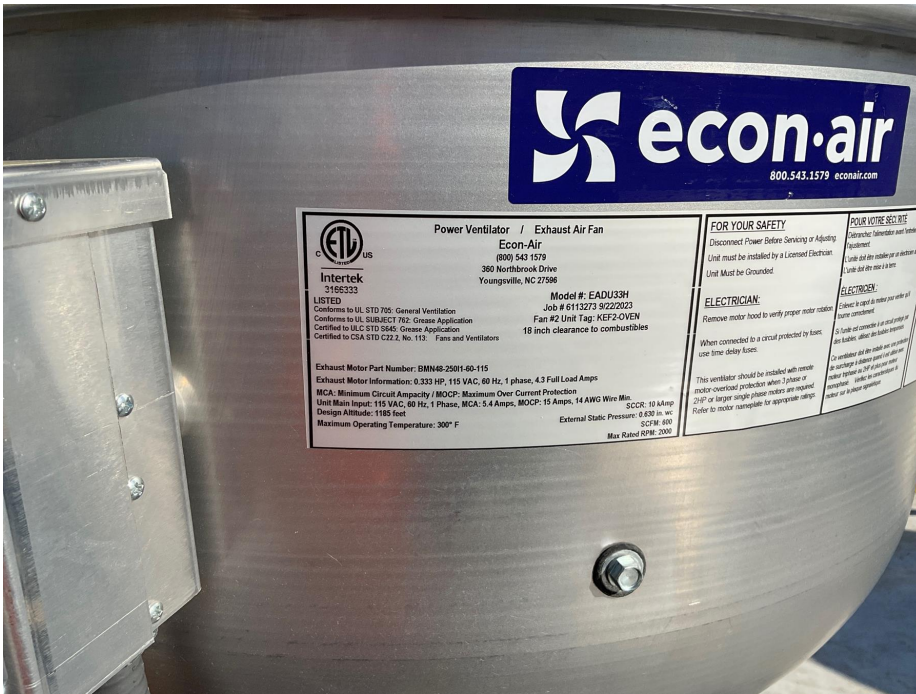
Fan 2 - EADU33H (KEF2-OVEN) (KEF2-OVEN)

Exhaust CFM: Design = 600 Actual = 572 (95.3% of design)

Record the ECM Speed		Actual: 75
VOLTS	Design: 115	Actual: 122
HP	Design: 0.333	Actual: 0.333
HUB SET SCREW TIGHT	Design: Yes	Actual: Yes
FAN LEVEL	Design: Yes	Actual: Yes
ROTATION	Design: Correct	Actual: Correct
FAN VIBRATION	Design: Good	Actual: Good
RPM - DESIGN	Design: 1357	Actual: 1350
RPM - MAX	Design: 2000	Actual: N/A
RPM - MAX RECOMMENDED	Design: 1600	Actual: N/A
FLA	Design: 4.3	Actual: 2.3
OVERLOAD SET POINT	N/A	
PHASE	Design: 1	Actual: 1
Unit within five miles from the coast?		Actual: No
INSPECT ALL EXTERIOR SIDES OF UNIT. ANY VISIBLE DAMAGE	Design: No	Actual: No
SPEED CONTROL VOLTAGE	Design: 65	Actual: N/A

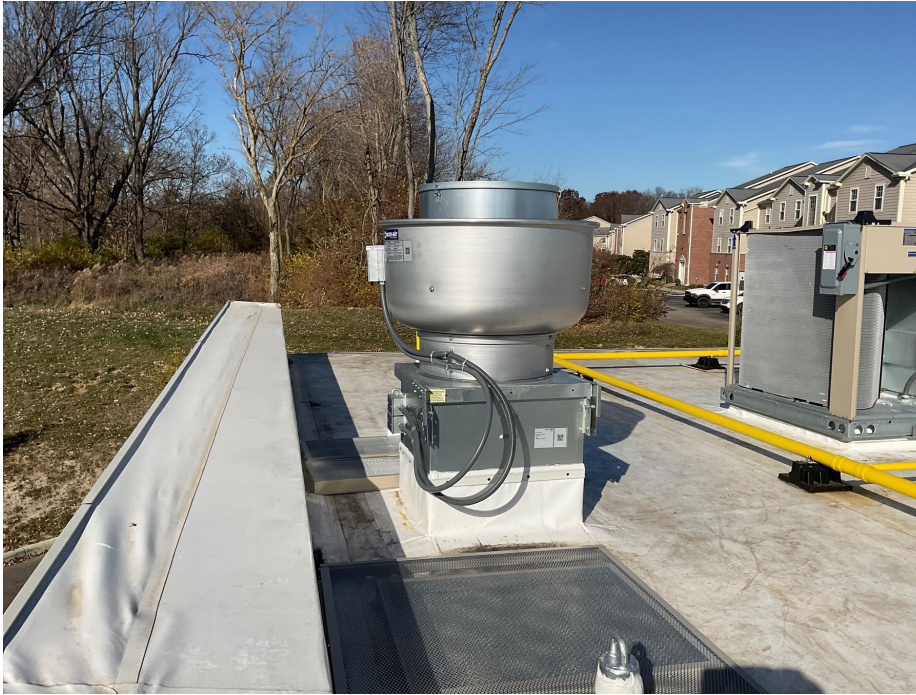
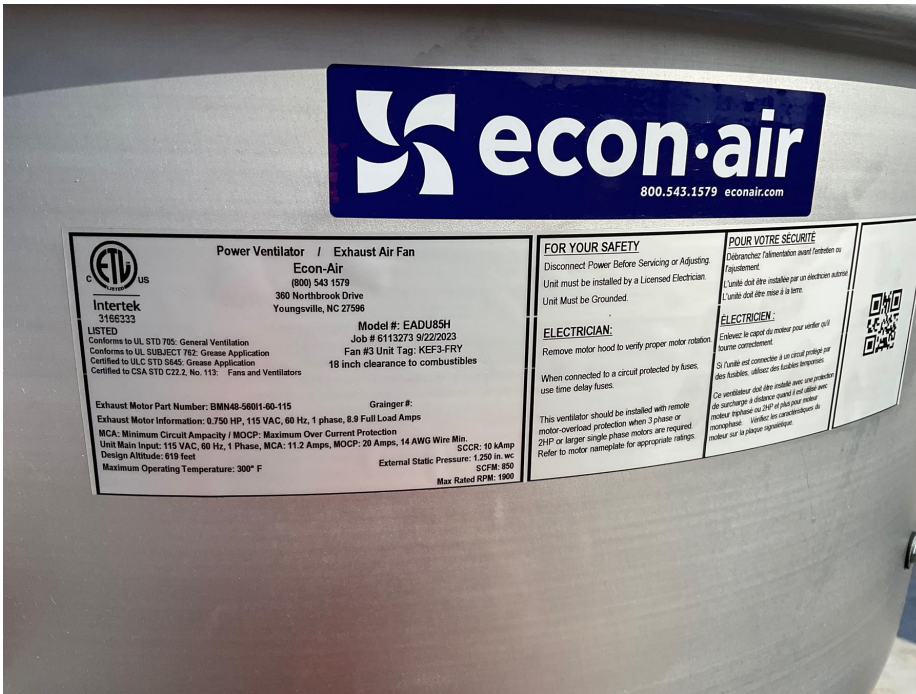
Fan 3 - EADU85H (KEF3-FRY) (KEF3-FRY)

Exhaust CFM: Design = 850 Actual = 807 (94.9% of design)

Record the ECM Speed		Actual: 48
VOLTS	Design: 115	Actual: 122
HP	Design: 0.75	Actual: 0.75
HUB SET SCREW TIGHT	Design: Yes	Actual: Yes
FAN LEVEL	Design: Yes	Actual: Yes
ROTATION	Design: Correct	Actual: Correct
FAN VIBRATION	Design: Good	Actual: Good
RPM - DESIGN	Design: 1189	Actual: 864
RPM - MAX	Design: 1900	Actual: N/A
RPM - MAX RECOMMENDED	Design: 1600	Actual: N/A
FLA	Design: 8.9	Actual: 2.1
OVERLOAD SET POINT	N/A	
PHASE	Design: 1	Actual: 1
Unit within five miles from the coast?		Actual: No
INSPECT ALL EXTERIOR SIDES OF UNIT. ANY VISIBLE DAMAGE	Design: No	Actual: No
SPEED CONTROL VOLTAGE	Design: 65	Actual: N/A

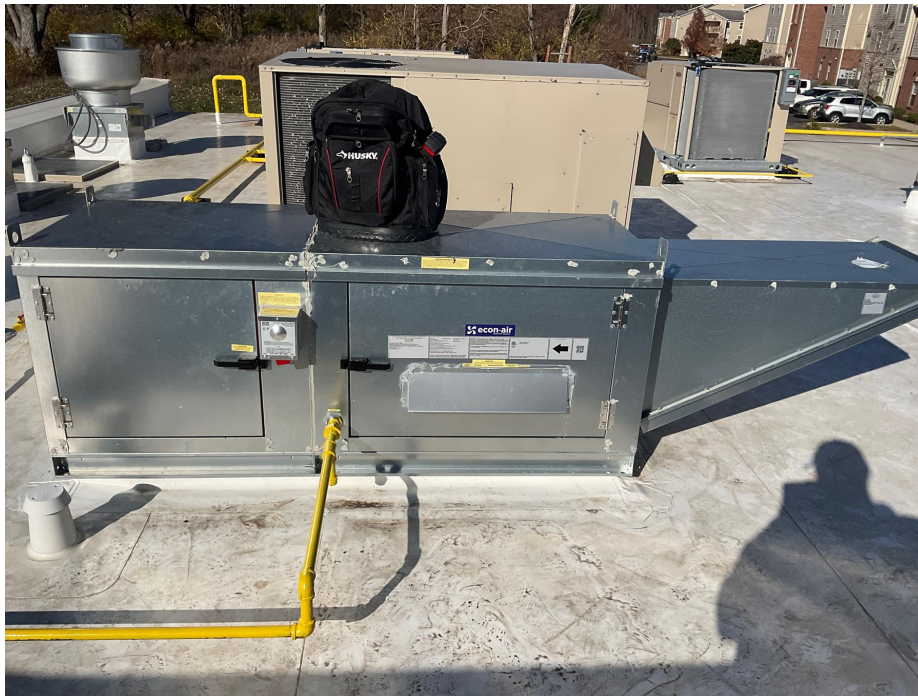
Fan 4 - EA1-D.250-15D (HMUA1) (HMUA1)

Supply CFM: Design = 1630 Actual = 1659 (101.8% of design)

VOLTS	Design: 208	Actual: 211
Is the main transformer (TR-01) tapped for the correct voltage?		Actual: Yes
HP	Design: 1.5	Actual: 1.5
HUB SET SCREW TIGHT	Design: Yes	Actual: Yes
FAN LEVEL	Design: Yes	Actual: Yes
ROTATION	Design: Correct	Actual: Correct
FAN VIBRATION	Design: Good	Actual: Good
RPM - DESIGN	Design: 1740	Actual: 1449
RPM - MAX	Design: 3000	Actual: N/A
RPM - MAX RECOMMENDED	Design: 2400	Actual: N/A
FLA	Design: 4.4	Actual: 3
OVERLOAD SET POINT N/A		
PHASE	Design: 3	Actual: 3
DAMPER INSTALLED	Design: Yes	Actual: Yes
Unit within five miles from the coast?		Actual: No
INSPECT ALL EXTERIOR SIDES OF UNIT. ANY VISIBLE DAMAGE		Actual: No
Record the VFD HZ	Design: 59.7 Hz	Actual: 49.7
MCA	Design: 5.5 Amps	Actual: 6.7
MOCp	Design: 15 Amps	Actual: 15
Is Supply Fan bolted/secured to curb?	Design: Yes	Actual: Yes

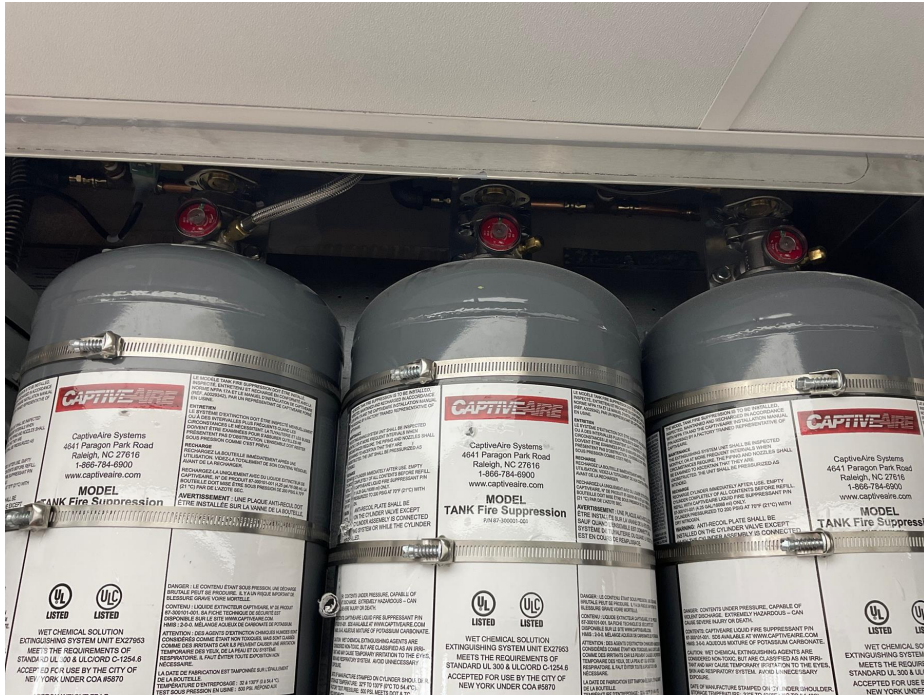
Actuator is in Shipped position with shipping plates mounted upon arrival? Upload Picture.

Actual: **Yes**

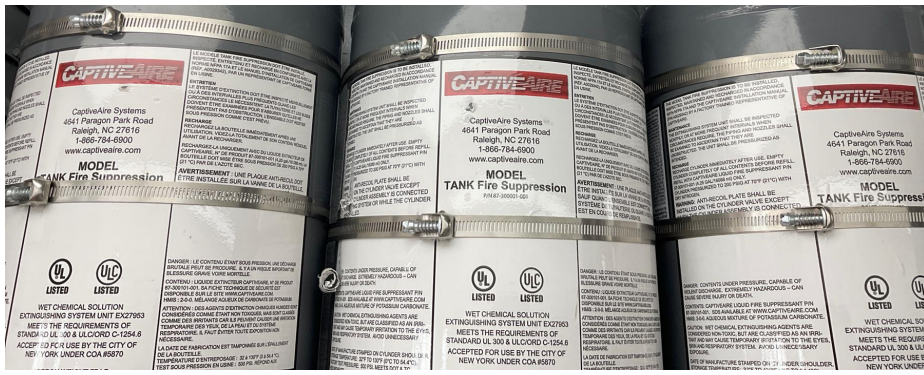
Is the system commissioned with the actuator bolted onto the TANK Fire Suppression system tank? Upload Picture. Design: **Yes** Actual: **No**

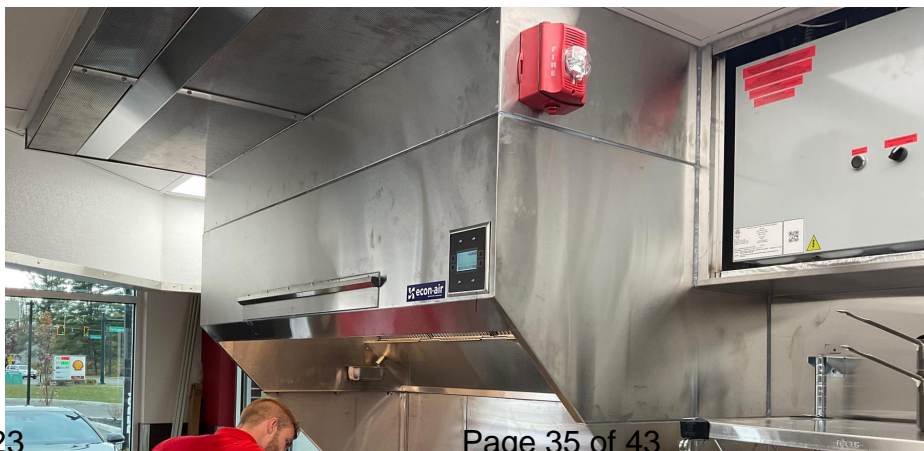
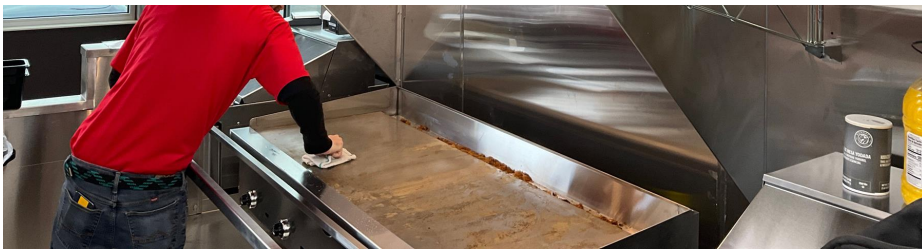
Is appliance specific protection piped with adequate protection? Upload picture.
