Report: Renew  
Date: 11/30/2021

**PROJECT**  
**FREDDY'S - SOUTH WICHITA - RENEW 3FH (4)**

3450 S MERIDIAN  
WICHITA, KS 67217

Project: FREDDY'S - SOUTH WICHITA - RENEW 3FH (4)

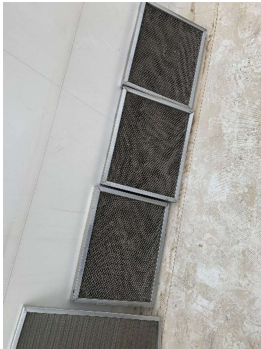
MAU  
DIRTY OUTSIDE AIR FILTERS

MAU: The intake filters had slight dirt accumulation. They were washed.

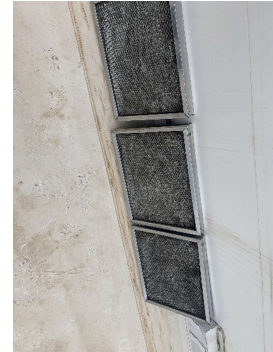
MAU  
CLEAN OUTSIDE AIR FILTERS

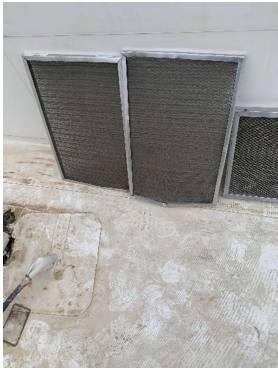
RTU-1 (DINING)  
DIRTY OUTSIDE AIR FILTERS

RTUs: There evaporator coil was rinsed off and cleaned. During warmer months a self-cleaning chemical is sprayed on the evaporator. The outside air filters were rinsed off to remove any dirty, so the unit stays at the designated outside air set point. Based on static pressures, amps, and fan rpm it shows that the total supply has not changed since the last test and balance.

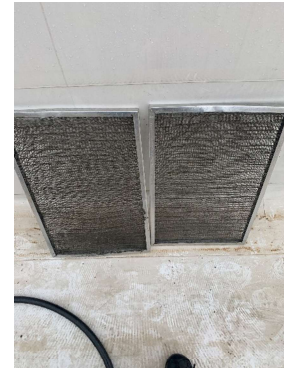
RTU-1 (DINING)  
CLEAN OUTSIDE AIR FILTERS

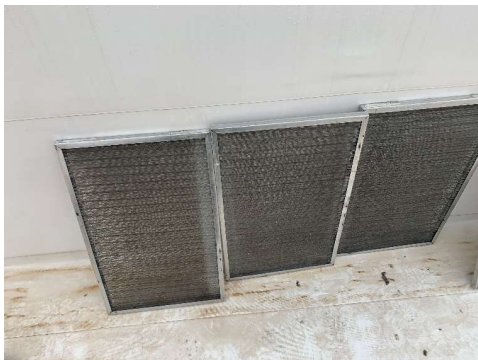
RTU-2 (KITCHEN)  
DIRTY OUTSIDE AIR FILTERS

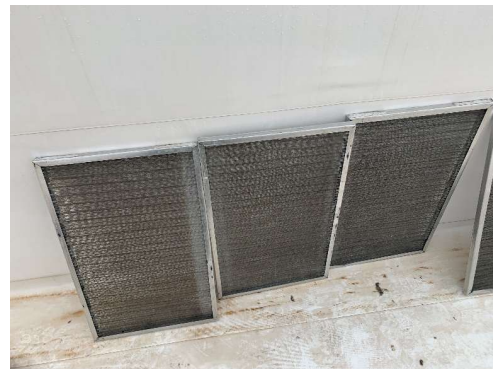
RTU-2 (KITCHEN)  
CLEAN OUTSIDE AIR FILTERS

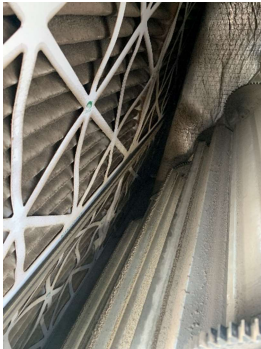
RTU-1 (DINING)  
DIRTY EVAPORATOR FILTERS

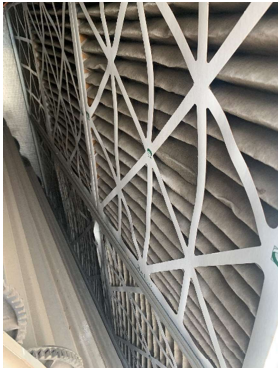
RTU-2 (KITCHEN)  
DIRTY EVAPORATOR FILTERS

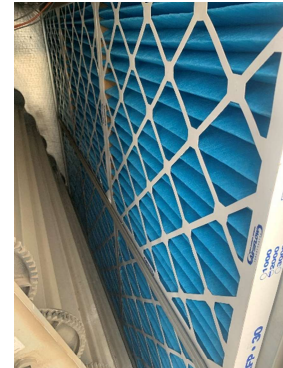
RTU-2 (KITCHEN)  
CLEAN EVAPORATOR FILTERS

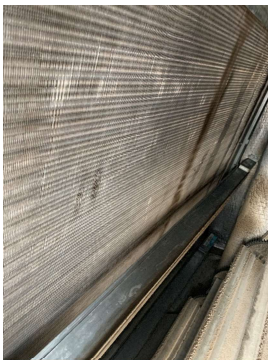
RTU-1 (DINING)  
DIRTY EVAPORATOR

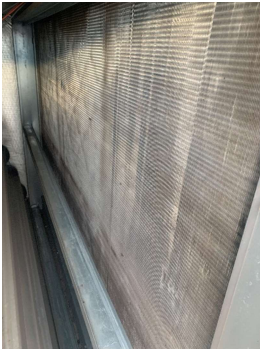
RTU-2 (KITCHEN)  
DIRTY EVAPORATOR

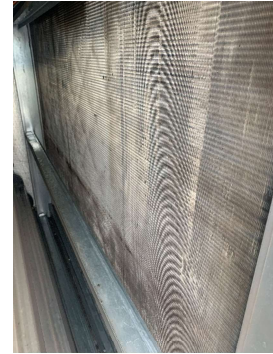
RTU-2 (KITCHEN)  
CLEAN EVAPORATOR

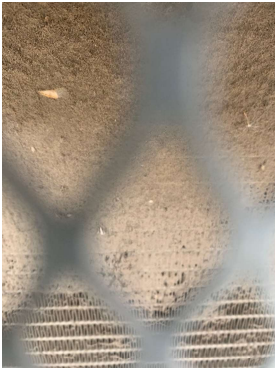
RTU-1 (DINING)  
DIRTY CONDENSER

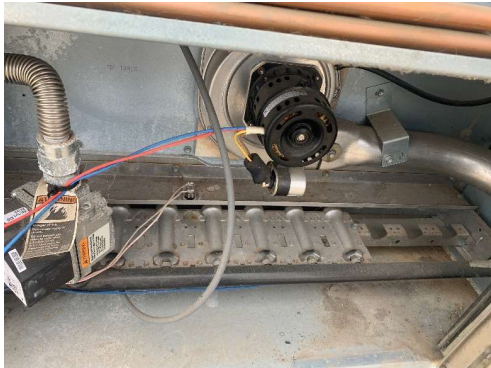
**RTU-2 (KITCHEN)  
DIRTY HEATER SECTION**

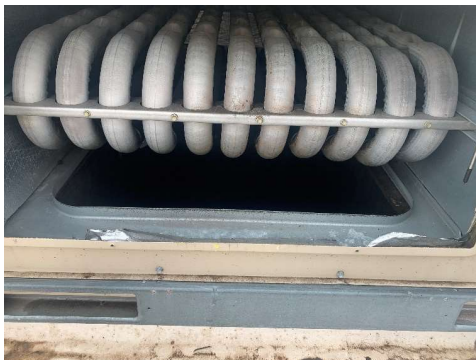
**RTU-1 (DINING)  
BURNER TUBE INSPECTION**

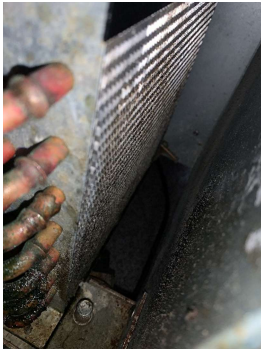
DXC-2 (MEAT COOLER 1)  
DIRTY CONDENSER FILTER

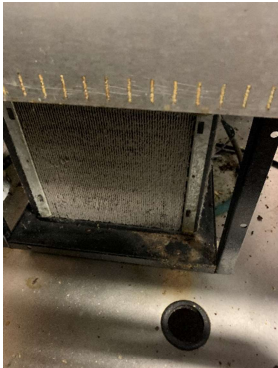
DXC-3 (PREP TABLE)  
DIRTY CONDENSER

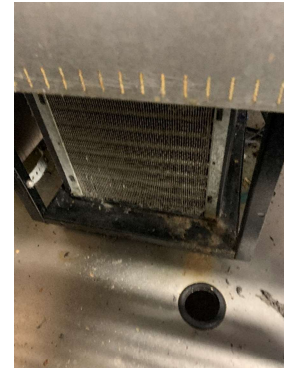
DXC-3 (PREP TABLE)  
CLEAN CONDENSER

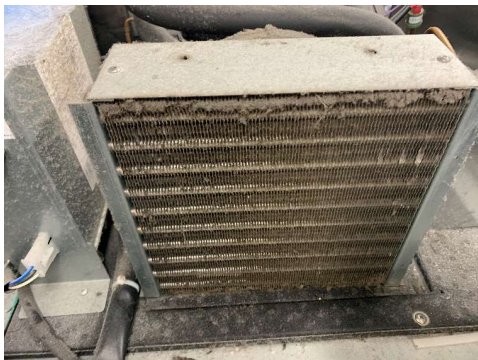
DXC-4 (FRYER FREEZER)  
DIRTY CONDENSER

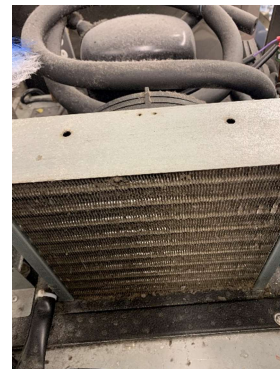
DXC-4 (FRYER FREEZER)  
CLEAN CONDENSER

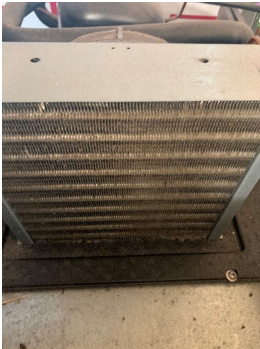
DXC-5 (SUNDAE PREP)  
DIRTY CONDENSER

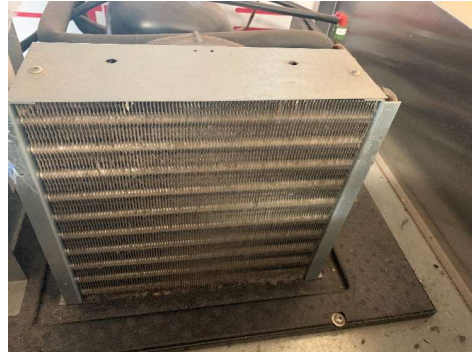
DXC-5 (SUNDAE PREP)  
CLEAN CONDENSER

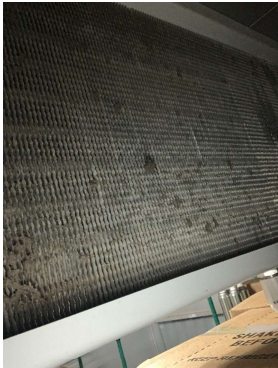
DXC-1 (WALK-IN COOLER)  
DIRTY EVAPORATOR

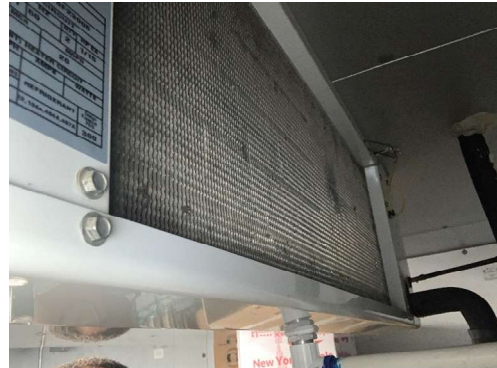
DXC-1 (WALK-IN COOLER)  
CLEAN EVAPORATOR

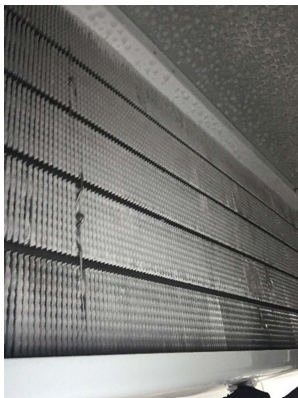
DXC-1 (WALK-IN FREEZER)  
DIRTY EVAPORATOR

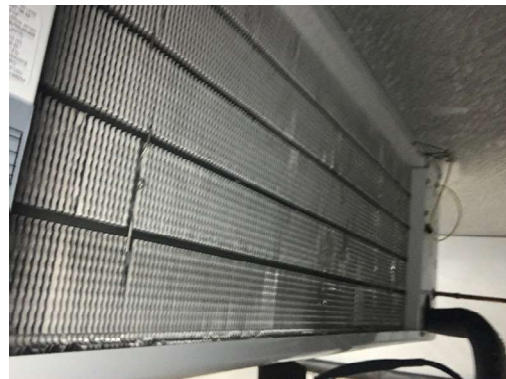
DXC-1 (WALK-IN FREEZER)  
CLEAN EVAPORATOR

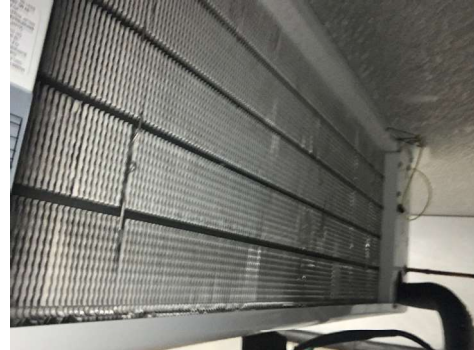
DXC-1 (WALK-IN FREEZER)  
CLEAN EVAPORATOR
