Report: TAB

Function: Test, Adjust, & Balance

**08-04-25 KURA SUSHI SAN FRANCISCO, CA
(REVIVE)**

Project: 08-04-25 KURA SUSHI SAN FRANCISCO, CA (REVIVE)

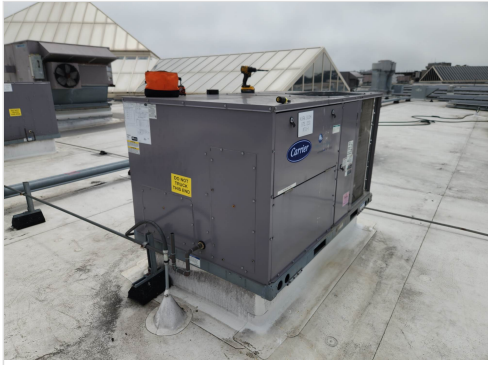
Asset: RTU1

Test Data		
	Design	Actual
SF CFM	2000	1987
SF RPM	-	1484
RA CFM	-	1987
OA CFM	-	0
RL Voltage	-	487/487/487
RL Amperage	-	0.76/0.77/0.76
SF Rotation	-	CCW
SF System SetPt	-	8.6VDC
RA Damper Position	-	100%
Min OA Damper Position	-	N/A
Min OA Damper Type	-	N/A
OA Enthalpy Setpt	-	N/A

Performance Data		
	Design	Actual
MA Plenum SP	-	-0.25"
Fan Suction SP	-	-0.49"
Fan Discharge SP	-	0.33"
Total ESP	0.6"	0.58"
Fan Total SP	-	0.82"

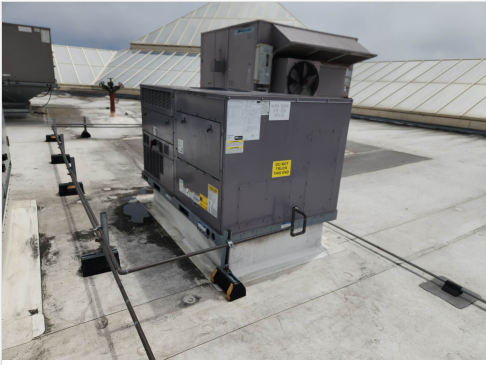
Asset: RTU2

Test Data		
	Design	Actual
SF CFM	2000	2033
SF RPM	-	1509
RA CFM	-	2033
OA CFM	-	0
RL Voltage	-	487/487/487
RL Amperage	-	1.01/1.01/1.01
SF Rotation	-	CCW
SF System SetPt	-	8.9VDC
RA Damper Position	-	100%
Min OA Damper Position	-	N/A
Min OA Damper Type	-	N/A
OA Enthalpy Setpt	-	N/A

Performance Data		
	Design	Actual
MA Plenum SP	-	-0.37"
Fan Suction SP	-	-0.51"
Fan Discharge SP	-	0.42"
Total ESP	0.6"	0.79"
Fan Total SP	-	0.93"

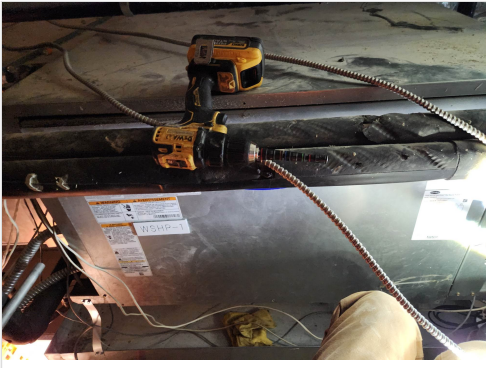
Asset: WSHP1

Test Data		
	Design	Actual
SF CFM	5000	4699
SF RPM	-	NA
RA CFM	4465	4170
OA CFM	535	529
RL Voltage	-	487/487/487
RL Amperage	-	3.7/3.7/3.7
SF Rotation	-	CCW
SF System SetPt	-	NA
RA Damper Position	-	100% OPEN
Min OA Damper Position	-	40% OPEN
Min OA Damper Type	-	MANUAL
OA Enthalpy Setpt	-	N/A

General	
	Actual
Fan Rotation Correct	YES
Unit Filters Clean	NO
Condensate Drain Installed	YES

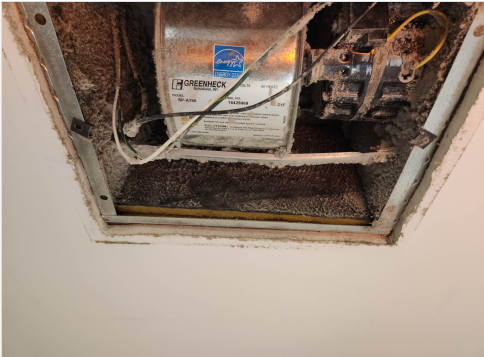
Asset: EF4

Test Data		
	Design	Actual
CFM	150	144
Fan RPM	1160	NA
Fan Rotation	-	CCW
Motor RPM	-	NA
System SetPt	-	SINGLE SPEED
RL Voltage	-	NA
RL Amperage	-	NA
Total ESP	0.125"	0.19"
Fan Inlet SP	-	ATM
Fan Discharge SP	-	0.19"

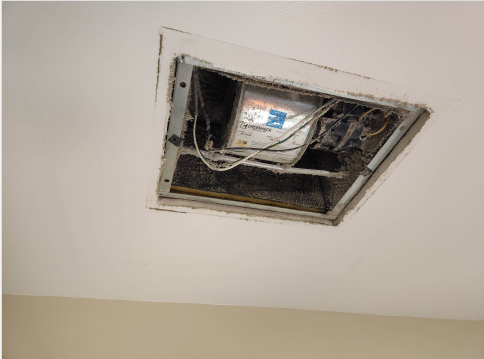
Asset: EF5

Test Data		
	Design	Actual
CFM	150	147
Fan RPM	1160	NA
Fan Rotation	-	CCW
Motor RPM	-	NA
System SetPt	-	SINGLE SPEED
RL Voltage	-	NA
RL Amperage	-	NA
Total ESP	0.125"	0.181"
Fan Inlet SP	-	ATM
Fan Discharge SP	-	0.181"

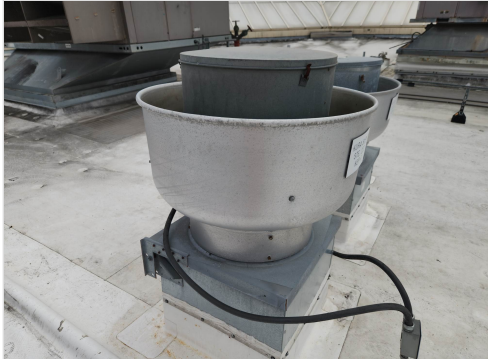
Asset: KEF1

Test Data		
	Design	Actual
CFM	1050	1051
Fan RPM	1268	1330
Fan Rotation	-	CCW
Motor RPM	-	1330
System SetPt	-	70%
RL Voltage	-	210
RL Amperage	-	3.3
Total ESP	1.25"	0.98"
Fan Inlet SP	-	-0.98"
Fan Discharge SP	-	ATM

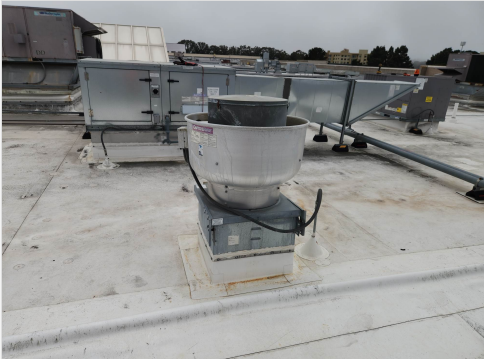
Asset: KEF2

Test Data		
	Design	Actual
CFM	1450	1431
Fan RPM	1262	1463
Fan Rotation	-	CCW
Motor RPM	-	1463
System SetPt	-	77%
RL Voltage	-	210
RL Amperage	-	3.9
Total ESP	1.0"	1.11"
Fan Inlet SP	-	-1.11"
Fan Discharge SP	-	ATM

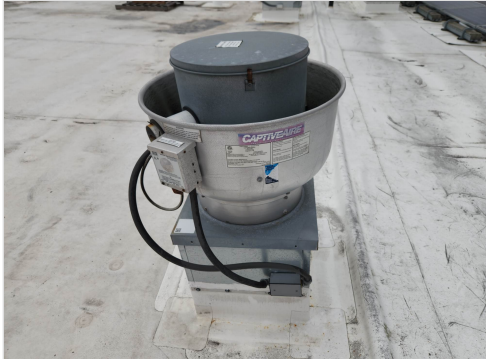
Asset: KEF3

Test Data		
	Design	Actual
CFM	800	811
Fan RPM	1411	1560
Fan Rotation	-	CCW
Motor RPM	-	1560
System SetPt	-	78%
RL Voltage	-	120
RL Amperage	-	3.2
Total ESP	0.5"	0.55"
Fan Inlet SP	-	-0.55"
Fan Discharge SP	-	ATM

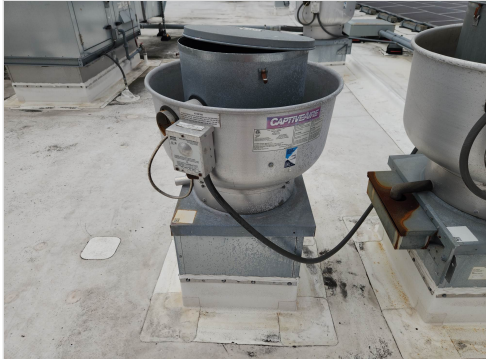
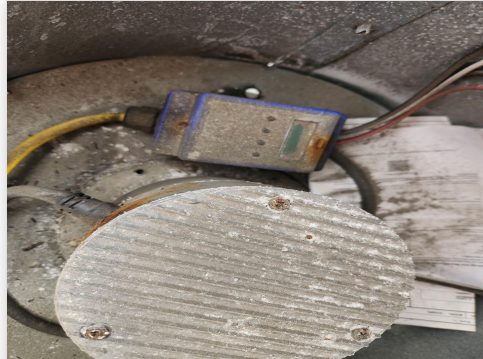
Asset: KEF4

Issue Name : KEF-4 IS NOT OPERATIONAL
Description : KEF-4 is not operational.
Created By : National TAB **Assigned To :** National TAB - Brianna Biggs
Status : Open
Priority : Urgent **Asset Tag :**
Originated Date : 08/07/2025 - Zack Eismin - National TAB

Test Data		
	Design	Actual
CFM	525	0
Fan RPM	1188	0
Fan Rotation	-	NA
Motor RPM	-	0
System SetPt	-	0
RL Voltage	-	0
RL Amperage	-	0
Total ESP	0.5"	0
Fan Inlet SP	-	0
Fan Discharge SP	-	0

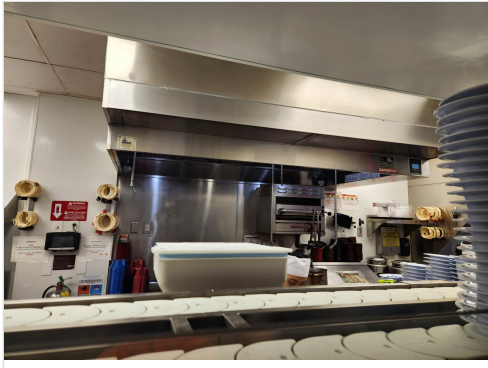
Asset: HD1

Test Data Supply		
	Design	Actual
Total Area	6.125	6.125
Kv factor (Vel)	0.89	0.89
Num of Readings	-	0
Ave FPM(corr)	-	0
CFM	1050	0

Test Data Exhaust		
	Design	Actual
Filter Type	CAPTRATE SOLO	CAPTRATE SOLO
Filter Size 1	16X16	16X16
Filter Qty 1	3	3
Filter AK factor size 1	1.62	1.62
Filter Total AK Area	4.86	4.86
Filter1 FPM	-	203
Filter2 FPM	-	229
Filter3 FPM	-	217
Filter Ave FPM(corr)	-	216.3
CFM	1050	1051

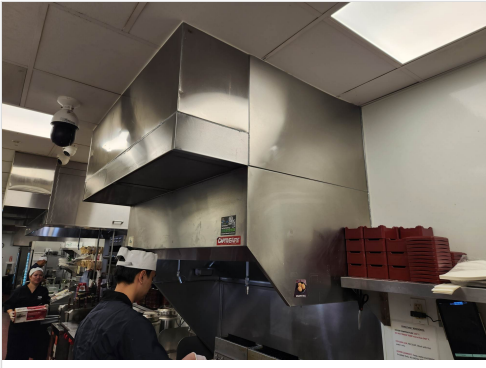
Asset: HD2

Test Data Supply		
	Design	Actual
Total Area	9.72	9.72
Kv factor (Vel)	0.89	0.89
Num of Readings	-	0
Ave FPM(corr)	-	0
CFM	1325	0

Test Data Exhaust		
	Design	Actual
Filter Type	CAPTRATE SOLO	CAPTRATE SOLO
Filter Size 1	16X20	16X20
Filter Qty 1	5	5
Filter AK factor size 1	2.08	2.08
Filter Total AK Area	10.4	10.4
Filter1 FPM	-	135
Filter2 FPM	-	154
Filter3 FPM	-	140
Filter4 FPM	-	137
Filter5 FPM	-	122
Filter Ave FPM(corr)	-	137.6
CFM	1450	1431
