TAB Punch List - Mar 25, 2024

L05068_Spring Station FSU (KY)

962 Breckenridge Lane, Louisville, Kentucky

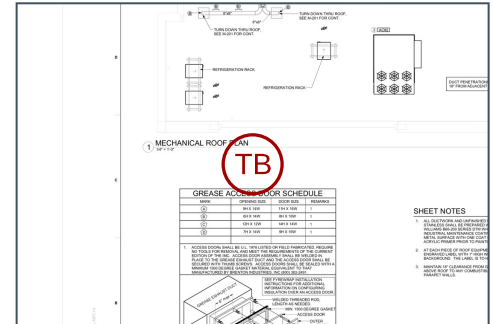
M-250

Cleanout doors do not meet size specifications listed in cleanout door schedule on M-250.

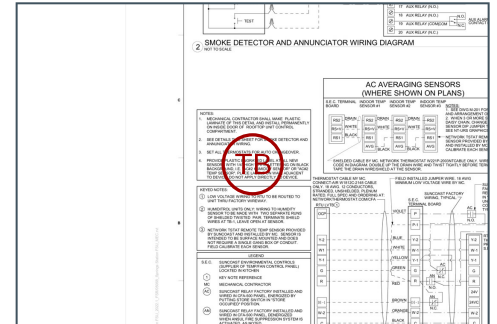
M-501

See M-501, Detail 1, Note 4:
1/4" High white
Lettering on black
background. Label on wall
ADJACENT TO DEVICE.
Sensors improperly
Labeled.
