**Report: TAB REPORT**  
**Function: Test, Adjust, & Balance**  
**Date: 03/03/2026**  
**Completed By: National TAB**

**PROJECT**  
**02-16-26 PENN STATION - UNION, KY**

Project: 02-16-26 PENN STATION - UNION, KY

**SDV Job #:** 8409244 - Penn Station V3B-6L (Union, KY)

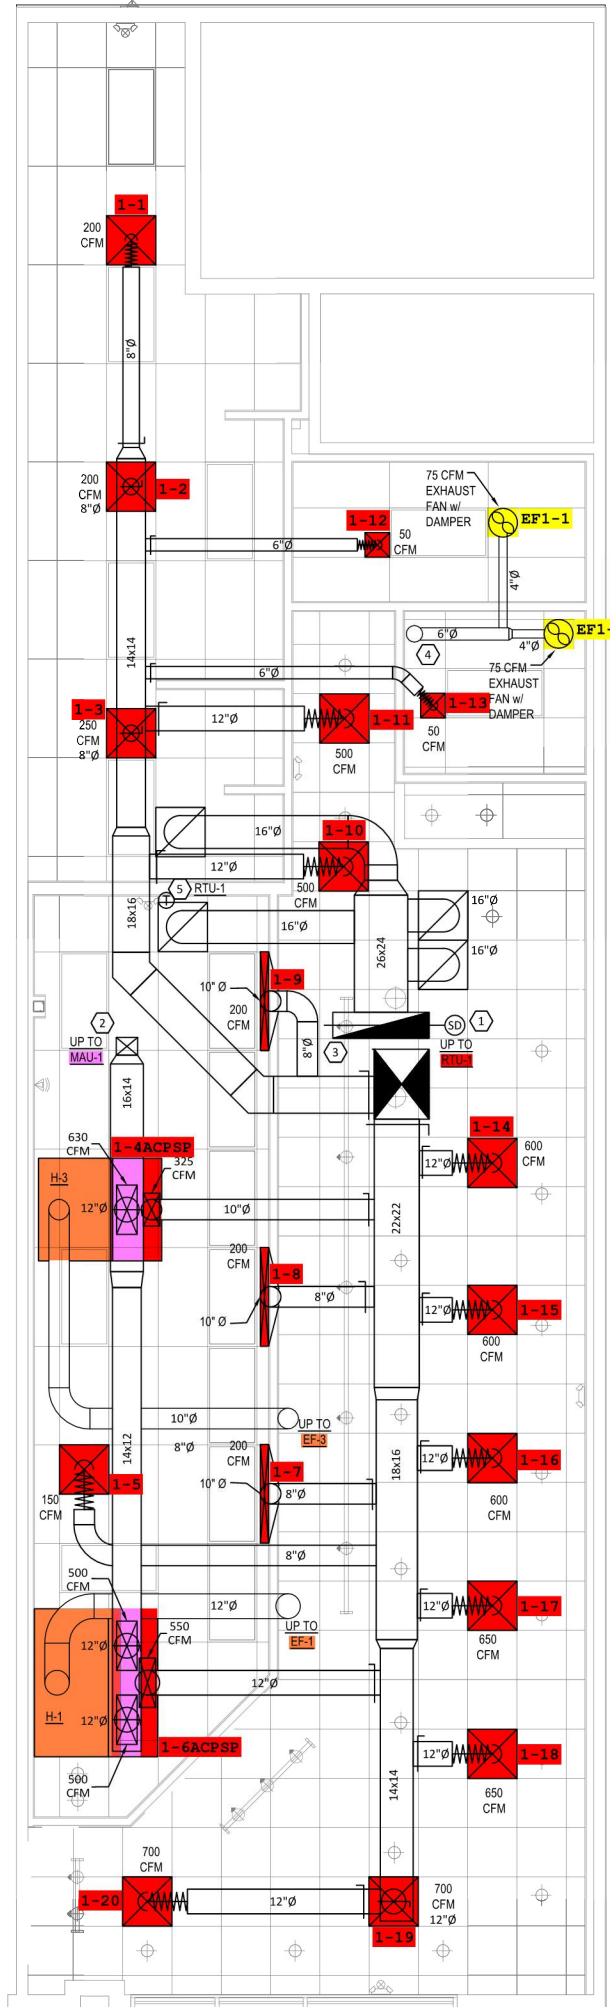
1  
M1.0

MECHANICAL - Floor 15

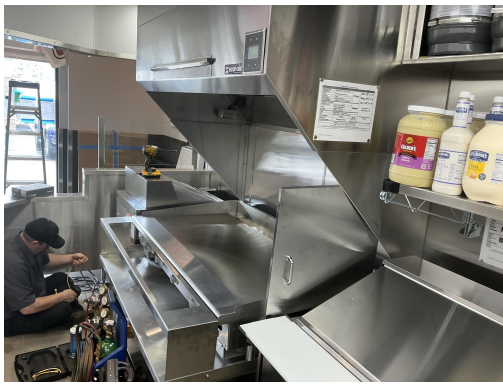
**Hood 1 ( HD1-Grill ) (HD1-Grill)**

Hung Using appropriate material to safely secure hood. Design: **Yes** Actual: **Yes**

*Contractors did a good job.*

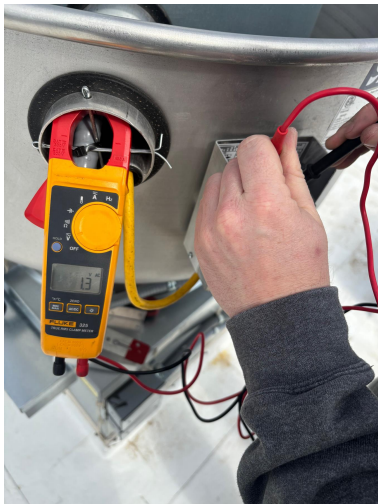
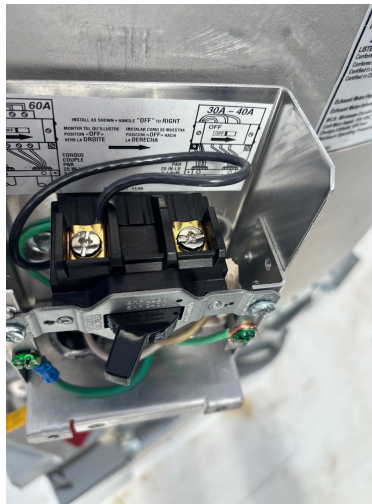
### Fan 1 - EADU85H (KEF1-GDL) (KEF1-GDL)

*Punch Item: Electrician  
Electrician did not land wires correctly on disconnect switch. This may cause issues with voltage drops in the future.*

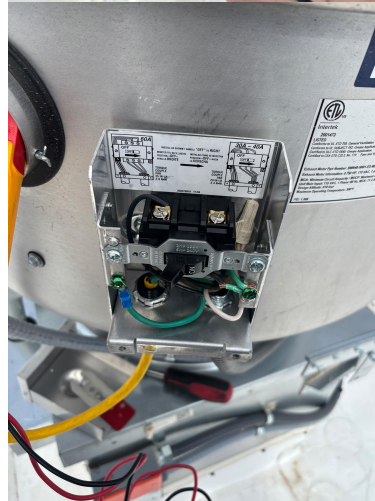
## Fan 2 - EADU85H (KEF2-FRY) (KEF2-FRY)

*Electrician did not land wires properly on disconnect switch. This may cause issues later on.*

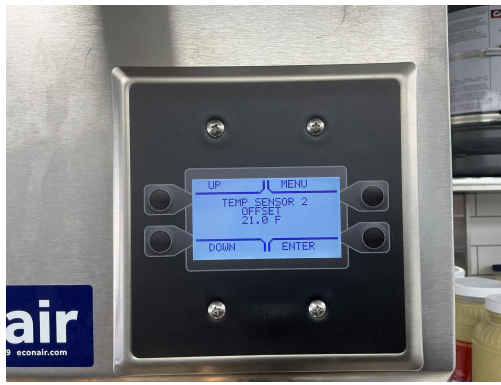
HOW MANY FAN ZONES ARE THERE	Design: 2	Actual: 2
HYSTERESIS TEMPERATURE		Actual: 2
Room Sensor Type	Design: RoomSensor	Actual: Room Sensor
Is room sensor wireless or wired?		Actual: Wired
Is room sensor operating correctly?		Actual: Yes
Upload Picture of installation
