Report: TAB REPORT
Function: Test, Adjust, & Balance
Date: 03/03/2026
Completed By: National TAB

PROJECT
02-16-26 PENN STATION - UNION, KY

SDV Job #: 8409244 - Penn Station V3B-6L (Union, KY)**Service Region:** 334 - Louisville, KY Service**Service Person:** Tom Stone**Customer Number:** 1136898**Customer Name:** Region 120 - AIR SOLUTIONS**Address:**
PENN STATION
U.S. Highway 42
UNION, KY 41091**Region Job #:** 8225907**Region Job Name:** Penn Station V3B-6L (Union, KY)**Sales Region:** 120 - Air Solutions**Sales Person:** Joe Hertenstein**Created By:** Tom Stone**Creation Date:** 2/26/2026 10:56 AM**Last Modified By:** Justin Fairchild**Last Modified Date:** 2/27/2026 11:43 AM**Dining Room Pressure:** 0**Kitchen Pressure:** 0**Hours On Job:** 0**Extra Hours:** 0**Completed:** Yes**Completed By:** Justin Fairchild**Completion Date:** 2/27/2026 11:43 AM**Job Site Meeting**

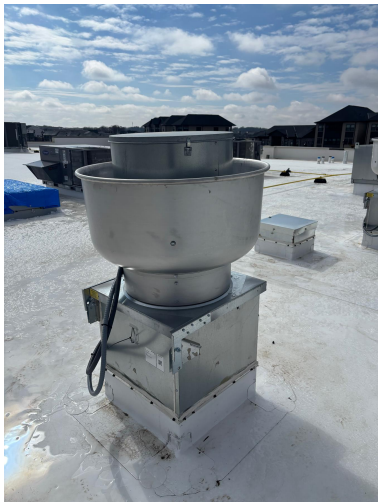
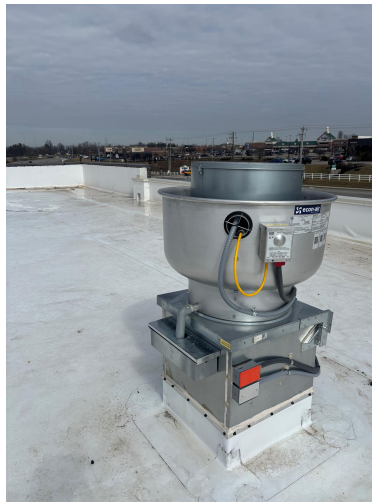
Fan 1 - EADU85H (KEF1-GDL) (KEF1-GDL)

*Punch Item: Electrician
Electrician did not land wires correctly on disconnect switch. This may cause issues with voltage drops in the future.*

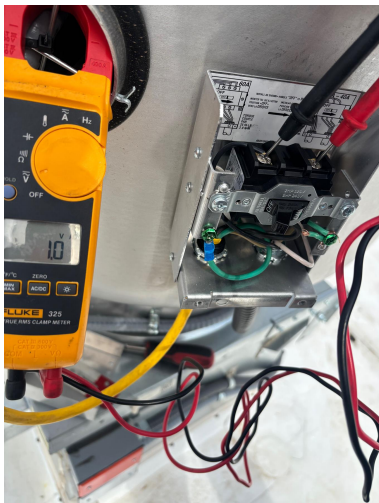
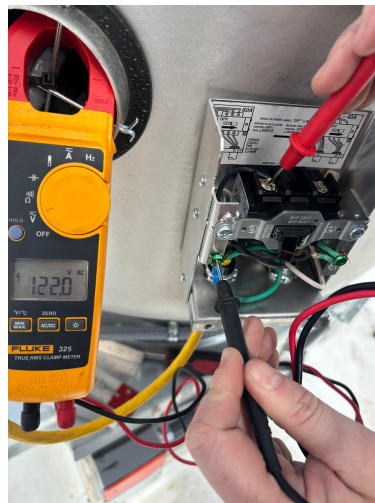
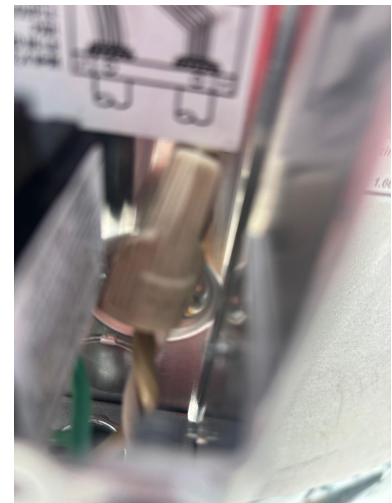
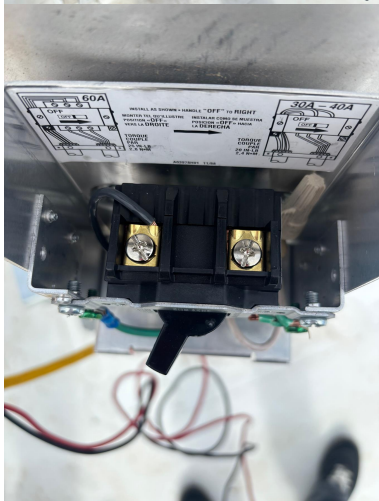
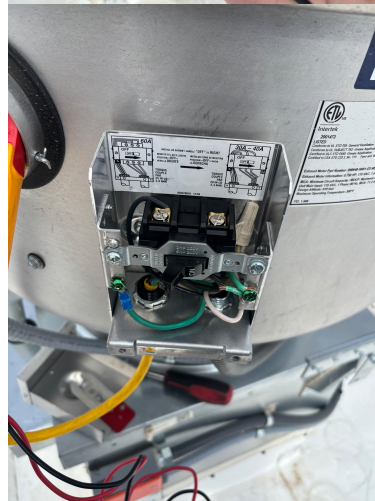
Fan 2 - EADU85H (KEF2-FRY) (KEF2-FRY)

Electrician did not land wires properly on disconnect switch. This may cause issues later on.
