**Report: FINAL TAB REPORT
Function: Test, Adjust, & Balance
Date: 8/30/2022**

**PROJECT
08-15 FIVE GUYS - SAVANNAH, GA**

Project: 08-15 FIVE GUYS - SAVANNAH, GA

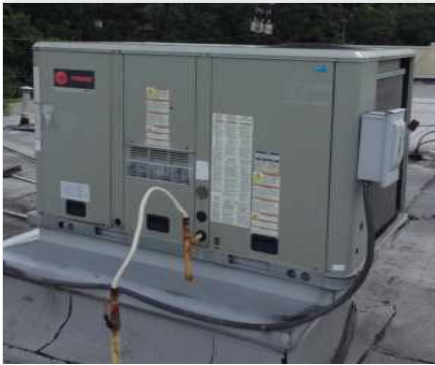
Screenshot_2022_08_30_08504
6.png

Issue Name : RTU-3 DOES NOT HAVE AN OA INTAKE INSTALLED.
Description : RECOMMEND INSTALLING.
Created By : National TAB **Assigned To :** National TAB - Dale Wheeler
Status : Open
Originated Date : 08/30/2022 - Will Turnbough - National TAB

Ideally the outside air for the RTU's would be balanced no higher than 20%, but we increased to maximum of 23% ratio which should be OK. IT is recommended that an outside air intake be installed on RTU-3.

3. Install OA intake on RTU-3 and balance to ~450 CFM. This would allow MUA to be reduced to 1500 CFM.
 4. Balance new EF for restroom (if installed) as low as possible. If this is installed it will impact how low the MUA can be reduced.

Notes:[1] UNIT GRILLS TO NOT MATCH WHAT IS SHOWN ON GRD. [2] UNIT DOES NOT HAVE AN OA CANOPY/ INTAKE INSTALLED RECOMMEND ONE BE INSTALLED ON UNIT.

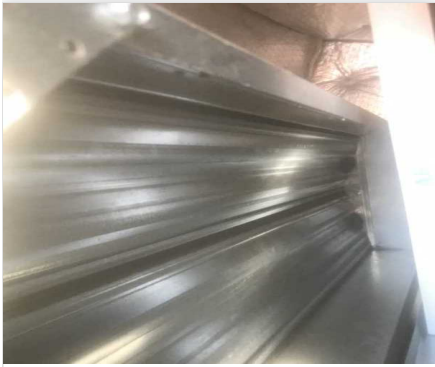
SAV3.jpg

Issue Name : RTU-E4 ECON

Description : ECON IS NOT FUNCTIONING CORRECTLY. OUTSIDE AIR HAD TO BE SET MANUALLY

Notes:[1] UNIT GRILLS DO NOT MATCH WHAT IS SHOWN ON GRD. [2] OA HAD TO BE SET MANUALLY DUE TO ECON NOT WORKING. UNIT TEMP. DISCHARGE IS 66F AT DIFFUSER
