**Report: Final Report
Function: Test, Adjust, & Balance
Date: 8/24/2022**

**PROJECT
08-15 FIVE GUYS - SAVANNAH, GA**

Project: 08-15 FIVE GUYS - SAVANNAH, GA

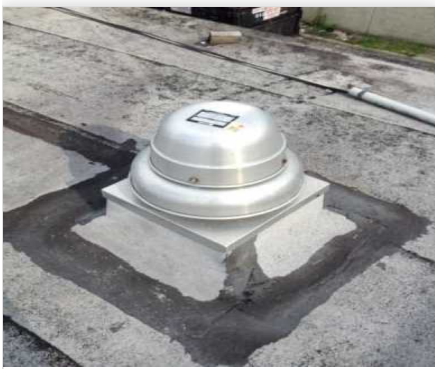
SAV4.JPG

Issue Name : EF2

Description : EF2 RR FAN IS NOT RUNNING MOTOR IS SEIZED, UNABLE TO BALANCE FAN.

RR FAN IS NOT FUNCTIONING / MOTOR IS SEIZED

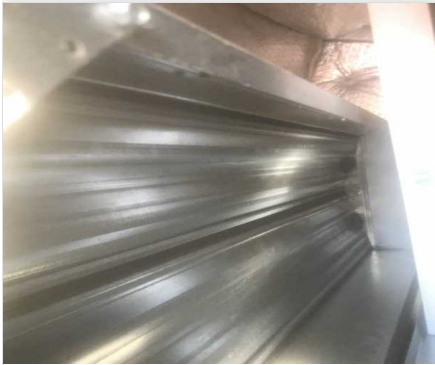
SAV3.jpg

Issue Name : RTU-E4 ECON

Description : ECON IS NOT FUNCTIONING CORRECTLY. OUTSIDE AIR HAD TO BE SET MANUALLY

Notes: [1] UNIT GRILLS DO NOT MATCH WHAT IS SHOWN ON GRD. [2] OA HAD TO BE SET MANUALLY DUE TO ECON NOT WORKING. UNIT TEMP. DISCHARGE IS 66F AT DIFFUSER
