**Report: FINAL TAB REPORT
Function: Test, Adjust, & Balance
Date: 8/29/2022**

**PROJECT
08-15 FIVE GUYS - SAVANNAH, GA**

Project: 08-15 FIVE GUYS - SAVANNAH, GA

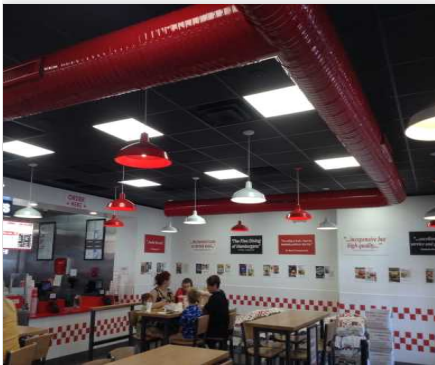
SAV2.JPG

Issue Name : SPIRAL DINING ROOM DUCT INSTALLED

Description : SPIRAL DINING ROOM DUCT INSTALLED IS CAPPED OFF AND DOES NOT CONNECT TO ANY RTU. FOUR WAY DIFFUSERS WERE INSTALLED IN THE DROP CEILING. THIS IS DIFFERENT THEN WHAT IS SHOWN ON THE GRD.

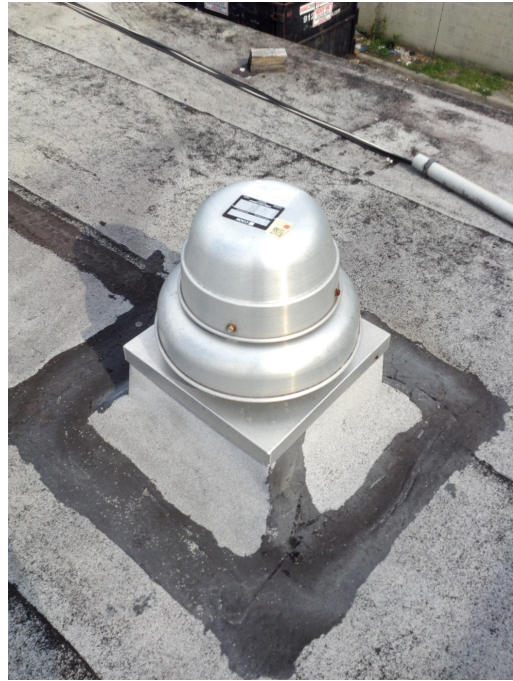
EF2

RR FAN IS NOT FUNCTIONING / MOTOR IS SEIZED

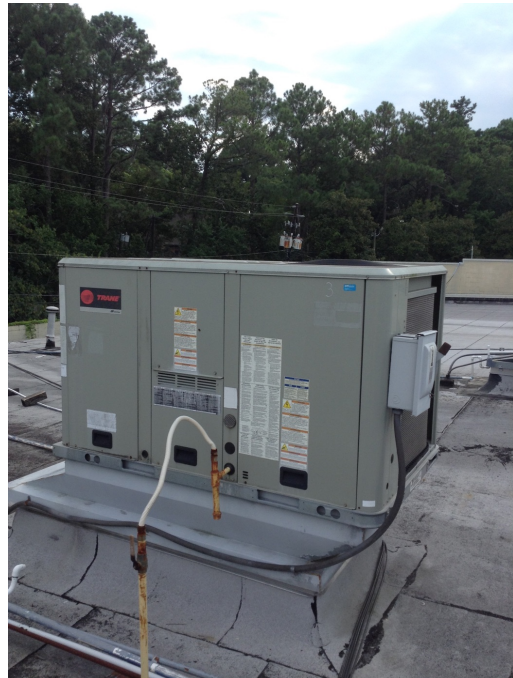
RTU-E3

Notes: [1] UNIT GRILLS TO NOT MATCH WHAT IS SHOWN ON GRD. [2] UNIT DOES NOT HAVE AN OA CANOPY/ INTAKE INSTALLED RECOMMEND ONE BE INSTALLED ON UNIT.
