PlanGrid Task Report - Jan 27, 2025

L05549_RELO Simpsonville FSU (SC)

Simpsonville, South Carolina

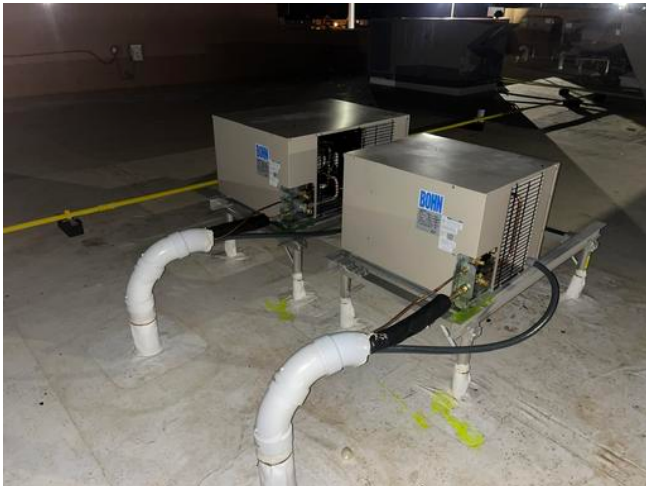
IMG_6849

#293 [REFG 999] [NEW] (MISC) [WIF & WIC]

WIF & WIC are not operational at this time unable check / test box temperatures.

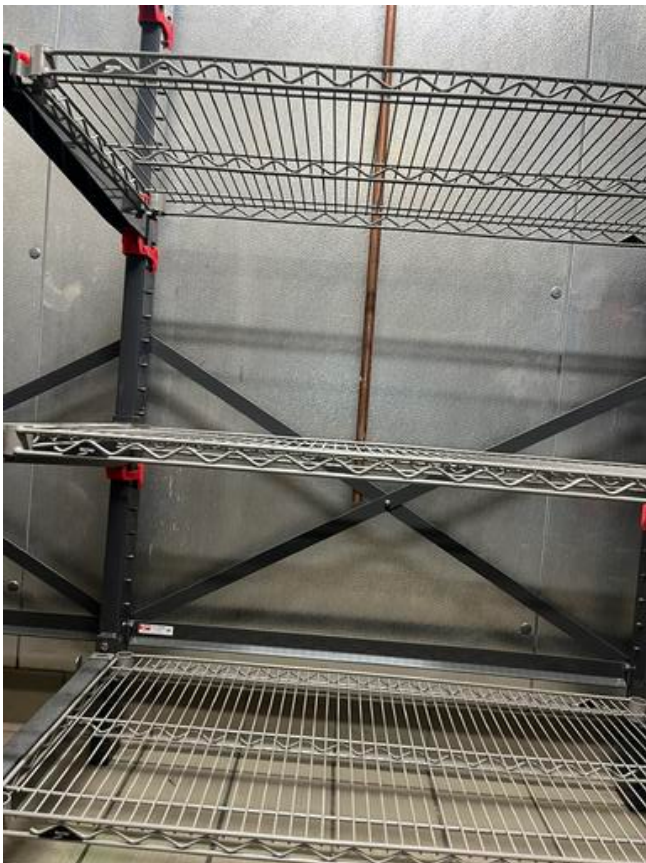
IMG_6857

#292 [REFG 509] [NEW] WIC/WIF Drains & P-Traps

WIF & WIC drains and p-traps have not been completed at this time.

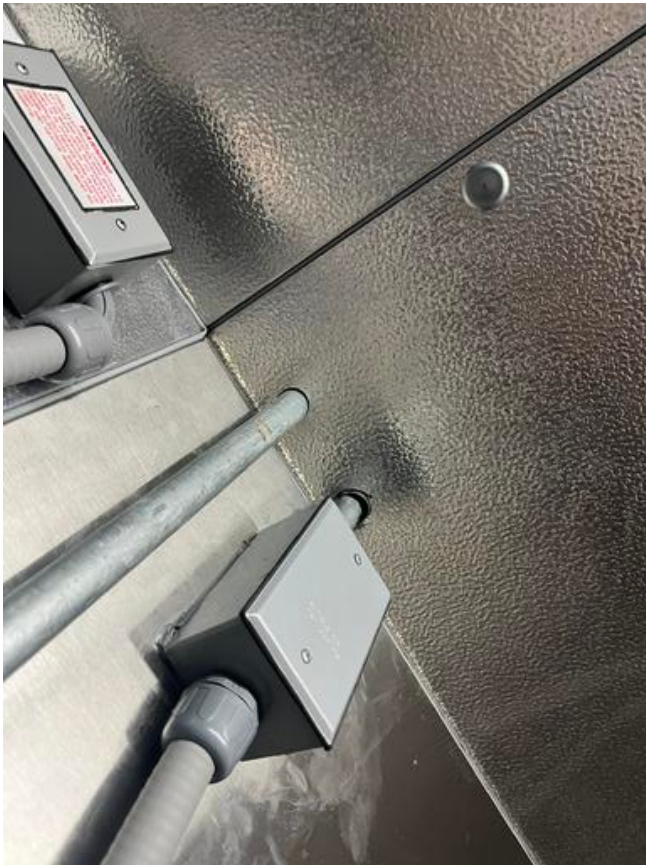
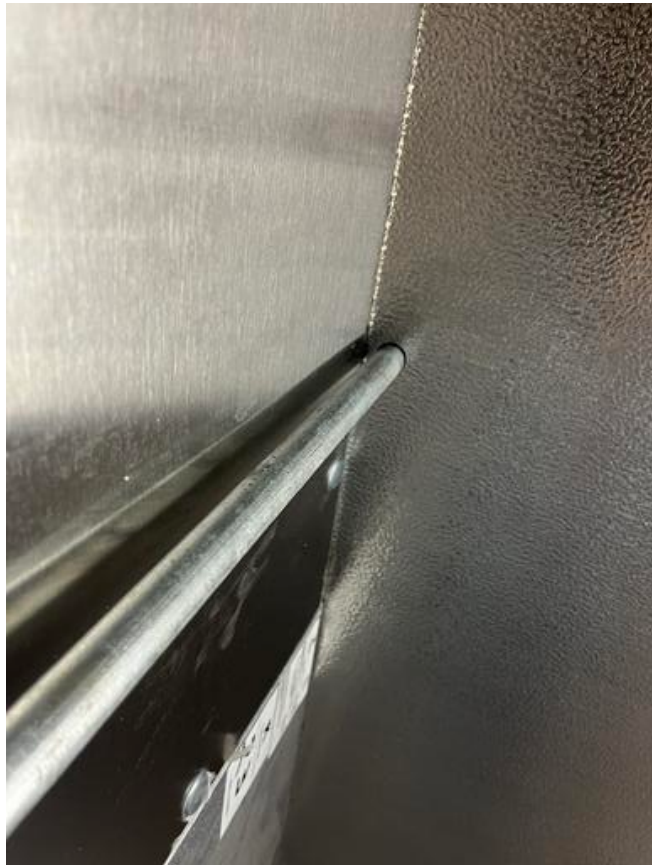
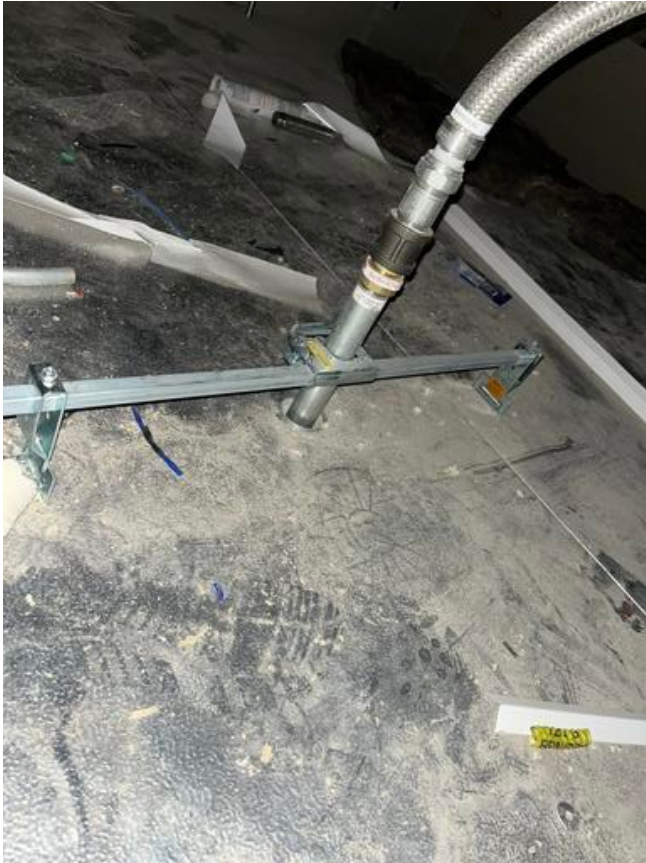
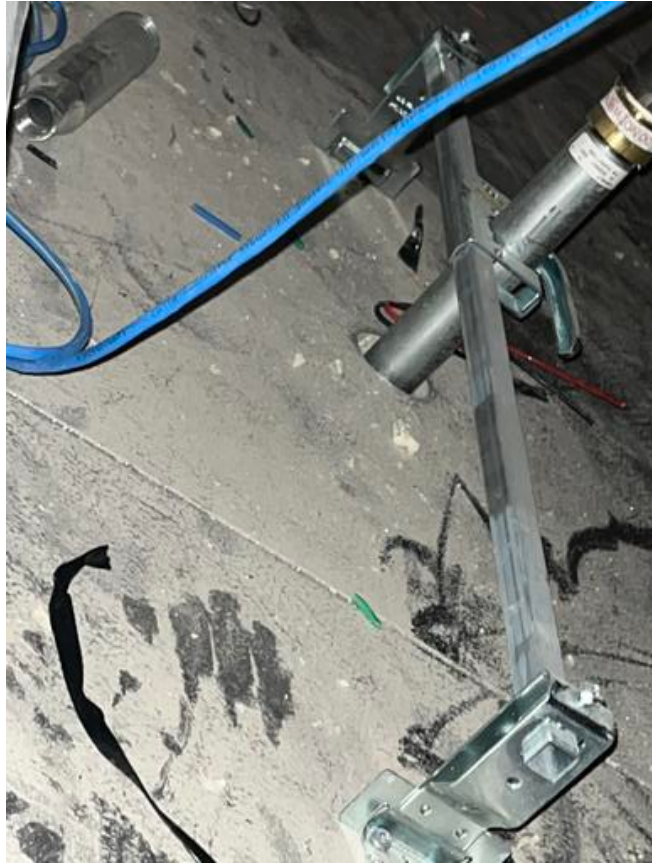
#291 [REFG 999] [NEW] (MISC) [WIF & WIC PENETRATIONS]

WIF & WIF penetrations
have not been sealed.

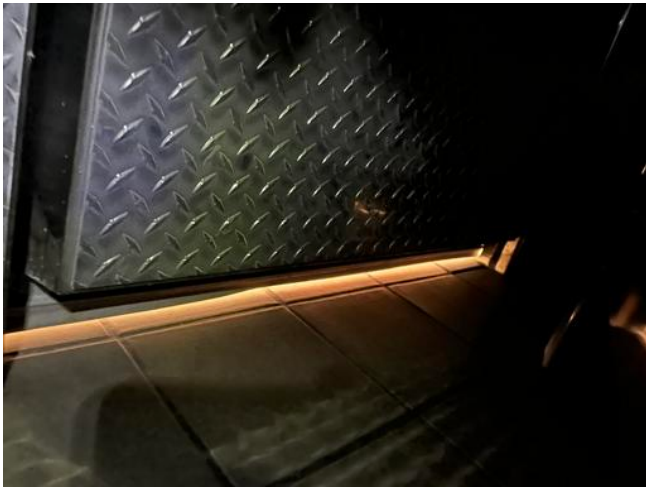
IMG_6856

#290 [REFG 505] [NEW] WIC door sweep vs threshold.

WIC door sweep is not sealed tightly with threshold when door is closed. Only translucent light should be present

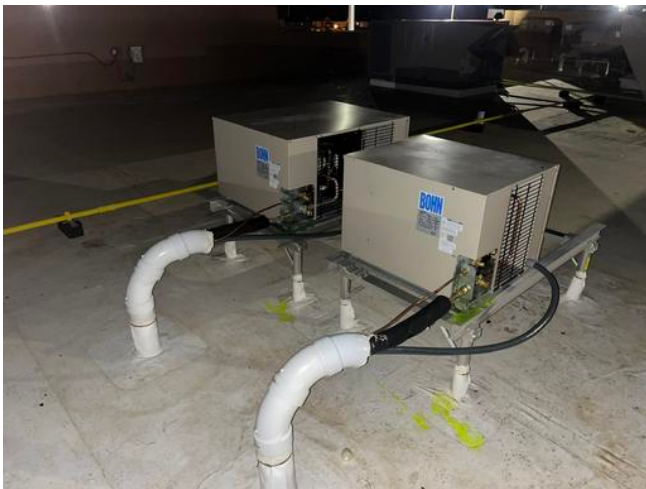
IMG_6849

#288 [REFG 516] [NEW] Condenser electrical disconnects.

WIF & WIC Electrical
disconnects are not installed
or labeled.

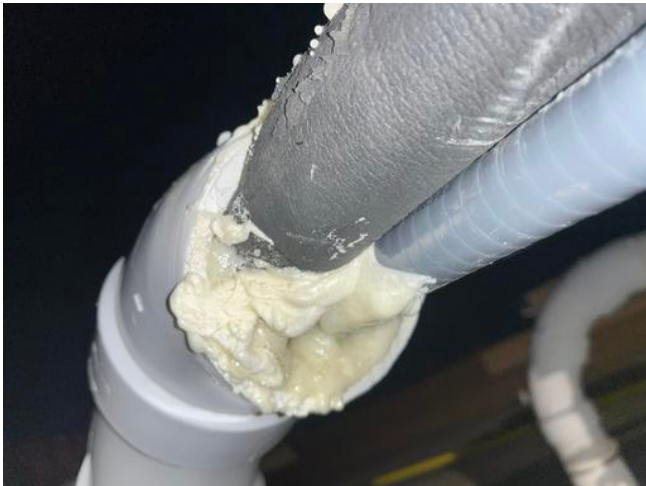
IMG_6846

#287 [REFG 511] [NEW] PVC pipe chase (gooseneck) installation.

WIF & WIC do not have a layer of Silicone caulking on top of the spray foam cut flush with gooseneck

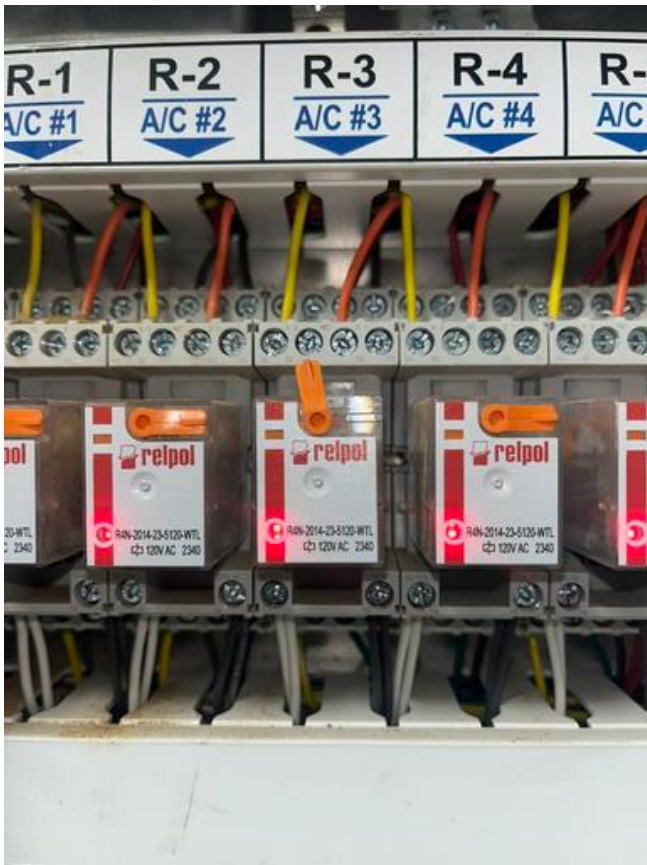
20250123_214728_photo

#286 [UNIT 499] [NEW] CRITICAL (MISC) – [AC3 BAD RELAY]

AC3 has a bad relay. I spoke with suncoast they will be shipping a new relay to the site.

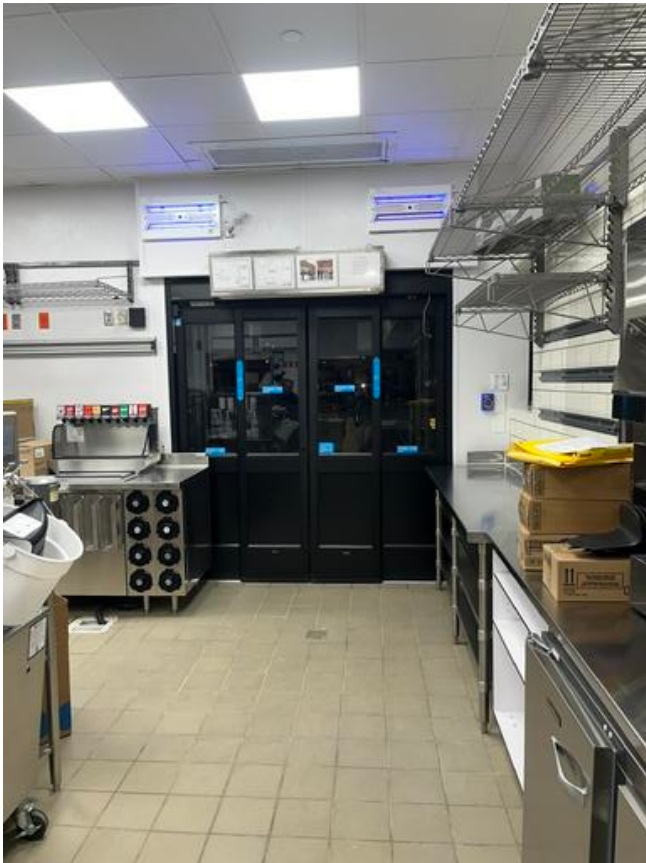
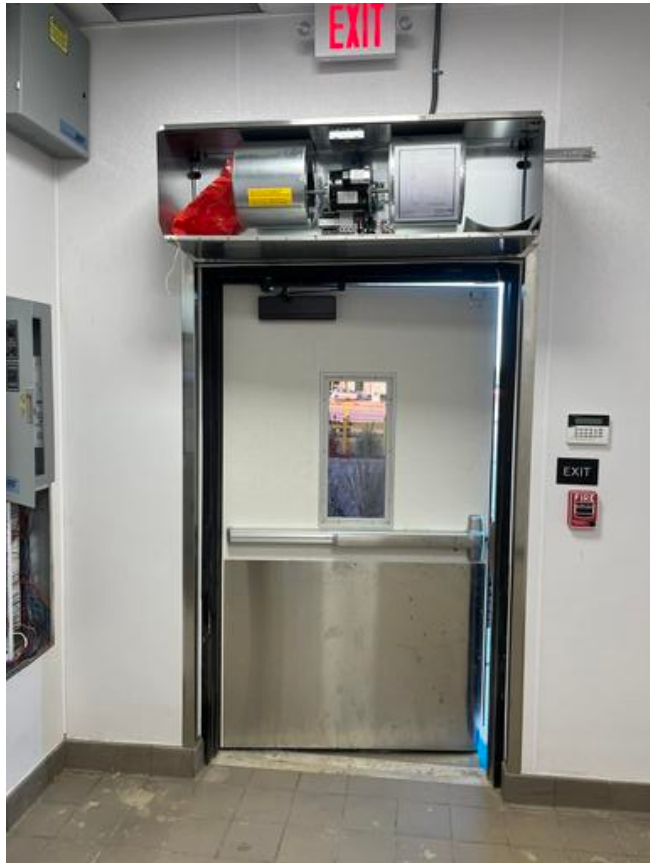
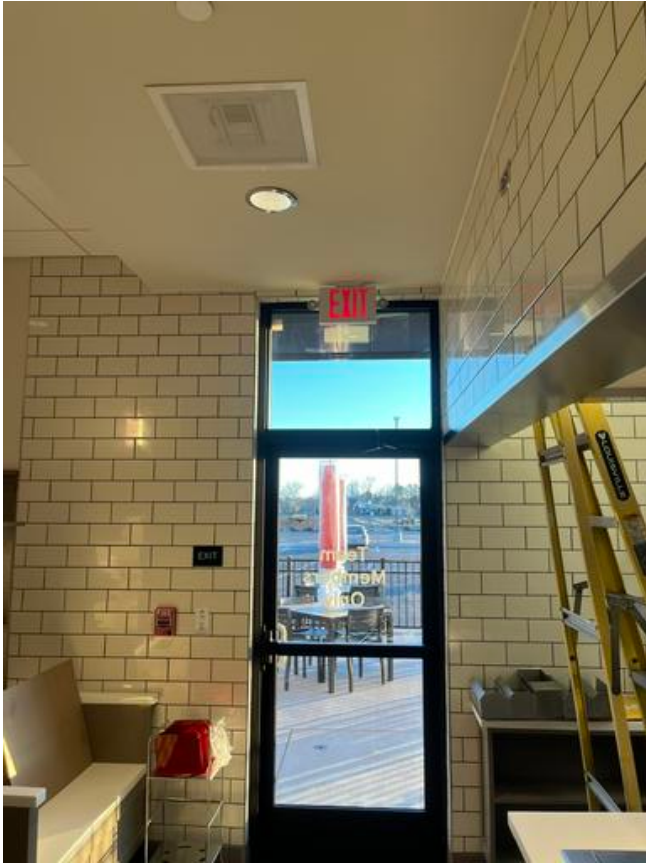
#285 [CURT 501] [NEW] Air curtain power.

AD1, AD2, AD3 ARE NOT
POWERED /
OPERATIONAL AT THIS
TIME.

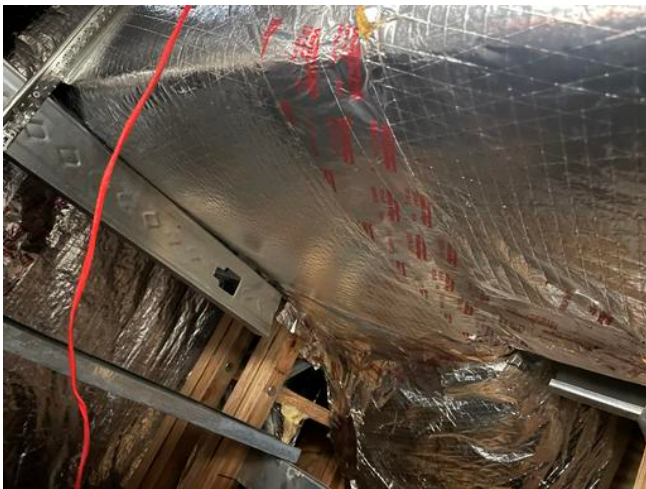
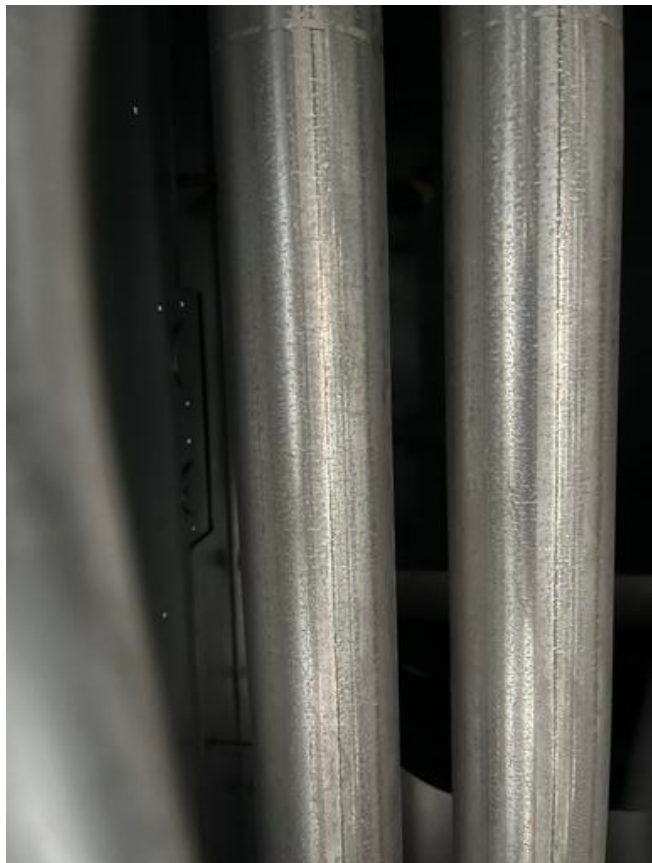
#284 [DUCT 499] [NEW] CRITICAL (TURNING VANES NOT INSTALLED)

AC3 turning vanes are not installed on main supply duct drop at first 90.

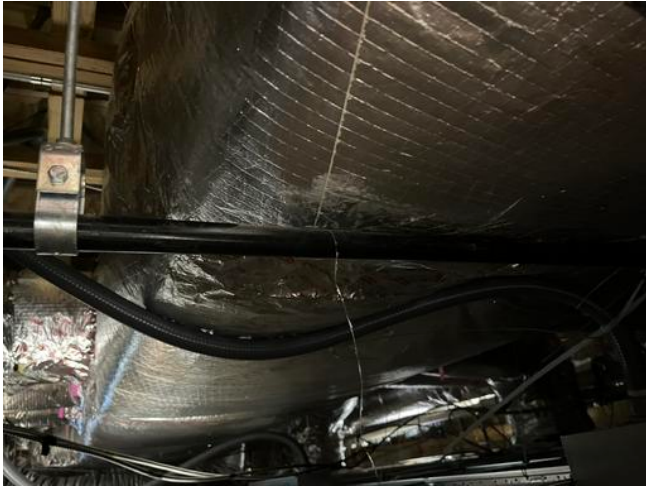
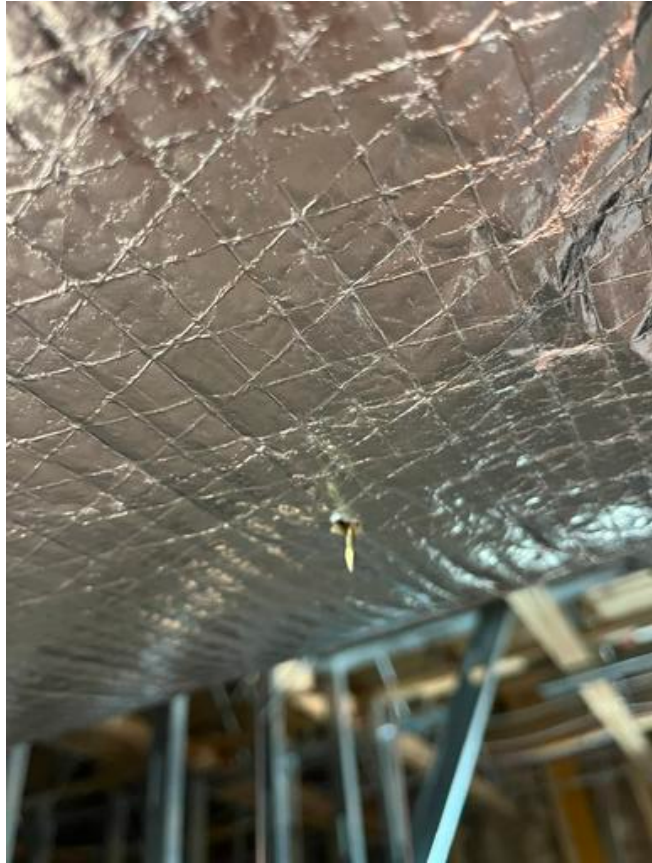
#283 [DUCT 501] [NEW] Insulation stick pins.

AC1 stick pins are not installed on all of supply trunk line 24" or wider.

AC2 stick pins are not installed on all of supply & return trunk lines 24" or wider.

AC3 stick pins are not installed on all of supply & return trunk lines 24" or wider.

AC4 stick pins are not installed on return trunk line 24" or wider.

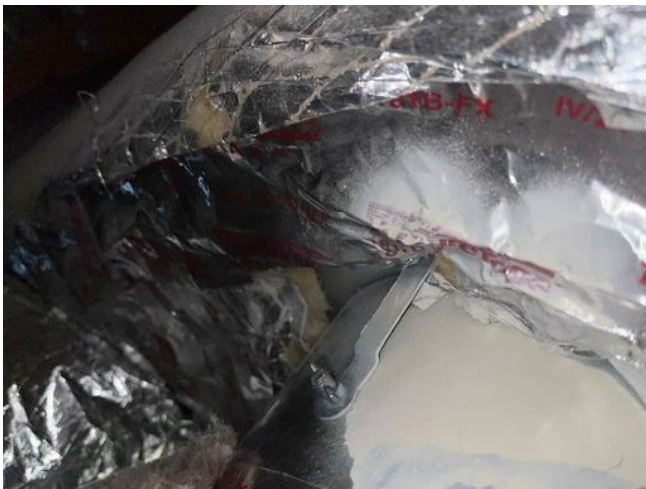
IMG_6832

#282 [DUCT 009] [NEW] CRITICAL – Damper incorrect type.

AC4 return dampers are the wrong type with incorrect standoff. Contact national account provider for replacements.

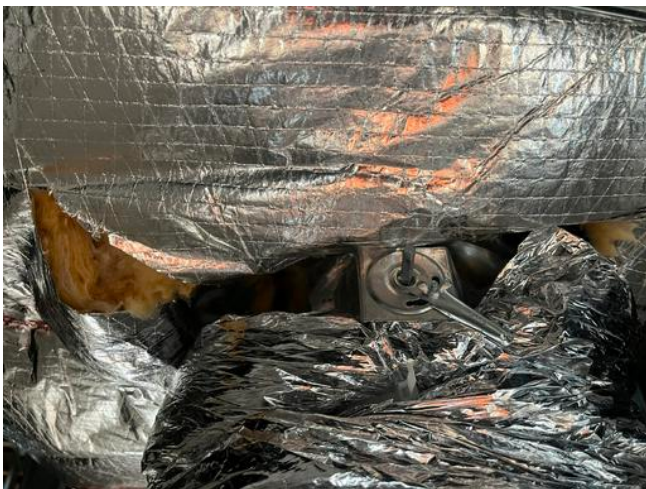
IMG_6769

#281 [DUCT 503] [NEW] Damper flags.

AC1 return dampers need flagged
AC2 not all supply and return dampers have been flagged at this time.
AC3 supply and return dampers need flagged
AC4 return dampers need flagged
AC5 return dampers need flagged

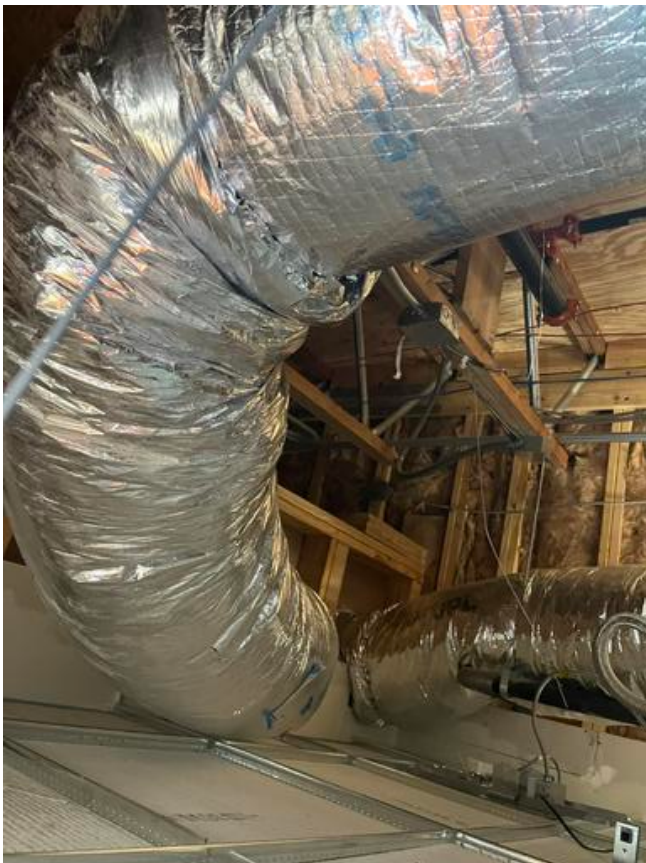
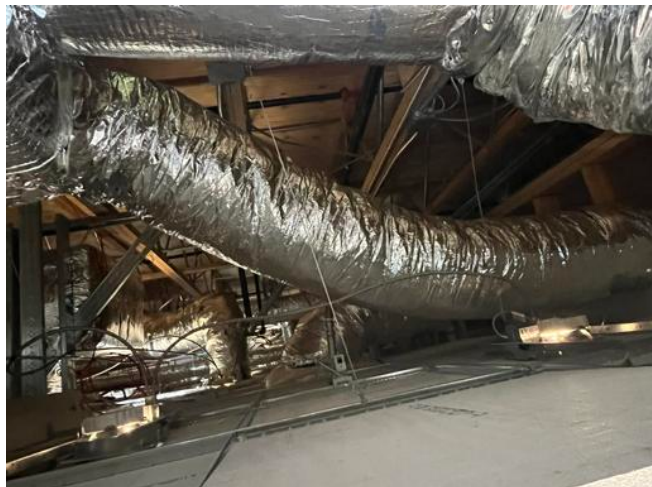
#280 [DUCT 006] [NEW] CRITICAL – Flex duct installation.

AC5 supply & return duct both have over 48" of flex installed on ductwork.

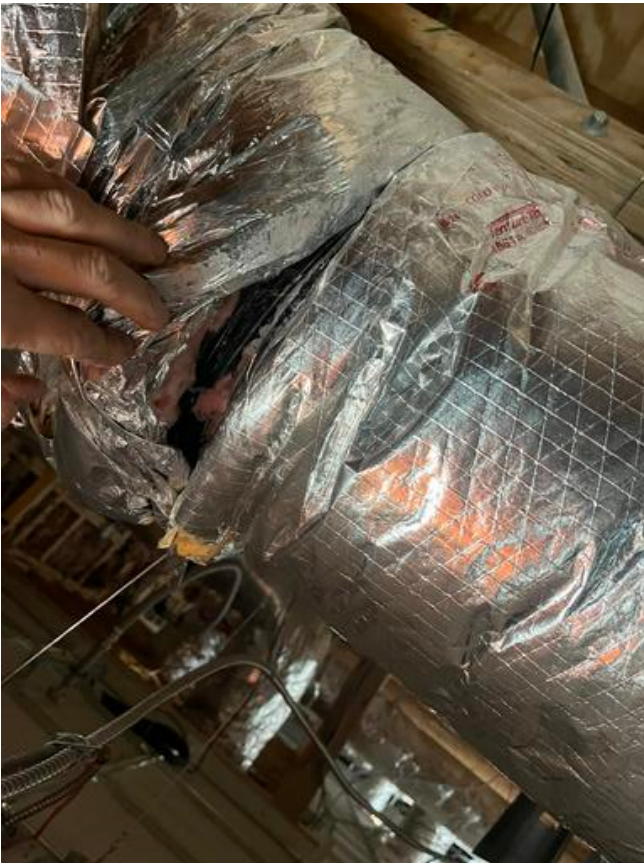
IMG_6758

#279 [DUCT 006] [NEW] CRITICAL – Flex duct installation.

AC5 tape or banding needs to be installed on the outer insulation jacket for sgrd1 & sgrd2.

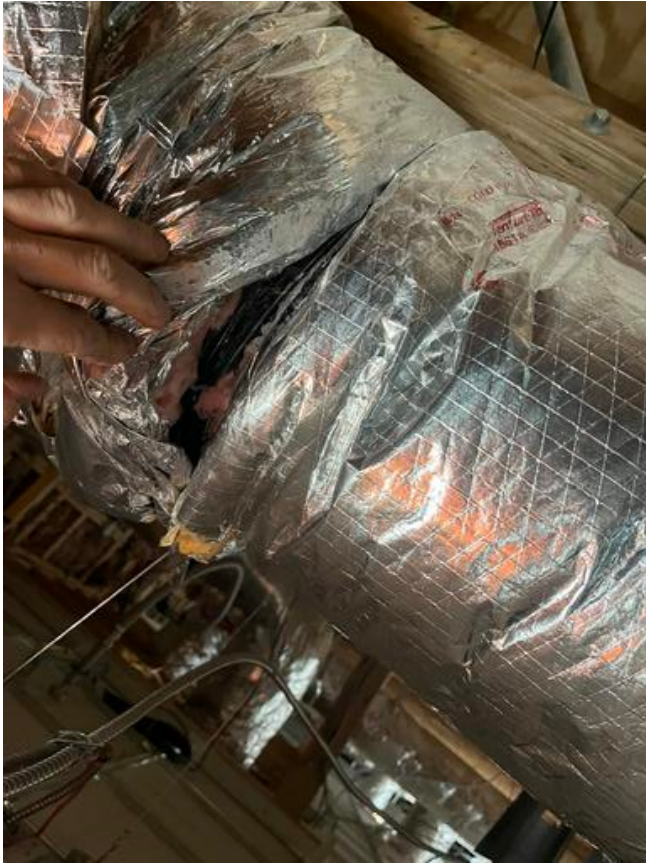
IMG_6758

#278 [DUCT 006] [NEW] CRITICAL – Flex duct installation.

AC1, AC2, AC3 INNERFLEX CORE SOME DIFFUSSERS ARE BANDED SOME ARE MASTIC AND BANDED AND SOME ARE MISSING TAPE, BANDING AND MASTIC. AC4 DRAWBAND AND MASTIC ARE USED TO SECURE ONE SIDE OF THE INNER FLEX CORE AND ONLY A DRAWBAND ON THE OTHER SIDE AC5 NO DRAWBAND OR TAPE WERE USED

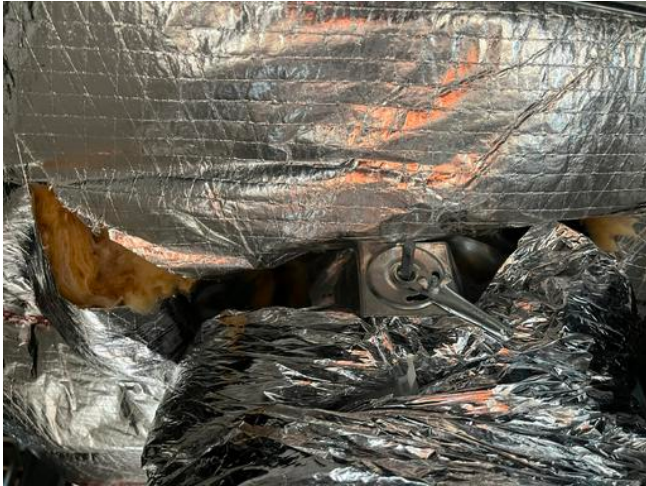
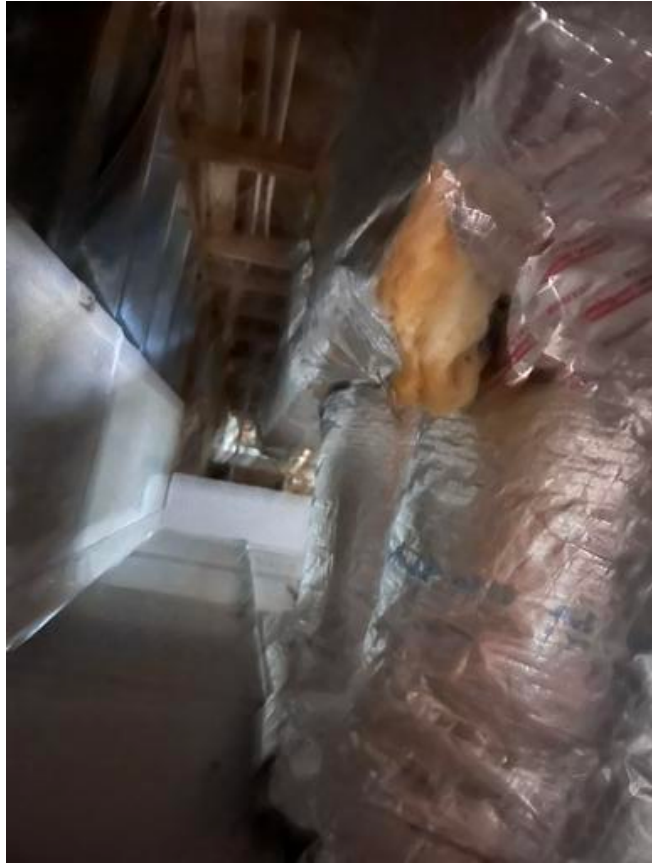
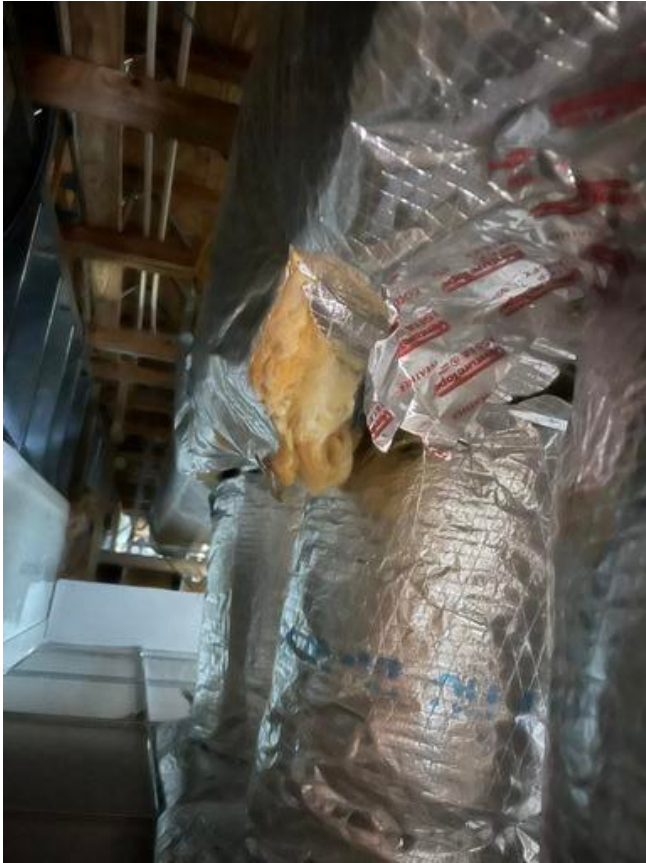
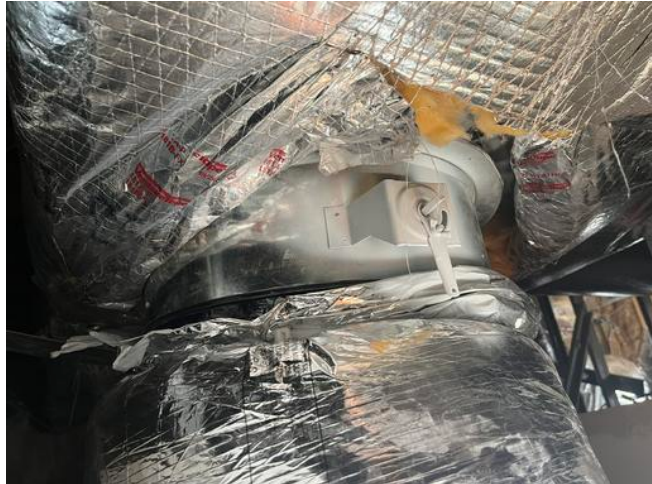
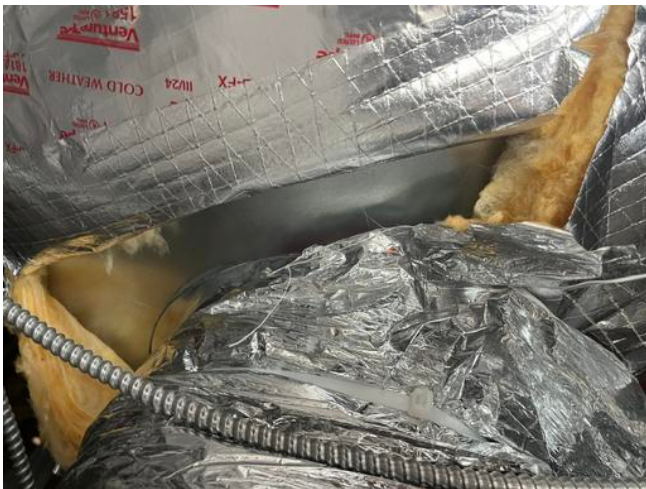
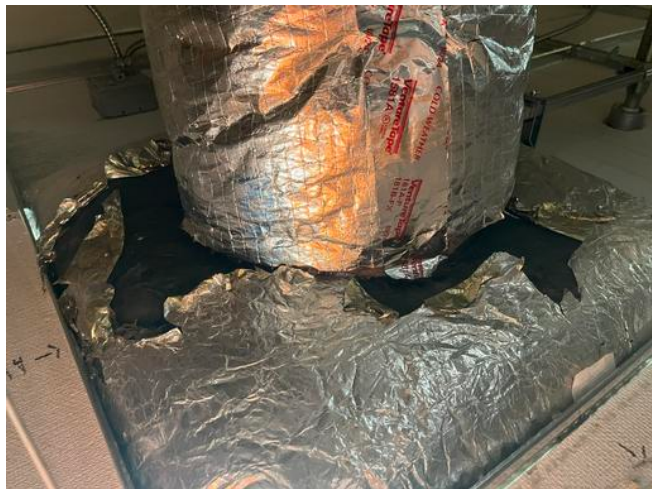
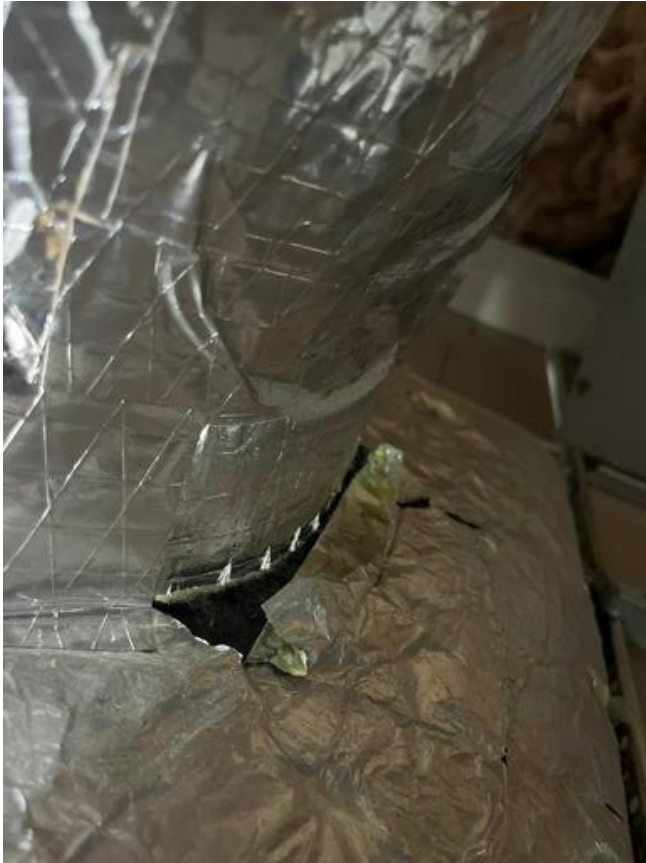
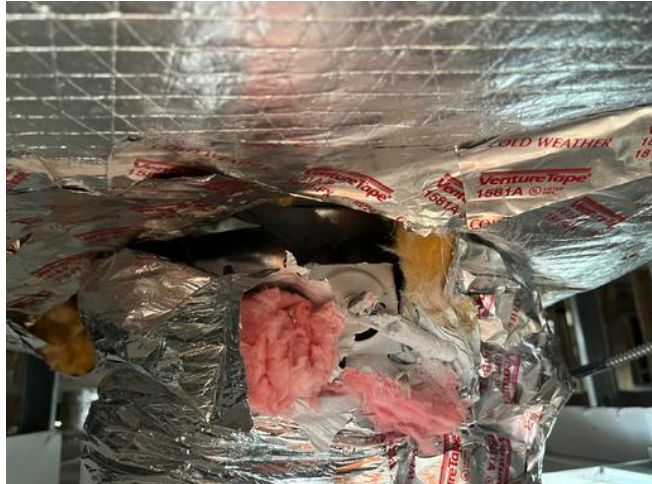
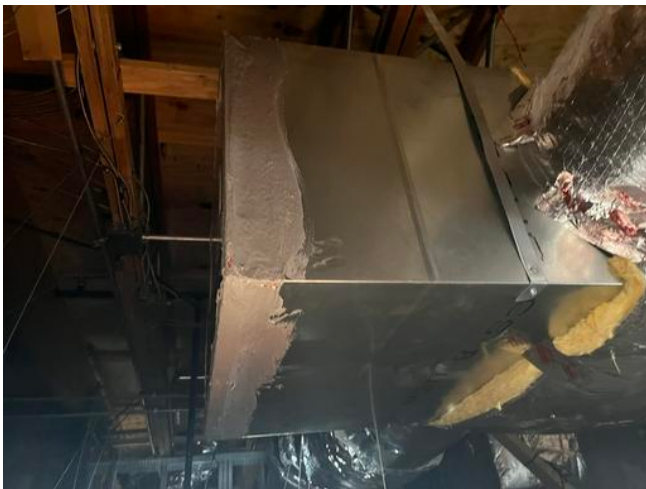
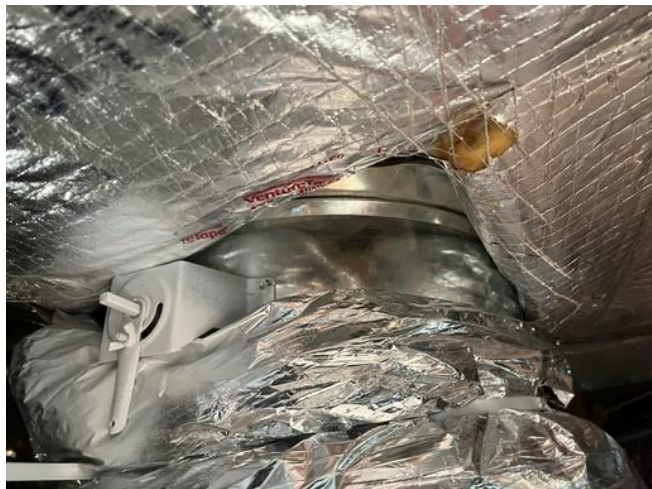
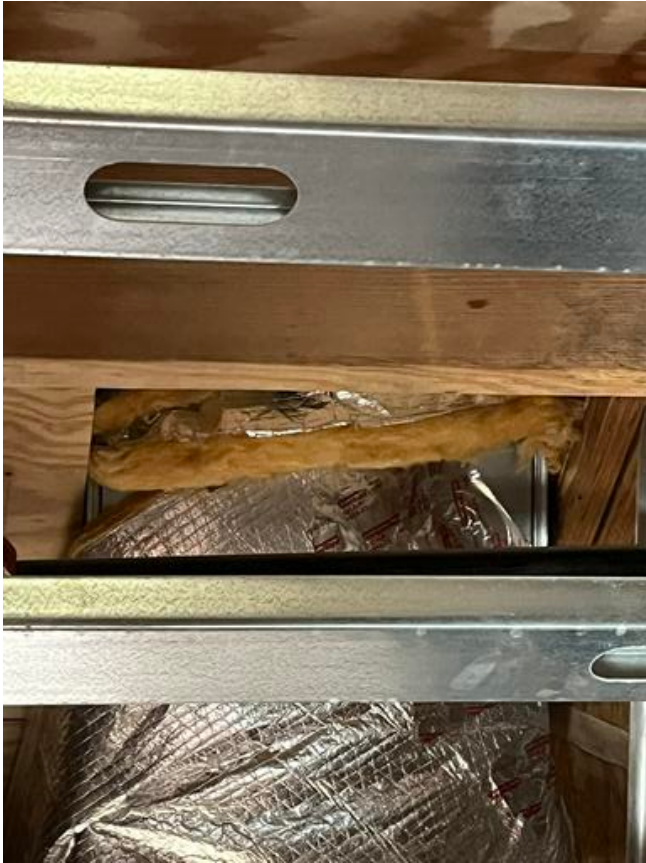
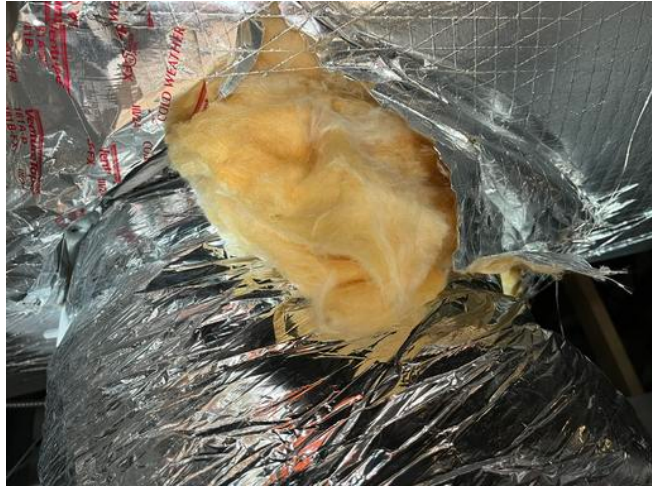
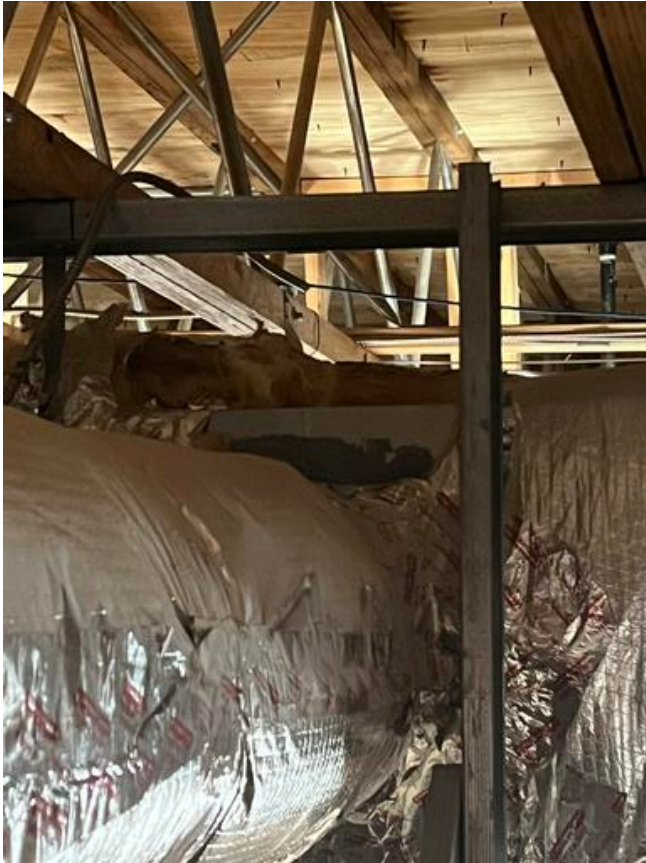
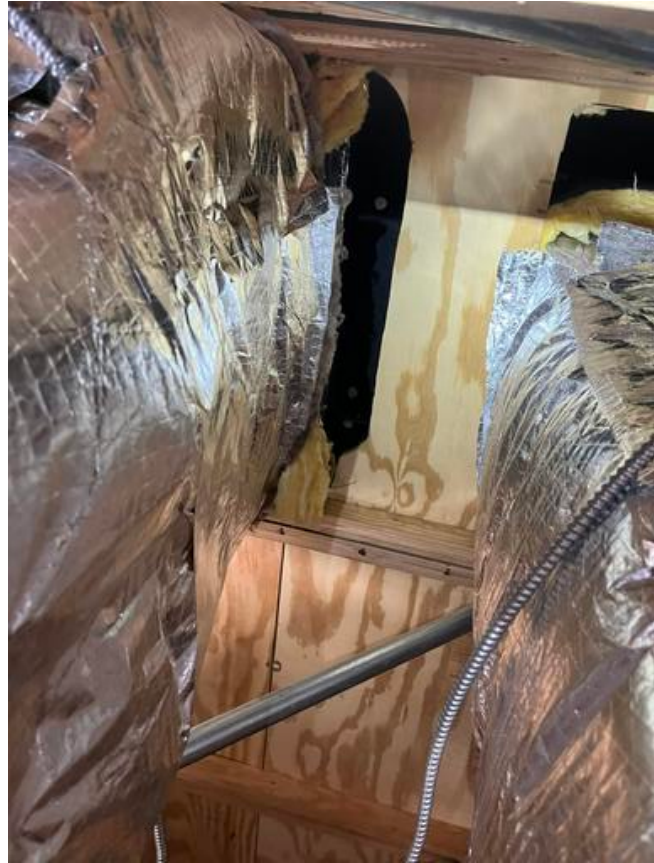
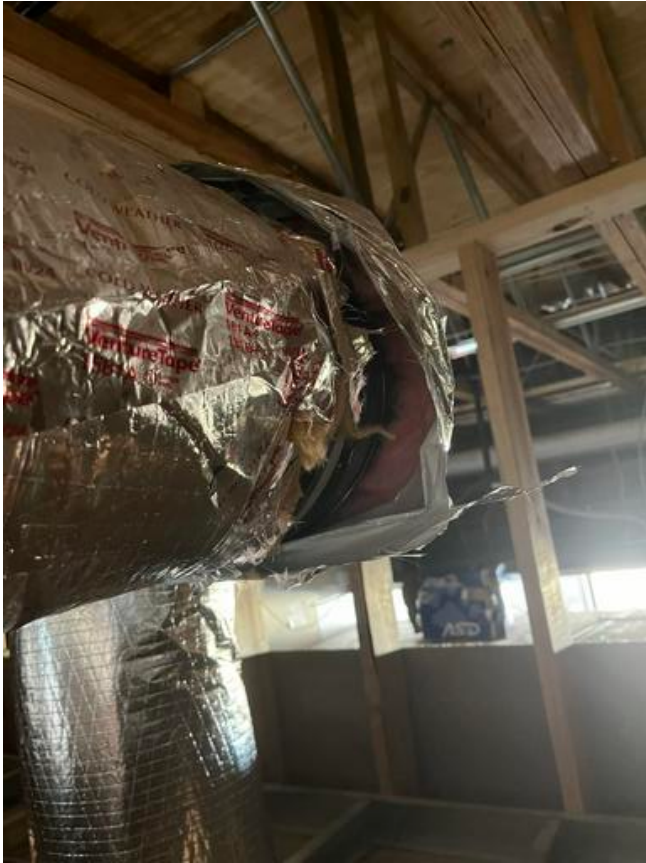
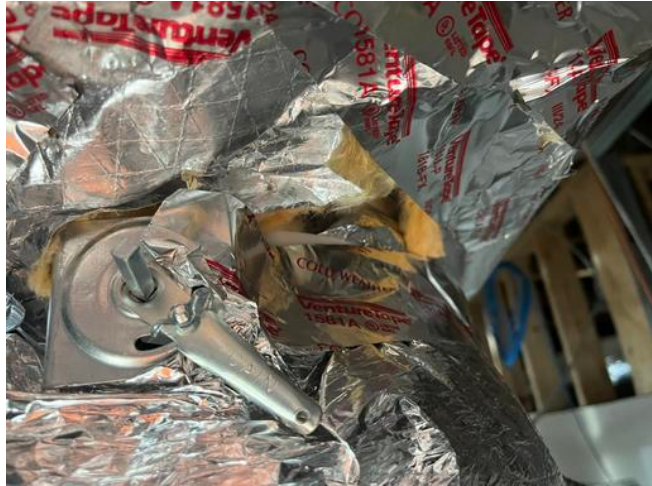
#277 [DUCT 507] [NEW] Ductwork is not fully insulated.

AC1, AC2, AC3 have exposed sheet metal. Supply & return ductwork in many spots are missing insulation. Recommend mechanical go through each duct run to ensure all sheet metal is insulated, and all insulation seams are taped.

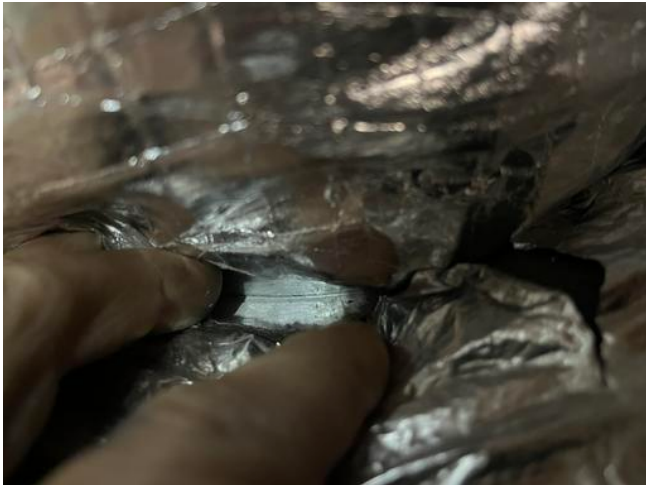
IMG_6757

#276 [DUCT 499] [NEW] CRITICAL (MISC) – [MASTIC]

AC1, AC2, AC3, AC4, AC5
mastic is not installed at the
rigid connection between
hard pipe and air device
collar for supply and return
grills.

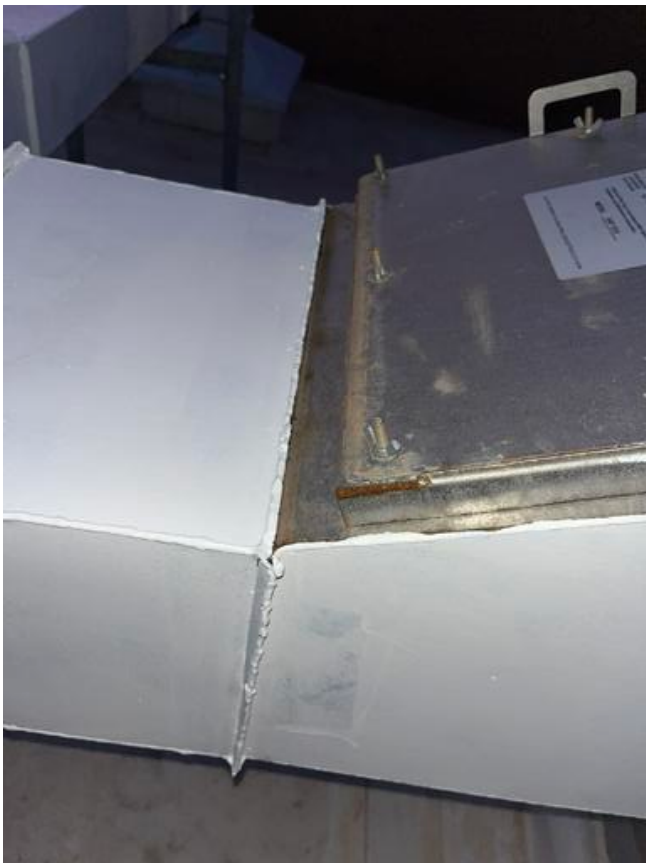
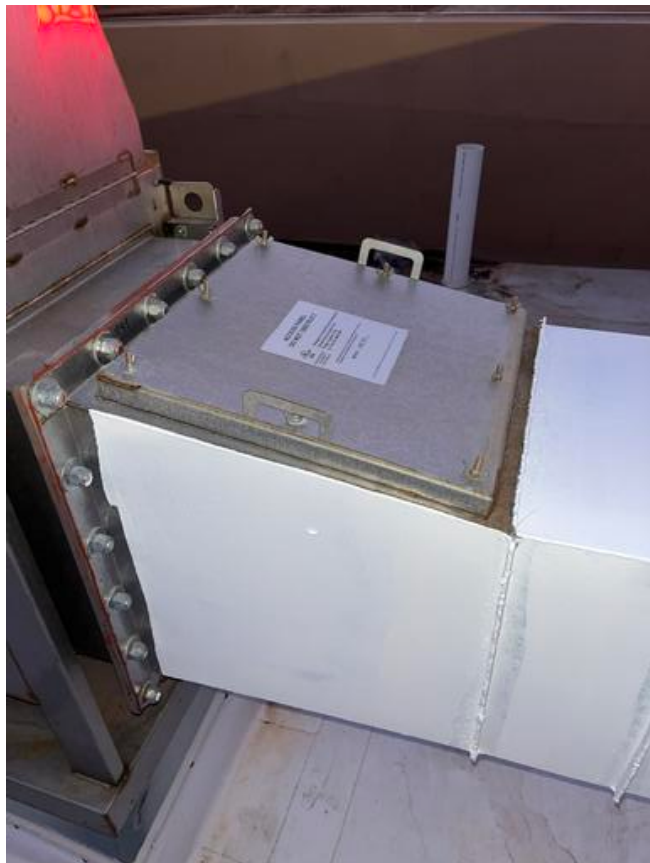
#275 [EXHA 509] [NEW] Grease exhaust duct is not fully painted.

EF1 & EF2 grease duct is not fully painted and has exposed metal.

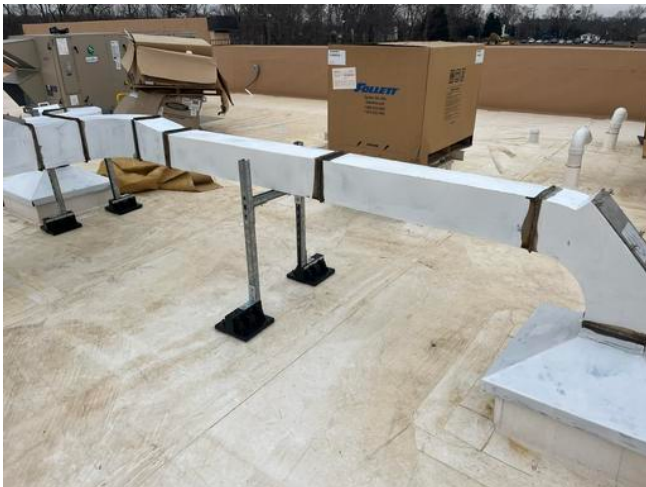
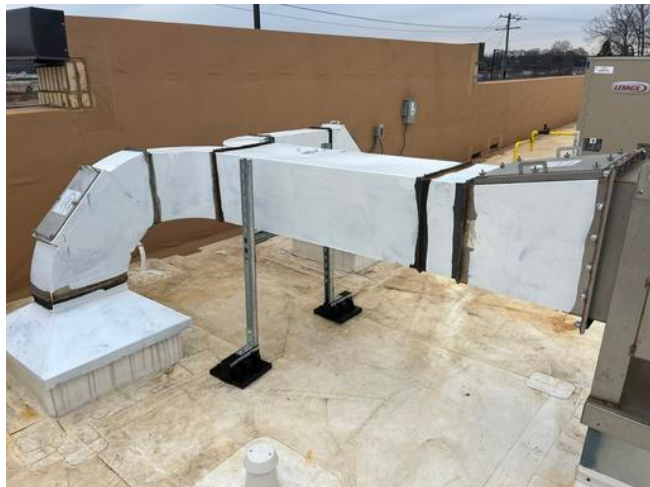
**#274 [EXHA 510] [NEW] Grease exhaust duct is not supported[EXHA 510] [NEW]
Grease exhaust duct is not supported properly..**

EF2 exhaust duct is to be supported per kitchen hood exhaust fan detail on 6'0" centers.

EF1 & EF2 rooftop grease duct should be supported at each duct drop into the space

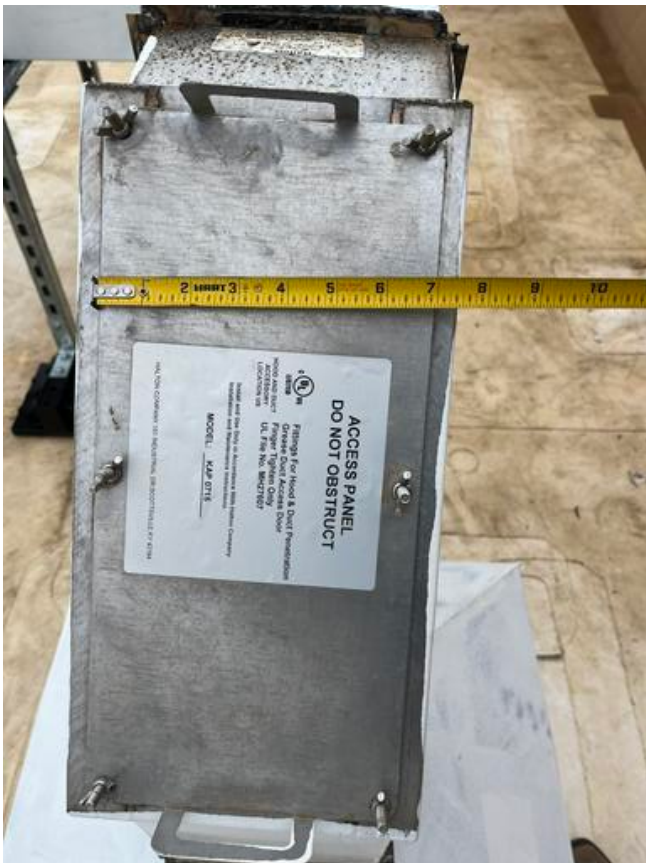
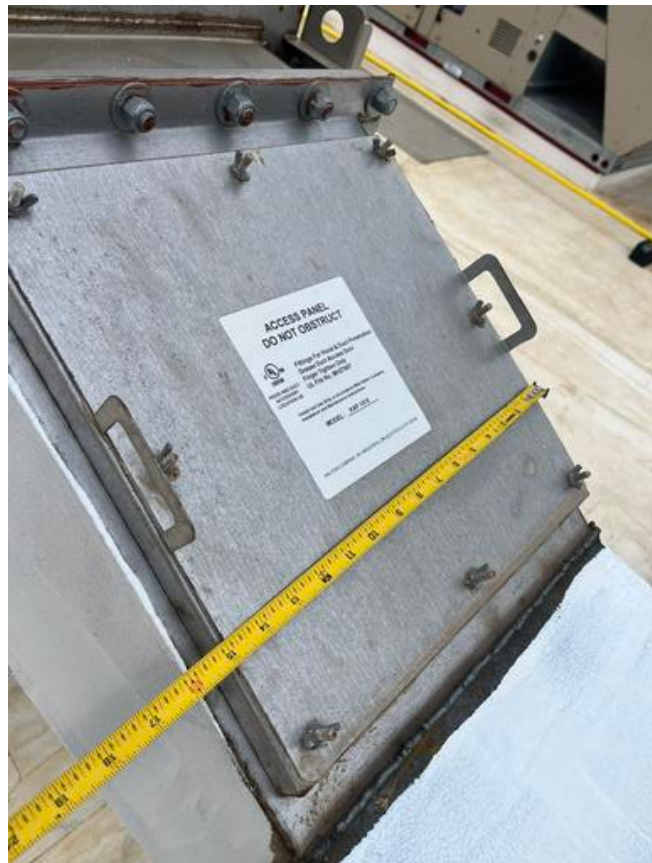
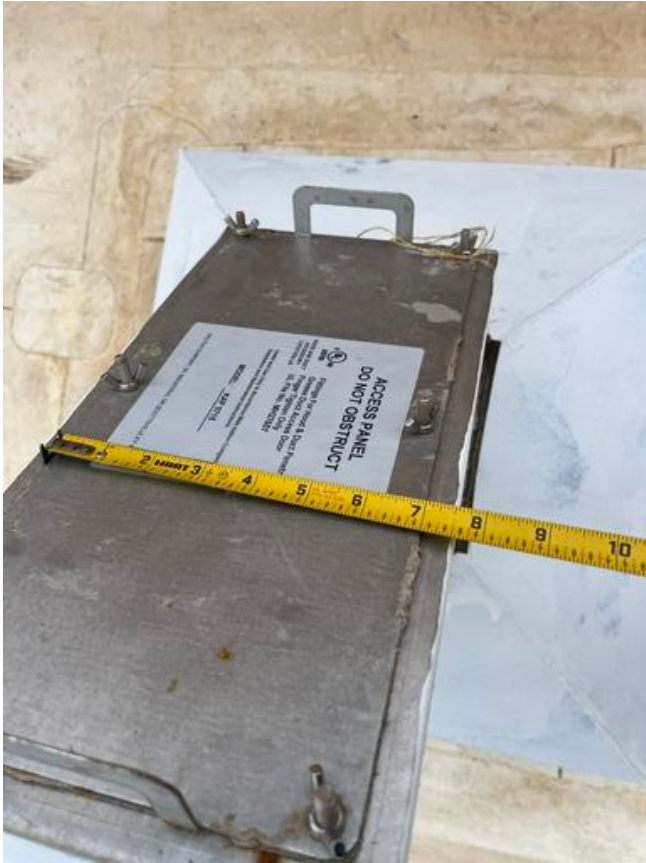
#273 [EXHA 001] [NEW] CRITICAL – Grease duct access doors.

EF1 & EF2 grease access doors are not the same size listed in prints.

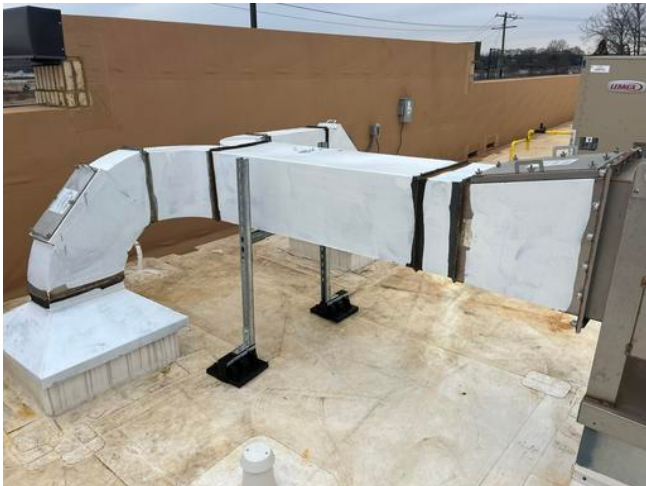
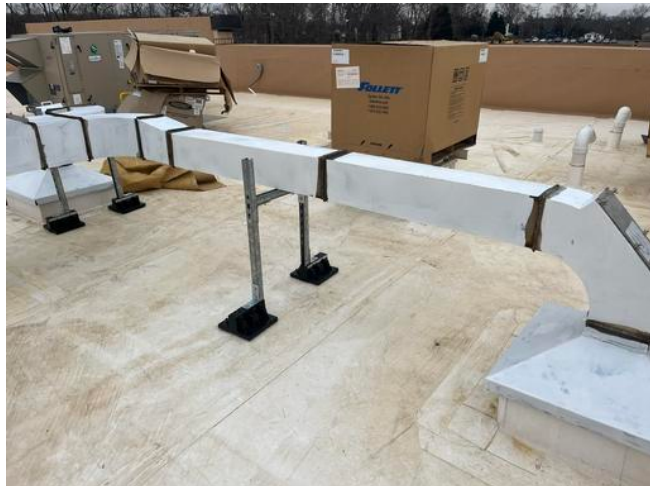
#272 [EXHA 001] [NEW] CRITICAL – Grease duct access doors.

EF1 is missing two grease cleanout doors per plans.
EF2 is missing two grease cleanout doors per plans.
