PlanGrid Task Report - Jan 27, 2025

L05549_RELO Simpsonville FSU (SC)

Simpsonville, South Carolina

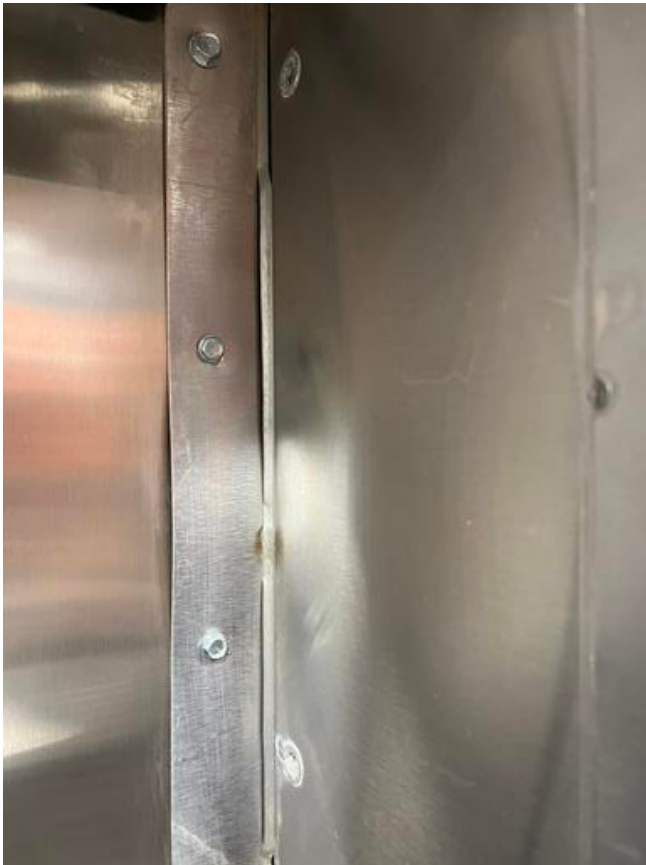
IMG_6712

#271 [HOOD 999] [NEW] (MISC) [GUSSET BRACKET SCREW]

Hood3 is missing gusset
bracket screws

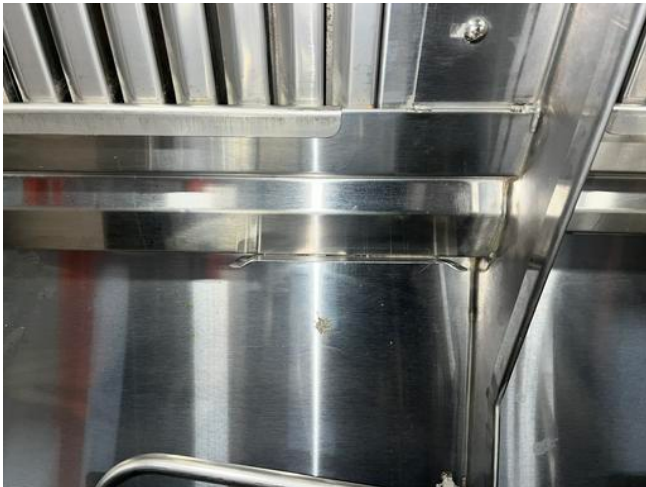
20250123_181720_photo

#270 [HOOD 512] [NEW] Missing Grease cup

Hood1L has a missing
grease cup.

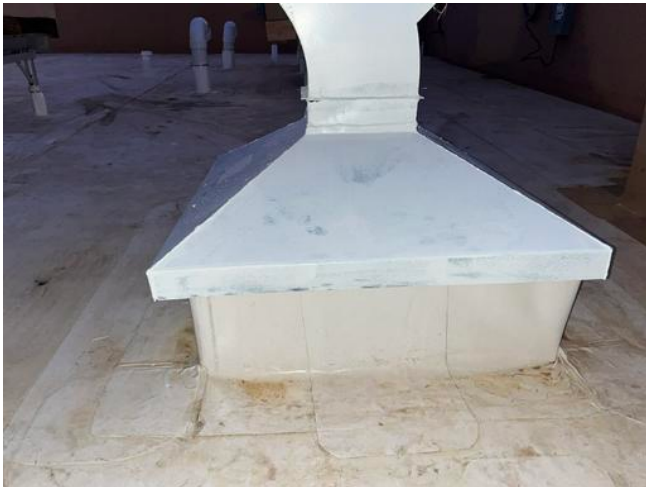
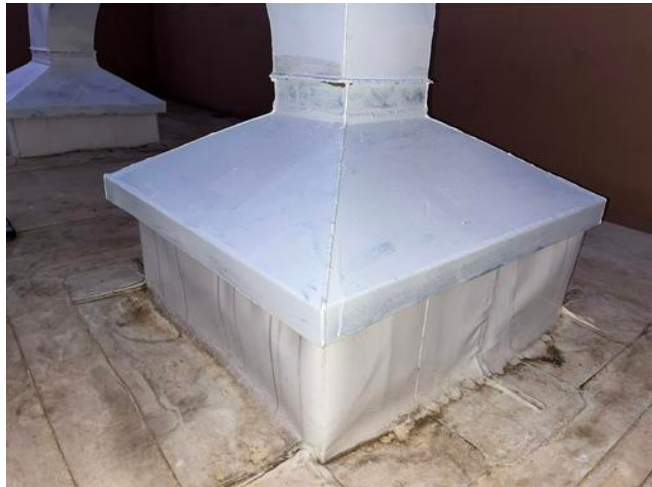
#268 [EXHA 511] [NEW] Grease exhaust duct curb cap.

EF1 & EF2 curb caps need to be secured with screws

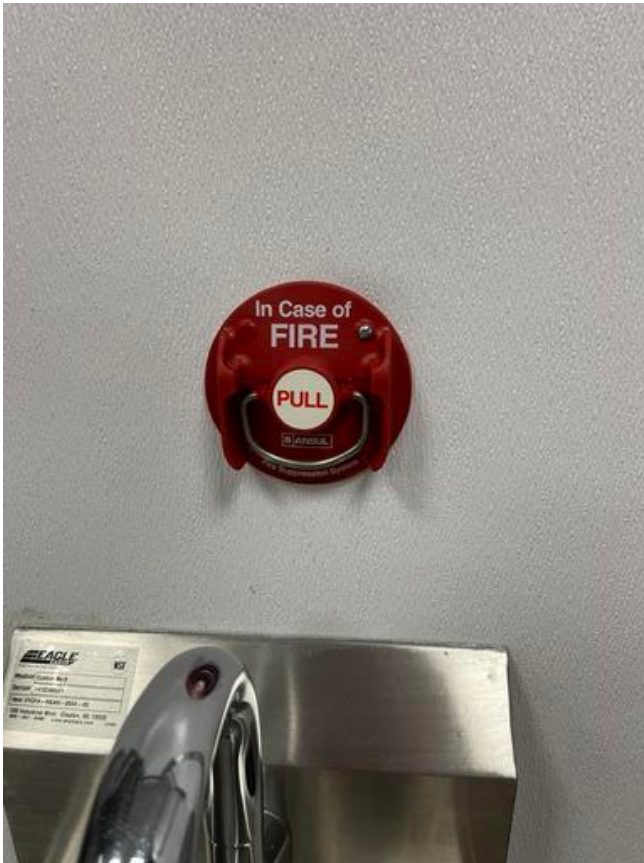
IMG_6709

#267 [CNTL 509] [NEW] Ansul pull labeling.

Ansul pull stations are not labeled.

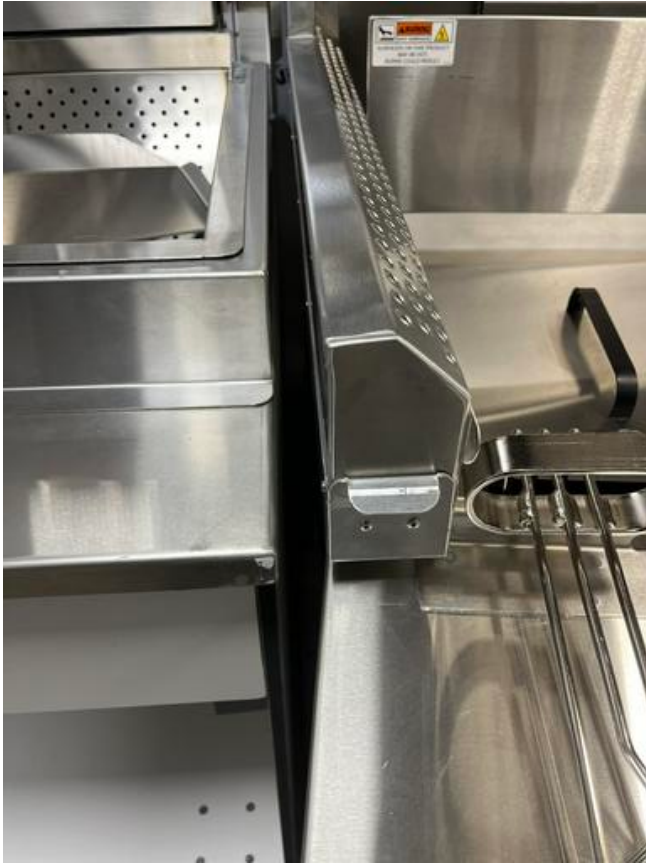
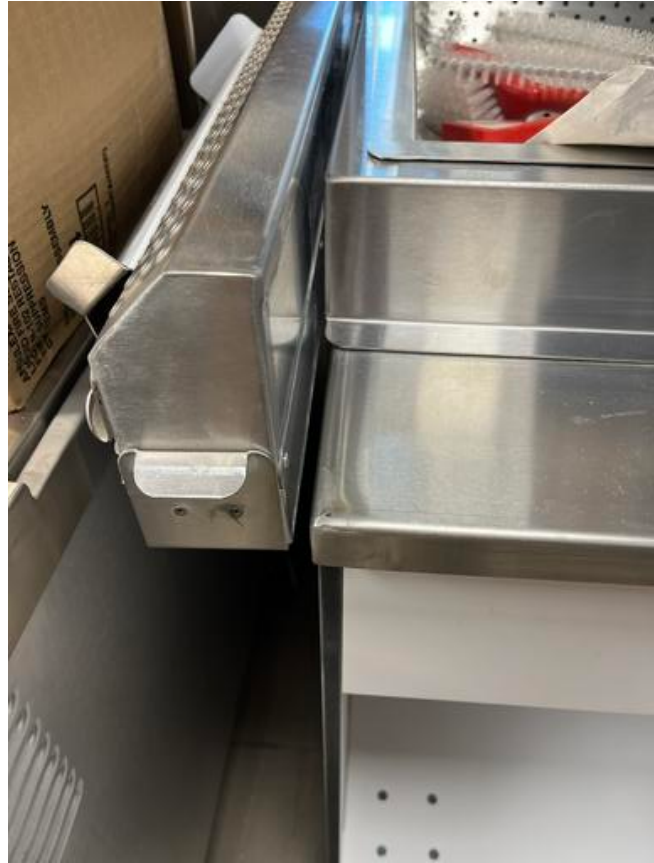
#266 [HOOD 508] [NEW] Side jet arm angle bracket.

Hood3 & Hood2 Halton supplied angle bracket that connects the integral side jet arm to the counter is missing / not installed. Secure bracket to arm and bracket to counter underneath removeable fry dump via stainless steel rivets.

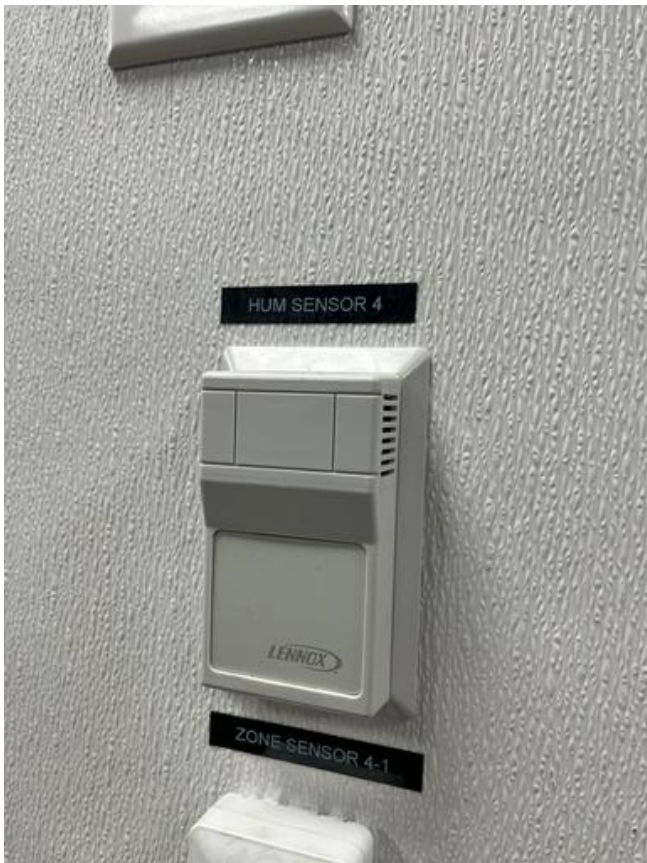
20250123_175552_photo

#265 [CNTL 508] [NEW] Controls labeling.

AC1, AC2, AC3, AC4 temp.
& humidity labels are not
hard plastic.

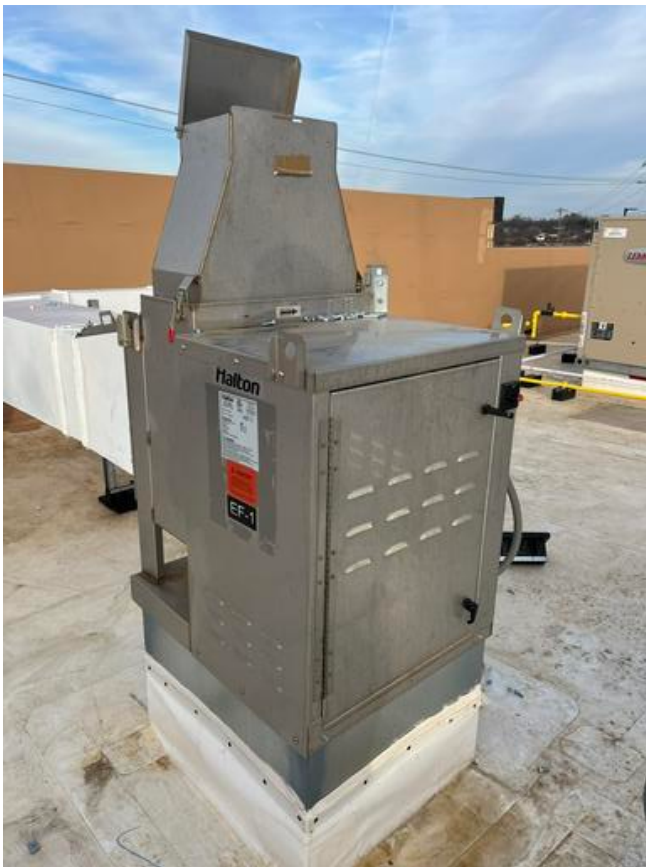
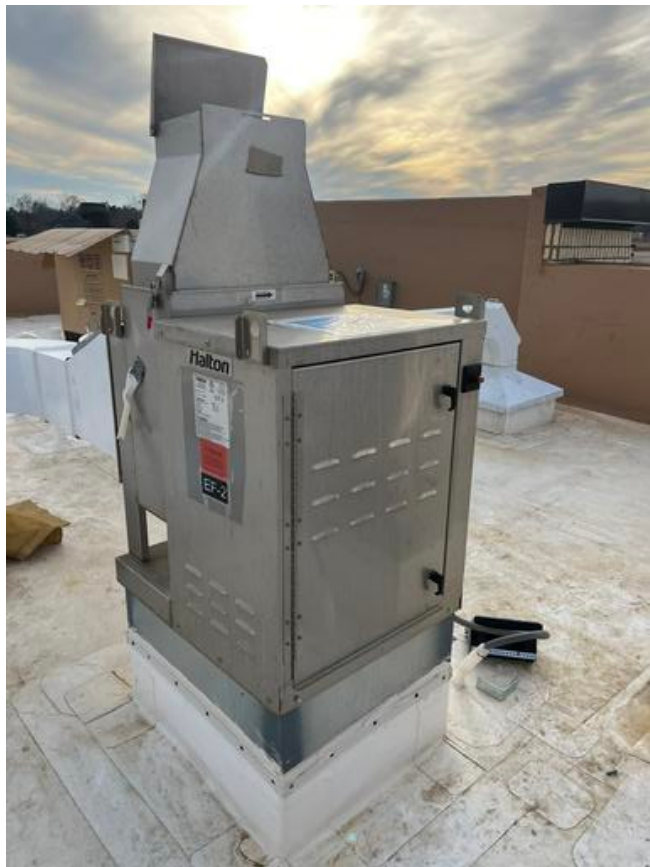
#264 [EXHA 507] [NEW] Exhaust fan drain line.

EF1 & EF2 PVC exhaust fan drain is not installed

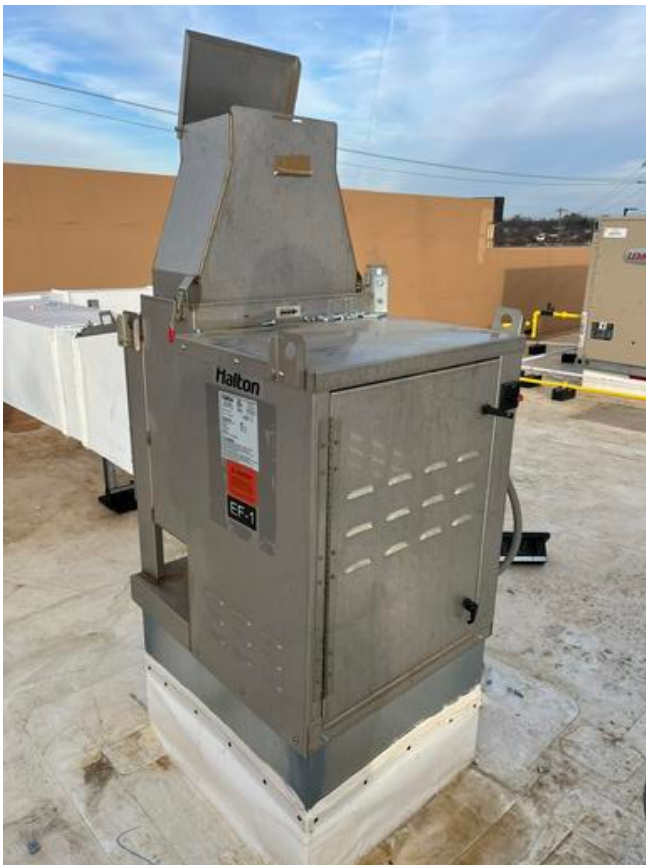
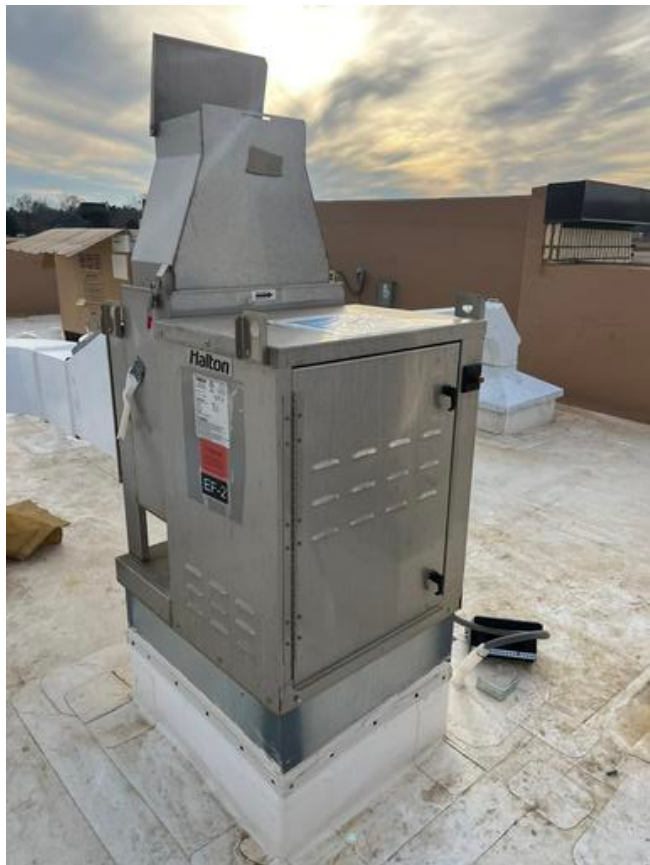
#263 [EXHA 508] [NEW] Exhaust fan G2 Drip Guard.

EF1 & EF2 drip guards are not installed.

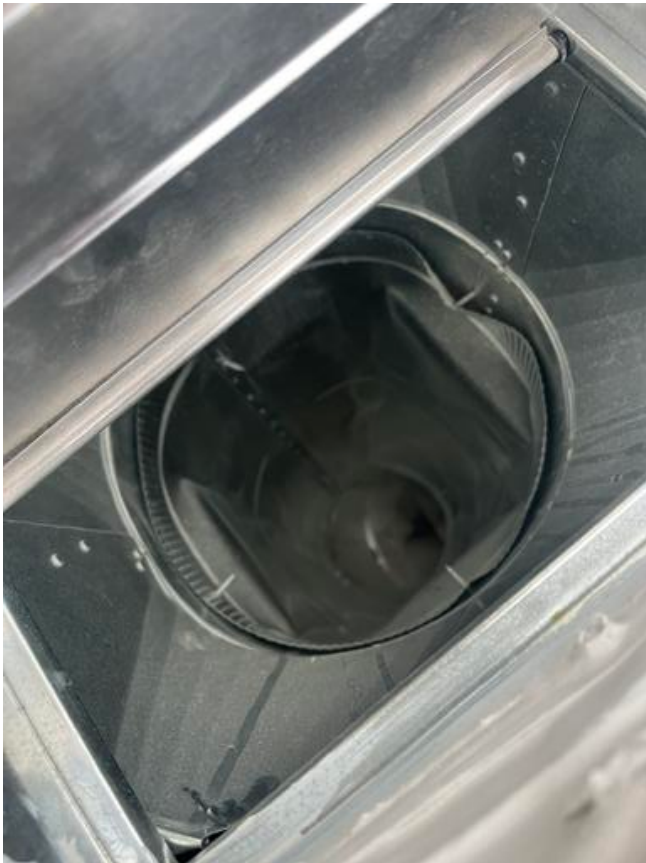
IMG_6735

#262 [EXHA 500] [NEW] Restroom rectangular duct riser.

EF3 main drop is not rectangular duct, prints call for rectangular duct to be installed with liner.

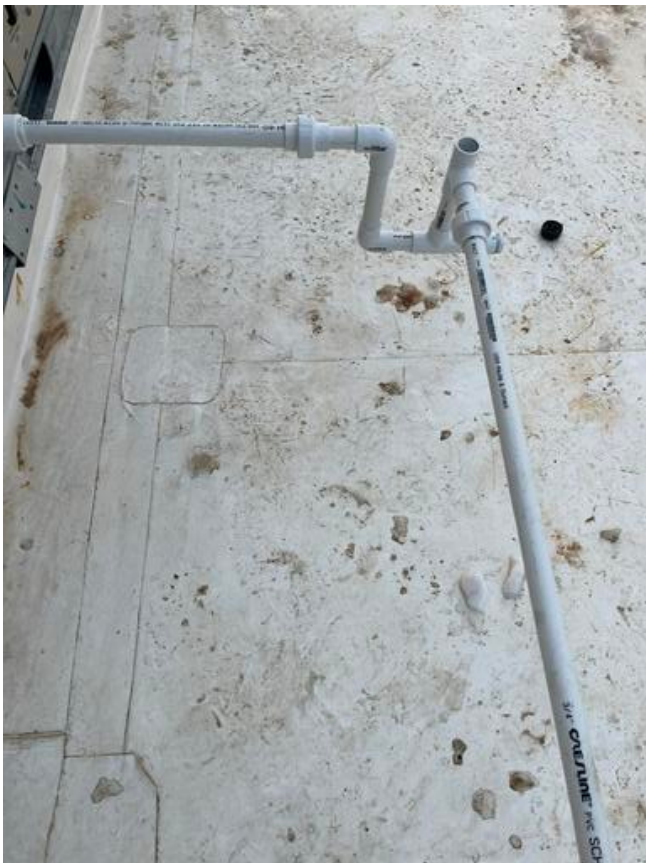
IMG_6824

#260 [UNIT 517] [NEW] Condensate piping construction.

AC3 condensate line is not the correct size listed in prints.

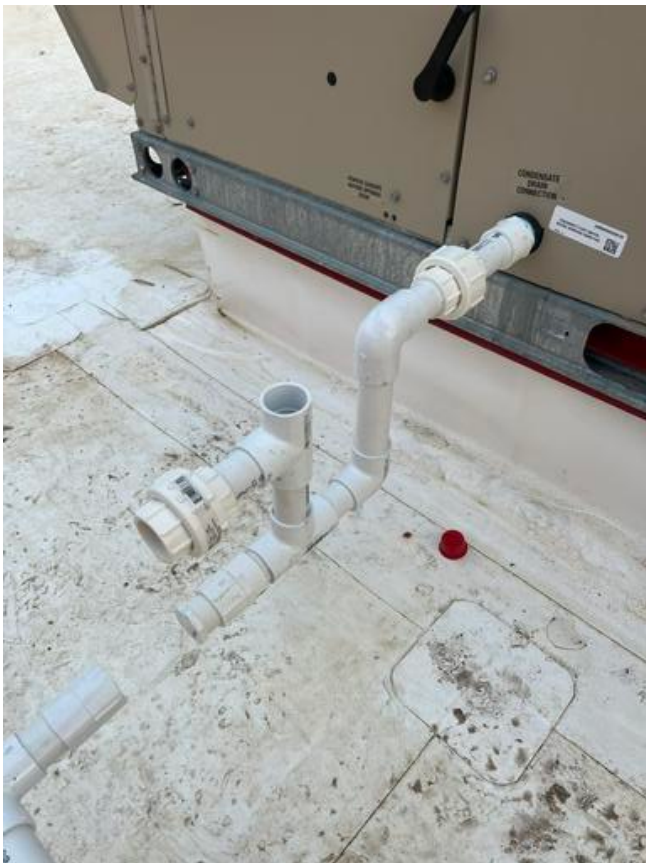
IMG_6823

#259 [UNIT 517] [NEW] Condensate piping construction.

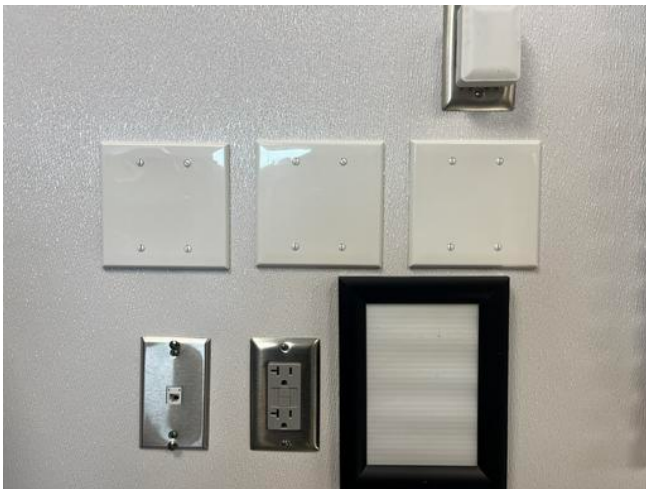
IMG_6804

#257 [CNTL 004] [NEW] CRITICAL – Annunciators not installed.

AC1, AC2, AC3, AC4, AC5
annunciators are not
installed or labeled.

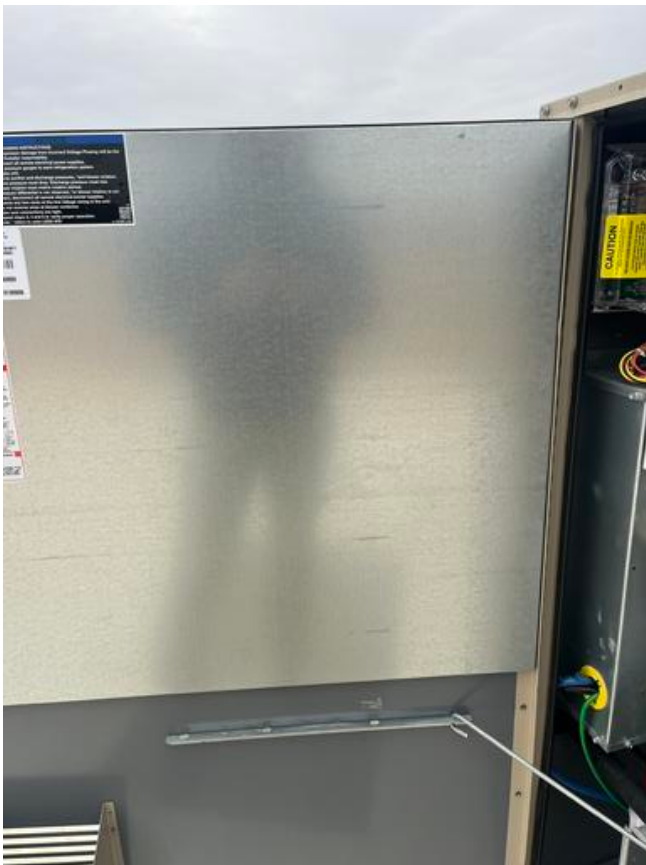
IMG_6733

AC1, AC2, AC3, AC4, AC5
Equipment missing
laminated copy of controls
detail low voltage wiring
diagrams.
