**Report By:**

National TAB  
1329 E. KEMPER ROAD  
SUITE 4210  
CINCINNATI, OH 45246

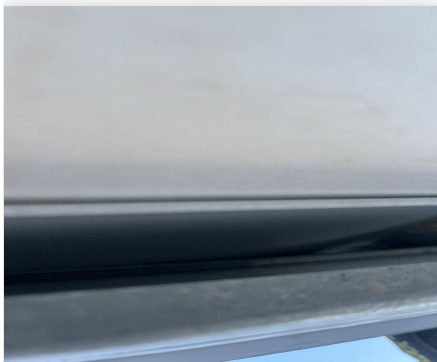
Project Issue File Details

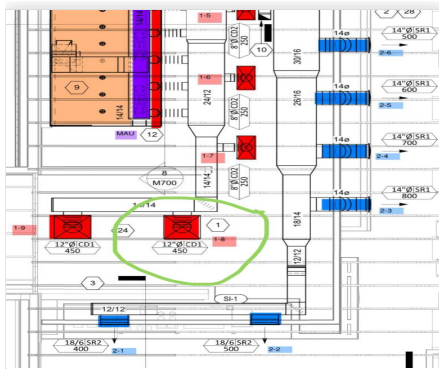
**Project Issue File Details**

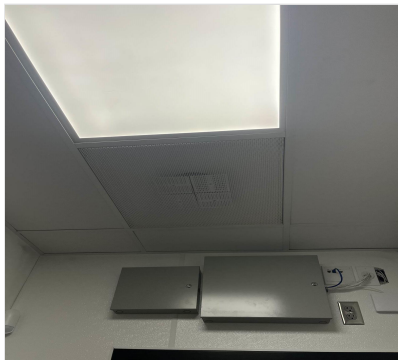
Office diffuser has some noise due to proximity to drop. Pinched flex as well as installed face damper contributing to noise. Appears installed per plan. Recommend diffuser is ducted off of duct further away from drop in future to reduce noise.
