AIR BALANCE SCHEDULE

07-11 CULVERS - ELLISVILLE, MO

Project: 07-11 CULVERS - ELLISVILLE, MO

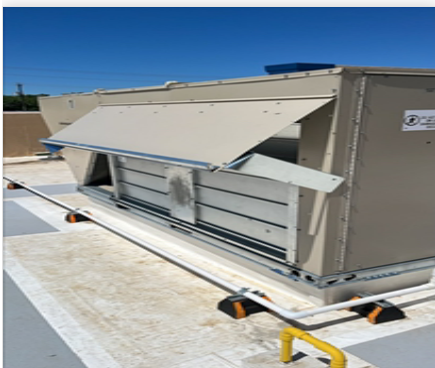
Makeshifthood.jpeg

Issue Name : asset note RTU1 [1]

Description : OA filters and hood have not arrived yet. GC helped make a makeshift hood to read OA measuring 14.75x76

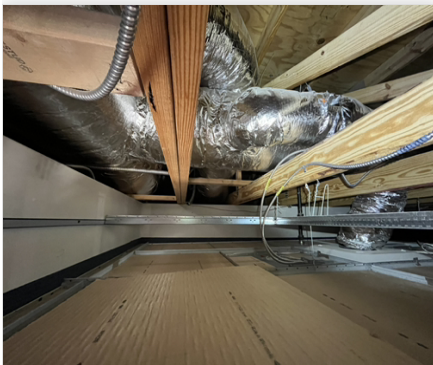
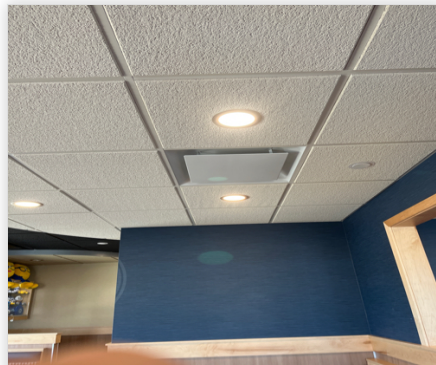
Issue Name : Diffuser note RTU1 SGRD 1-12 low on flow

Description : Branch is low on flow due to hard right angle coming out of one of the main duct lines. Diffuser is in an open space and should not create comfort issues

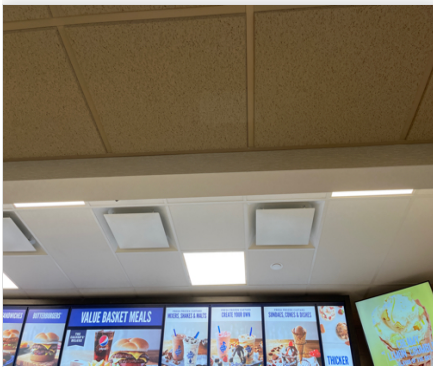
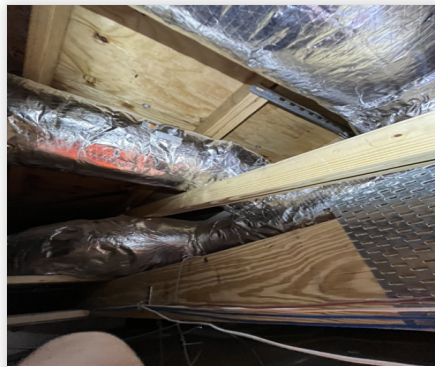
Issue Name : Diffuser note RTU1 SGRD 1-22 low on flow

Description : Duct is located too close to adjacent duct for the same area, causing turbulence and preventing more airflow from being pushed to diffuser. Since it is in an open area, I do not anticipate comfort issues.

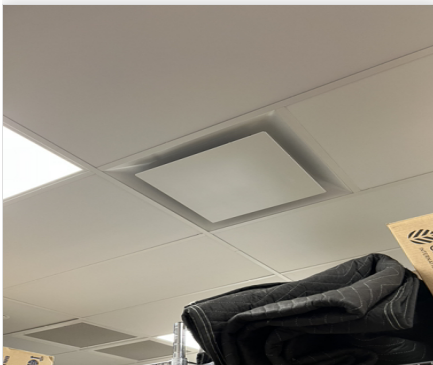
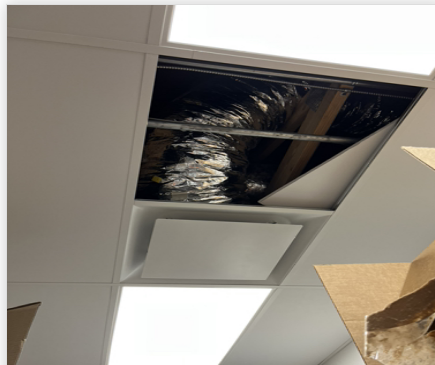
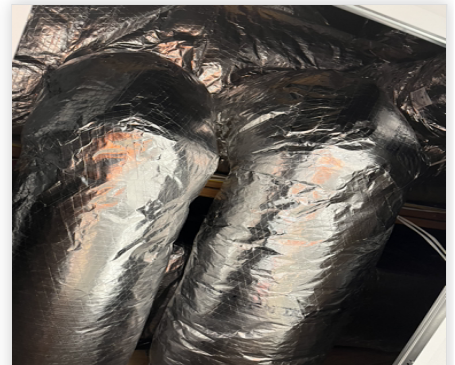
Issue Name : RTU2 diffusers for dry goods have no dampers

Description : Diffusers for dry goods do not have dampers. The 200 cfm diffuser is high and the 600 cfm diffuser is very low due to excess flex and ceiling restrictions. Since it is in an open area, I do not foresee it causing comfort issues.

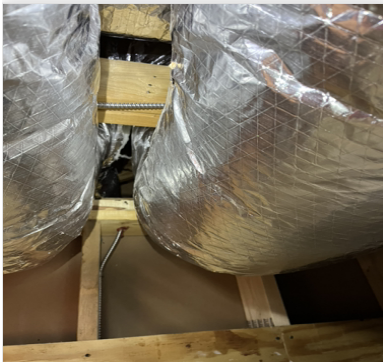
FuseIT3b45930d299243e192
4652ecb385abb5.jpeg

- **07/13/2022** **National TAB - Jacob Davidson**
 - Current airflow for each is 260/200 and 344/600. Pic is another angle looking for damper

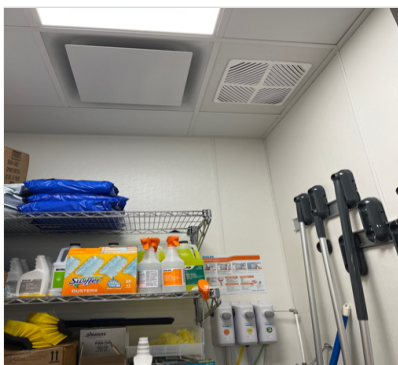
EF-1A

Mop room fan

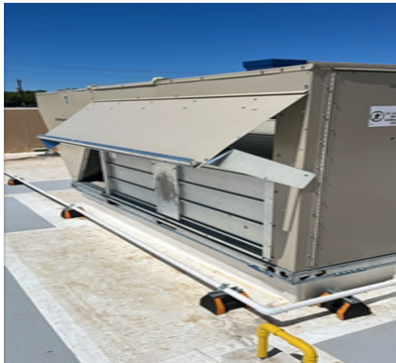
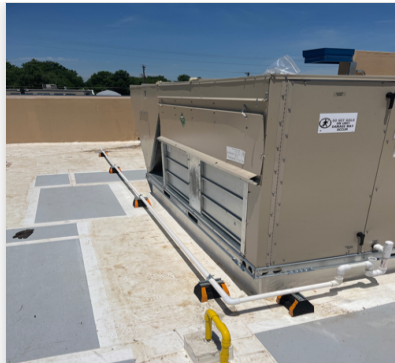
Makeshifhood.jpeg

Economizers are assembled and functional?

NO // 7-12-22 Economizer is installed, however full assembly for hood and OA filters has not arrived. OA read in open area as shown.

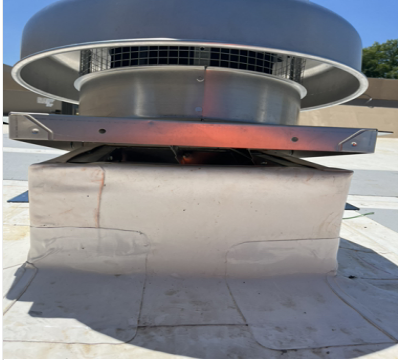
Is gas piping installed and valves turned on?	Yes
Unit free of noticeable noise and vibration	Yes
EF's	
Rotation is correct?	Yes
Belts are tight?	YES
Grease cup installed on hood fan?	Yes
Hinge kit installed installed on hood fan?	Yes
Lean grease rated fans back. Is grease duct installation adequate and is duct ran all the way to the base of the fan?	Yes
Flex conduit is long enough so that fan can be completely tilted back?	Yes
There is no major leakage around base of fan?	Yes
Is the motor operating below the motor FLA rating?	Yes
For restroom fan(s) is the back draft damper installed and can it fully open?	Yes

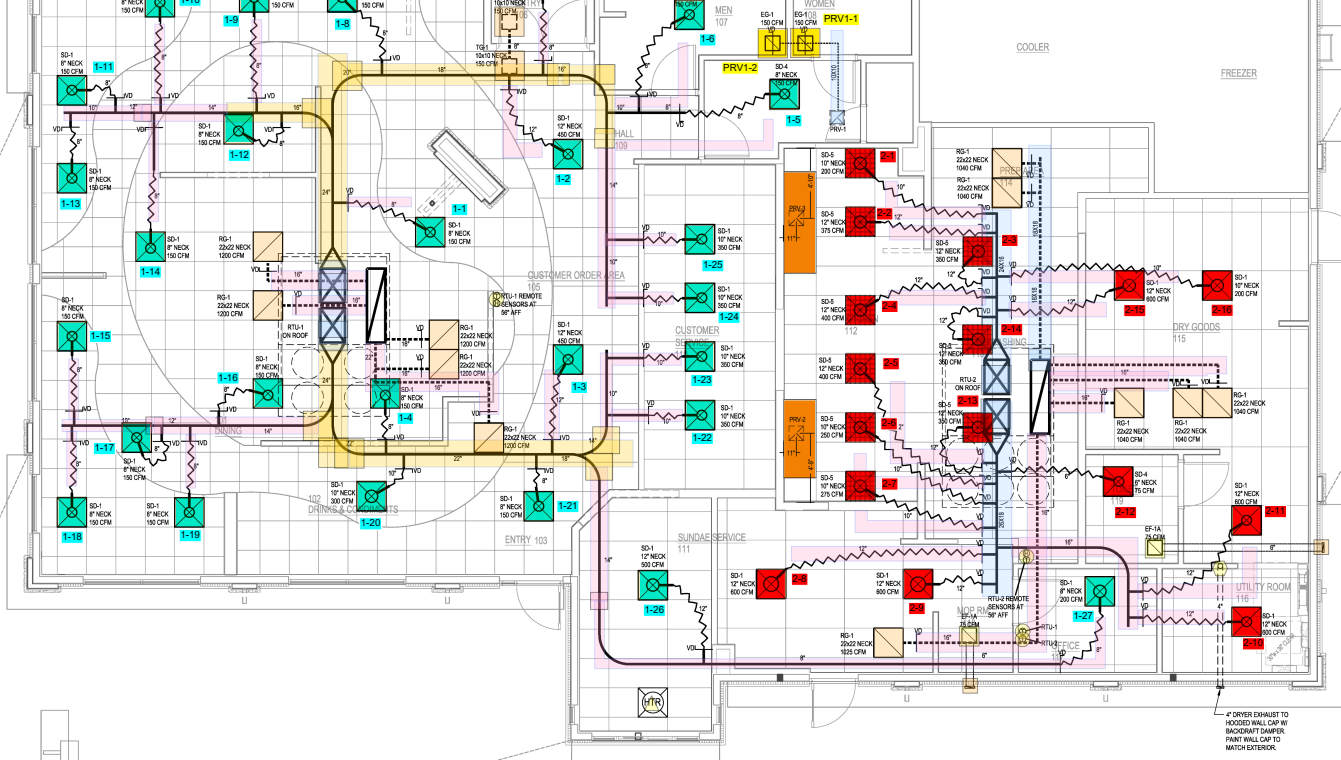
E5 HVAC PLAN
SCALE: 1/4" = 1'-0"

NOTE: ALL DUCTWORK TO BE LOCATED IN TRUSS SPACE WHERE POSSIBLE. SEE FRAMING PLAN.
HVAC SETPOINTS RECOMMENDED BY CORPORATE OPERATIONAL GUIDELINES:
1. DINING: HEATING 70 DEGF; COOLING 72 DEGF
2. KITCHEN: HEATING 68 DEGF; COOLING 74 DEGF

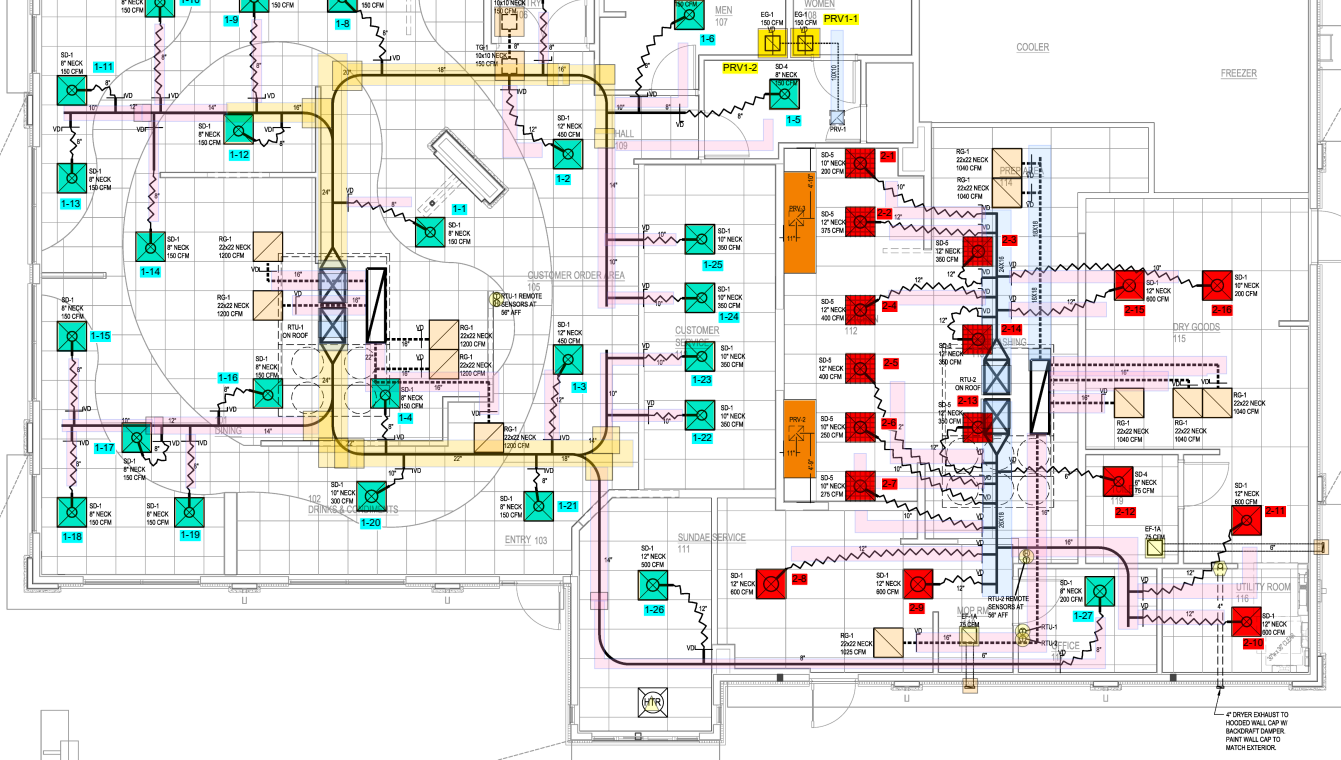
E5 HVAC PLAN
SCALE: 1/4" = 1'-0"

NOTE: ALL DUCTWORK TO BE LOCATED IN TRUSS SPACE WHERE POSSIBLE. SEE FRAMING PLAN.
HVAC SETPOINTS RECOMMENDED BY CORPORATE OPERATIONAL GUIDELINES:
1. DINING: HEATING 70 DEGF; COOLING 72 DEGF
2. KITCHEN: HEATING 68 DEGF; COOLING 74 DEGF
