Report: Brightview-DOAS1 Analysis

Function: Test, Adjust, & Balance

BVE - Brightview Senior Living (Eatontown, NJ)

Included in the Report below is data and analysis of DOAS-1 at the Brightview Senior living facility located in Eatontown NJ. The purpose of this analysis was to determine if the unit is meeting design and performance expectations on the Supply and exhaust side of the DOAS.

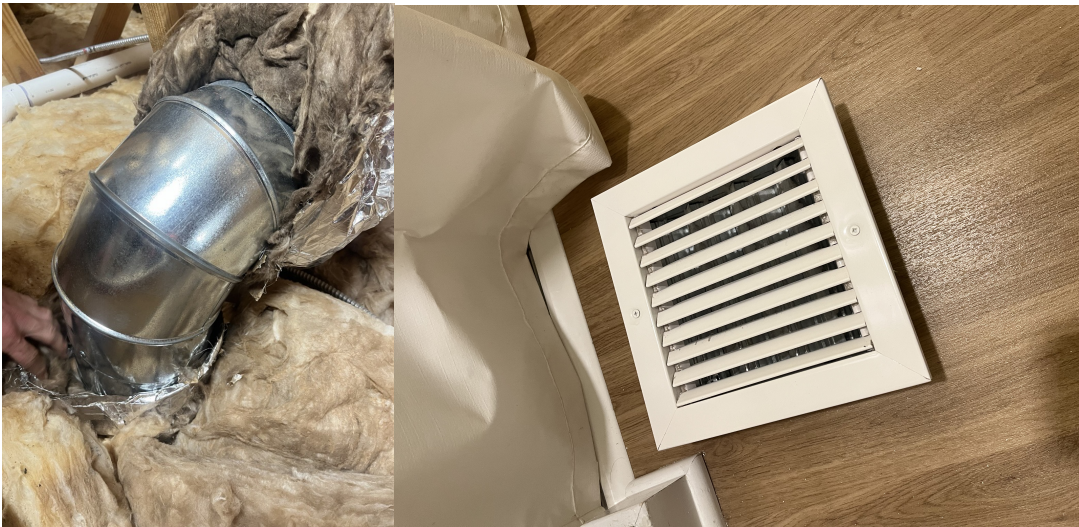
It was not possible to obtain a traverse of any part of the trunkline for the supply side of DOAS-1 due to the location of the duct above hard ceiling in the hallway and clearance needed to insert the pitot tube. Flow hood readings were taken on the supply side with three hood configurations types and it was found that there is no consistency and ability to triangulate hood readings or traverses. The hood readings on the supply side we deem as inaccurate. The reason for the discrepancy/inconsistency in readings is from the 1. Supply grille type, and 2. how the supply grille is connected to ductwork with an elbow directly on top of the plenum box. the configuration is creating turbulence across the flow hood grid where the flow hood requires laminar flow in order to read supply air accurately as you would see with a typical 4 way throw diffuser.

A total traverse of the DOAS supply was not possible so for further testing it would be recommended to read the total intake on the roof via alternative methods.
