**Report: PUNCHLIST**  
**Function: Test, Adjust, & Balance**  
**Date: 03/10/2026**  
**Completed By: National TAB**

**PROJECT**  
**03-09-26 QT #0588 OMAHA, NE**

QUIKTRIP  
4705 SOUTH 129TH EAST AVENUE  
TULSA, OK 74134

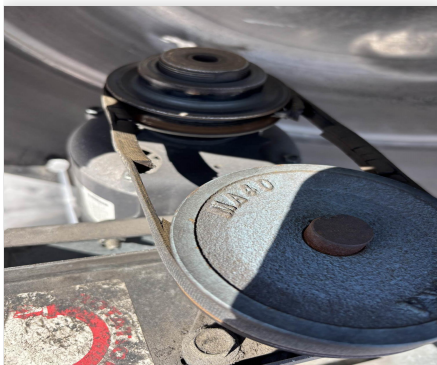
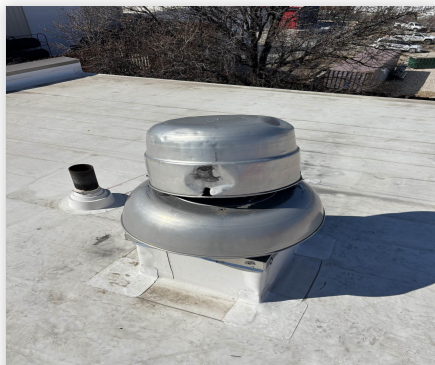
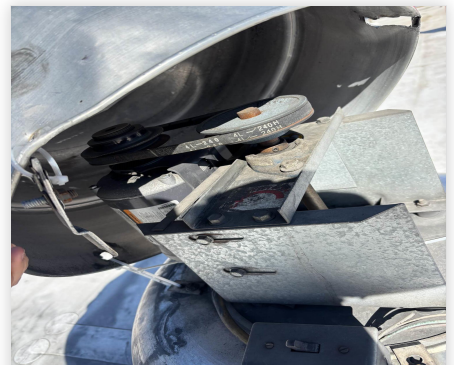
**Issue Name :** EF-1: Damage  
**Description :** EF-1 was found off upon arrival. Drive belt is cracked and missing chunks out of it. The cover is also heavily damaged and being held on with zip ties. Recommend replacing drive belt and cover. Unit left turned off.  
**Created By :** National TAB      **Assigned To :** National TAB - Dan Hertenstein  
**Status :** Open  
**Priority :** Urgent      **Asset Tag :** EF1  
**Originated Date :** 03/10/2026 - Kalen Kemp - National TAB

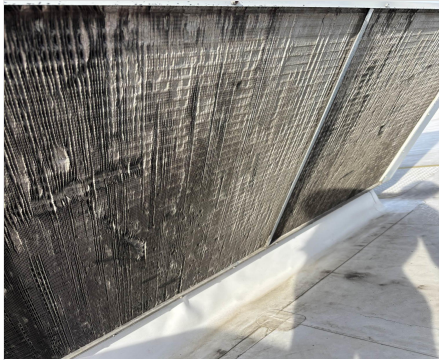
**Issue Name :** RT-2: Condenser Coil  
**Description :** The condenser coil for RT-2 is damaged. Recommend service.  
**Created By :** National TAB                      **Assigned To :** National TAB - Dan Hertenstein  
**Status :** Open  
**Priority :** Medium                                      **Asset Tag :**  
**Originated Date :** 03/11/2026 - Kalen Kemp - National TAB
