Report: Renew
Date: 12/9/2021

FREDDY'S EPOCH - LANSING, KS - RENEW 2HFB (2)

Section	Page #
Recommendation List	3
Site Pictures	4
Checklist Data	14
Summary Data	20
AHU/RTU	21
FAN - Supply	24
FAN - Exhaust	25
COIL - DX	29

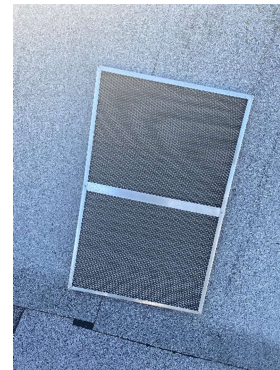
RTU-1 (DINING)
CLEAN OUTSIDE AIR FILTERS

RTUs: There evaporator coil was rinsed off and cleaned. During warmer months a self-cleaning chemical is sprayed on the evaporator. The outside air filters were rinsed off to remove any dirty, so the unit stays at the designated outside air set point. Based on static pressures, amps, and fan rpm it shows that the total supply has not changed since the last test and balance.

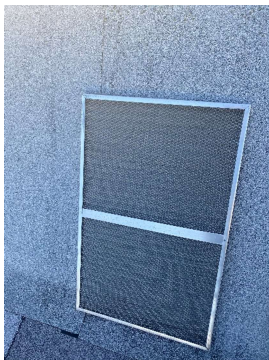
RTU-2 (FRONT KITCHEN/DINING)
DIRTY OUTSIDE AIR FILTERS

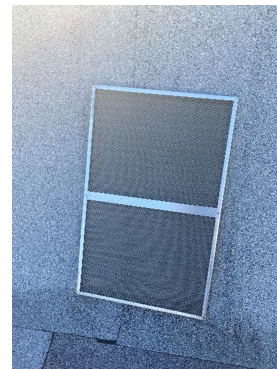
RTU-2 (FRONT KITCHEN/DINING)
CLEAN OUTSIDE AIR FILTERS

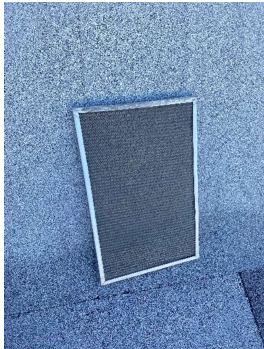
RTU-3 (DINING/RR)
DIRTY OUTSIDE AIR FILTERS

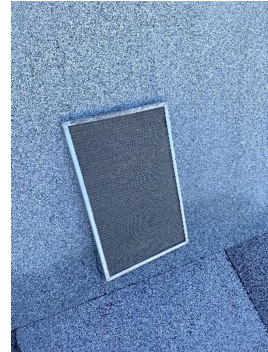
RTU-3 (DINING/RR)
CLEAN OUTSIDE AIR FILTERS

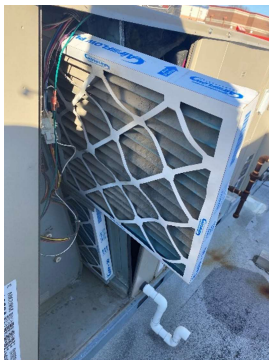
RTU-1 (DINING)
DIRTY EVAPORATOR FILTERS

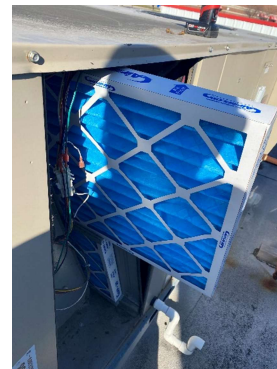
RTU-1 (DINING)
CLEAN EVAPORATOR FILTERS

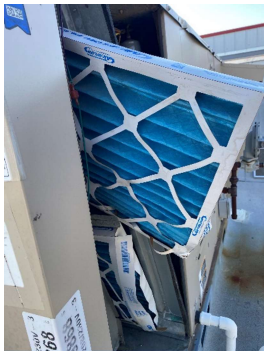
RTU-2 (FRONT KITCHEN/DINING)
DIRTY EVAPORATOR FILTERS

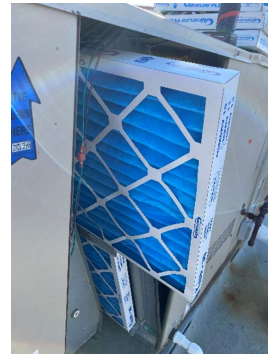
RTU-2 (FRONT KITCHEN/DINING)
CLEAN EVAPORATOR FILTERS

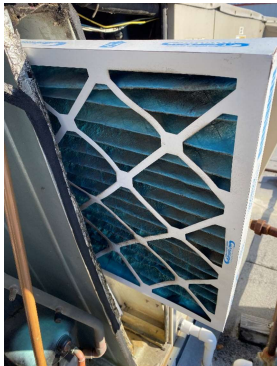
RTU-3 (DINING/RR)
DIRTY EVAPORATOR FILTERS

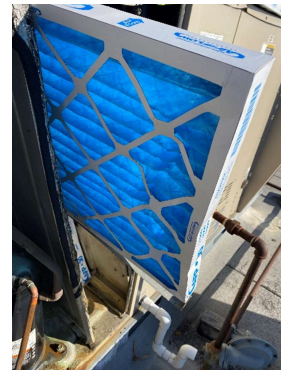
RTU-3 (DINING/RR)
CLEAN EVAPORATOR FILTERS

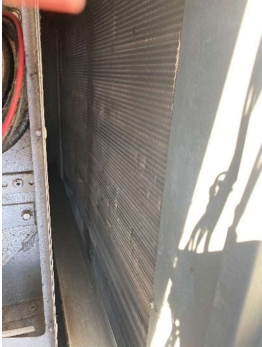
RTU-1 (DINING)
DIRTY EVAPORATOR

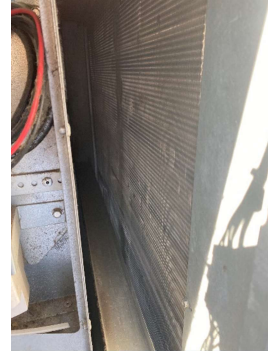
RTU-1 (DINING)
CLEAN EVAPORATOR

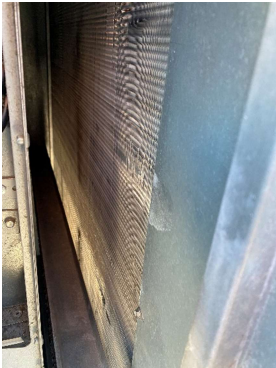
RTU-2 (FRONT KITCHEN/DINING)
DIRTY EVAPORATOR

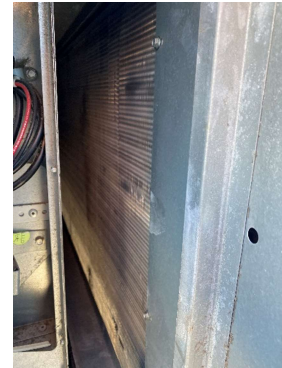
RTU-2 (FRONT KITCHEN/DINING)
CLEAN EVAPORATOR

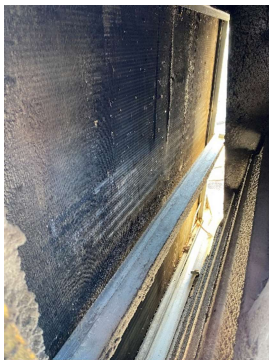
RTU-3 (DINING/RR)
DIRTY EVAPORATOR

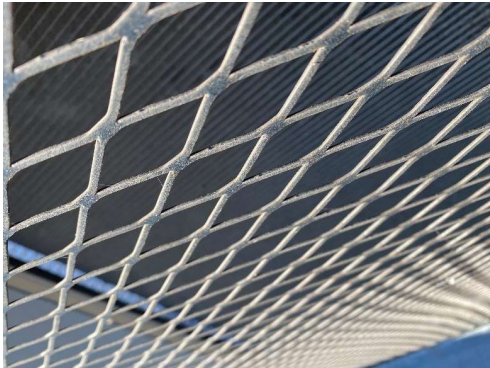
RTU-2 (FRONT KITCHEN/DINING)
DIRTY CONDENSER

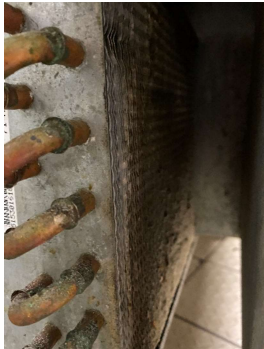
DXC-3 (MEAT COOLER 1)
DIRTY CONDENSER

Food equipment condensers were cleaned. The Walk-In evaporator were cleaned. All equipment is in good health unless stated in the Recommendation List.

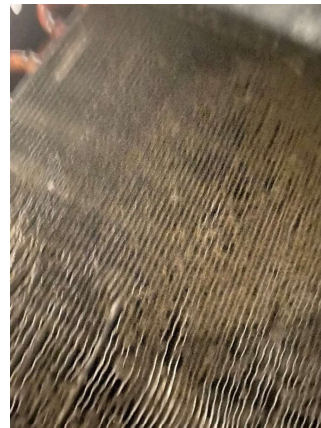
DXC-4 (MEAT COOLER 2)
CLEAN CONDENSER

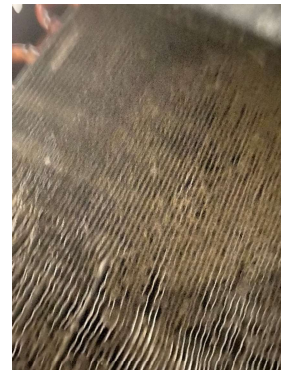
DXC-5 (PREP TABLE 1)
CLEAN CONDENSER

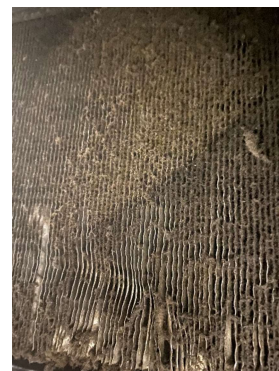
DXC-6 (PREP TABLE 2)
CLEAN CONDENSER

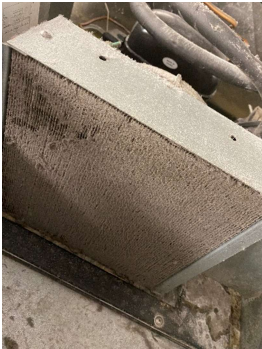
**DXC-7 (FRYER FREEZER)
DIRTY CONDENSER**

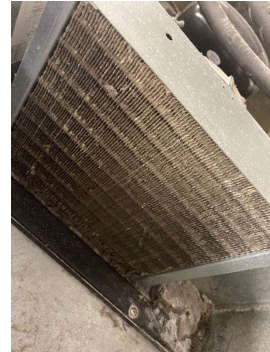
**DXC-7 (FRYER FREEZER)
CLEAN CONDENSER**

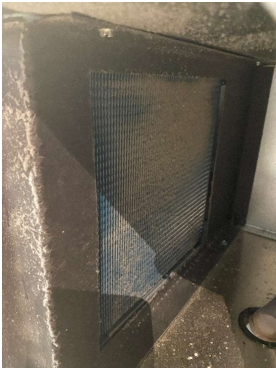
**DXC-8 (SUNDAE PREP)
DIRTY CONDENSER**

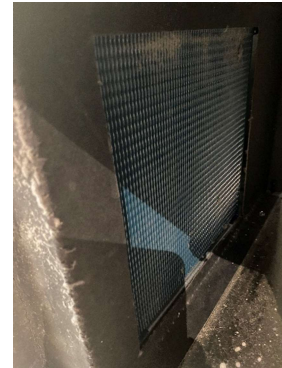
**DXC-8 (SUNDAE PREP)
CLEAN CONDENSER**

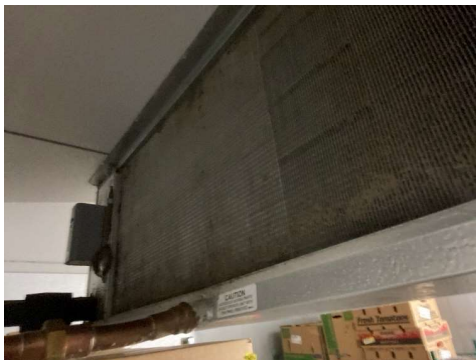
**DXC-1 (WALK-IN COOLER)
DIRTY EVAPORATOR**

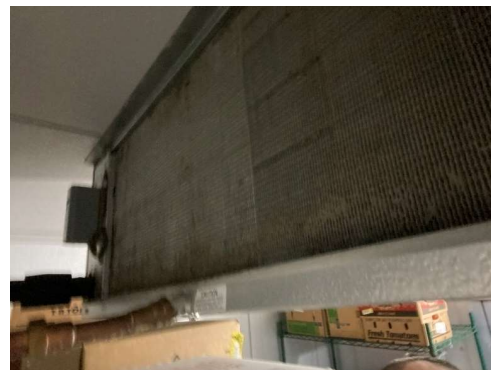
**DXC-1 (WALK-IN COOLER)
CLEAN EVAPORATOR**

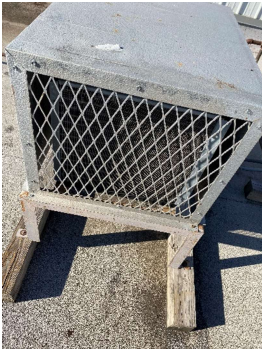
DXC-1 (WALK-IN COOLER)
DIRTY CONDENSER

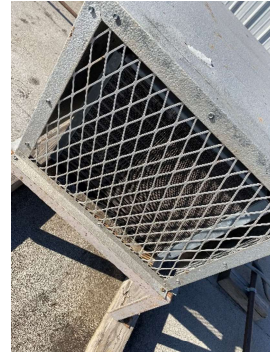
DXC-1 (WALK-IN COOLER)
CLEAN CONDENSER

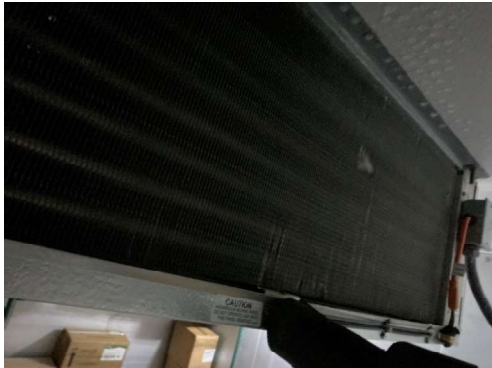
DXC-2 (WALK-IN FREEZER)
DIRTY EVAPORATOR

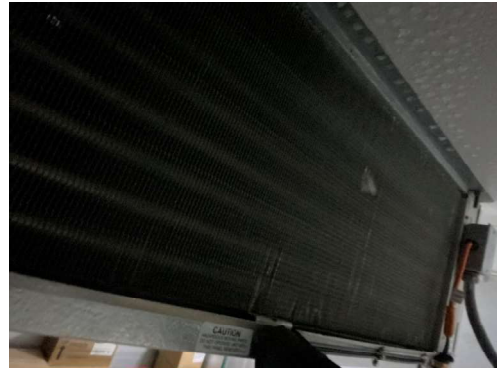
DXC-2 (WALK-IN FREEZER)
CLEAN EVAPORATOR

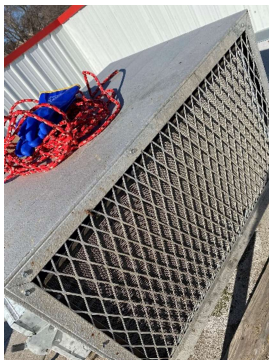
DXC-2 (WALK-IN FREEZER)
DIRTY CONDENSER
