Report: TAB REPORT
Function: Test, Adjust, & Balance
Date: 09/18/2024
Completed By: National TAB

PROJECT
06-17-24 PENN STATION CLEVELS, OH

Project: 06-17-24 PENN STATION CLEVES, OH

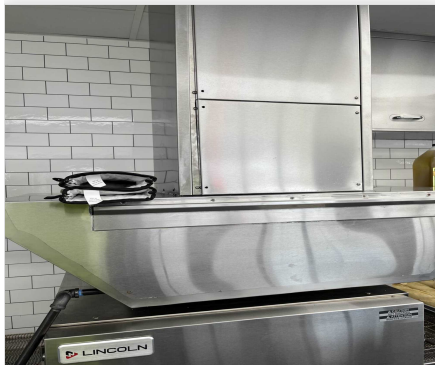
Issue Name : Hood 2 loose panel
Description : Loose panels on hood 2. Drop out of square by ~0.5" preventing panels from matching up.
Created By : National TAB **Assigned To :** National TAB - Joe Hertenstein
Status : Open
Priority : Low **Asset Tag :**
Originated Date : 06/17/2024 - Gabe Merk - National TAB

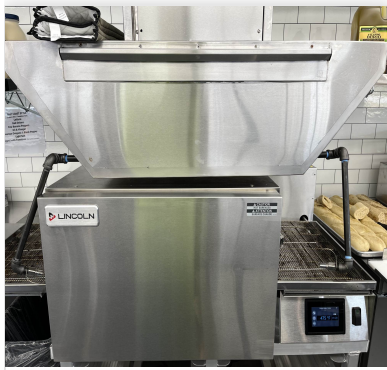
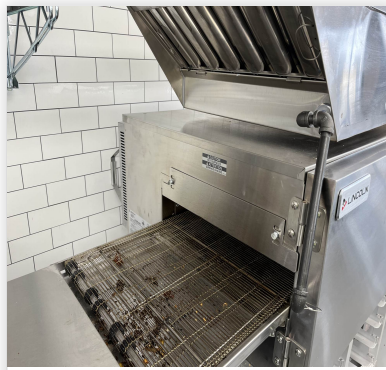
- **06/17/2024 National TAB - Gabe Merk**
 - Oven off centered. Permanent wall attachment prevents centering. ANSUL sprayer not covering opening.

- Gabe, I notice that oven is not centered under hood. Can it be moved over to the left ?
-

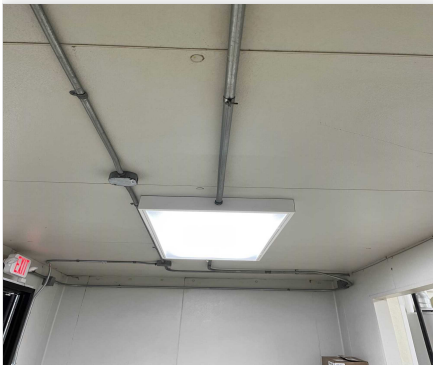
Issue Name : Missing diffuser
Description : Missing diffuser 2-11 in boh.
Created By : National TAB **Assigned To :** National TAB - Joe Hertenstein
Status : Open
Priority : Urgent **Asset Tag :**
Originated Date : 06/18/2024 - Gabe Merk - National TAB

2-11 NOT INSTALLED. LOAD ADDED TO 2-7,2-9, AND 2-10

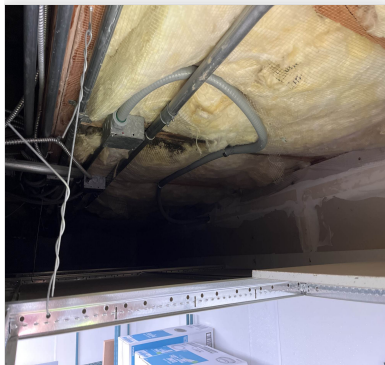
- **06/18/2024 National TAB - Gabe Merk**
 - Not much room to add through wall

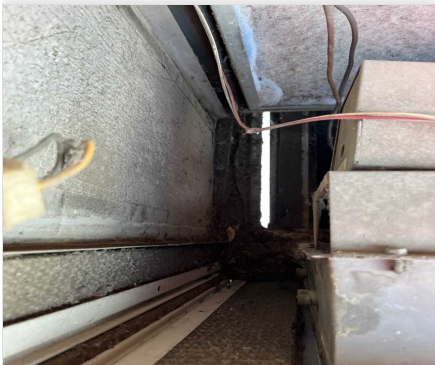
Issue Name : RTU1 Mixed air
Description : Rtu 1 has a mixed air leak at curb. This should be sealed to prevent any excess outdoor air/debris/creatures from entering unit.
Created By : National TAB **Assigned To :** National TAB - Joe Hertenstein
Status : Open
Priority : Urgent **Asset Tag :**
Originated Date : 05/29/2024 - Gabe Merk - National TAB

- **06/17/2024 National TAB - Gabe Merk**
 - Issue still open 6/17/24

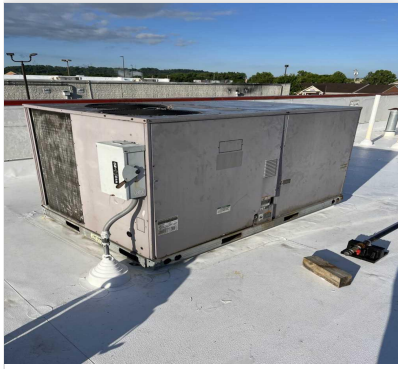
RTU-1

Notes:
 MOTOR MAXED ON AMPERAGE.
 DIRTY FILTERS REMOVED FOR TAB.
 DIFFUSER 1-9 DAMPER FULLY OPEN NOT REACHING FLOW.

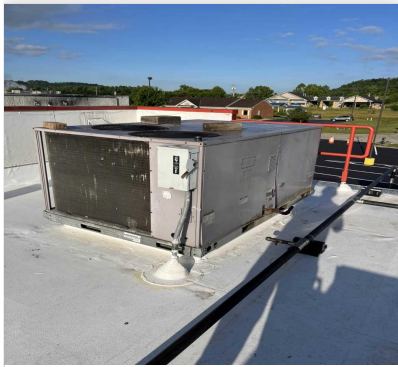
RTU-2

2-12 and 2-13 connected to RTU 1

UNDERSIZED DUCTWORK TO COOKLINE DIFFUSERS 2-2,2-3,2-4,2-6 INSTALLED 2X4" DUCTS FOR EACH.

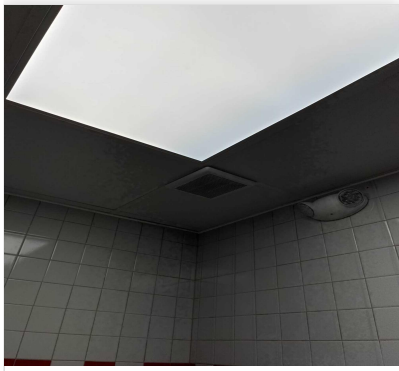
EF-5

Notes:
SINGLE SPEED FAN.
NO OBSTRUCTIONS TO NOTE.
UNABLE TO INCREASE AIRFLOW.

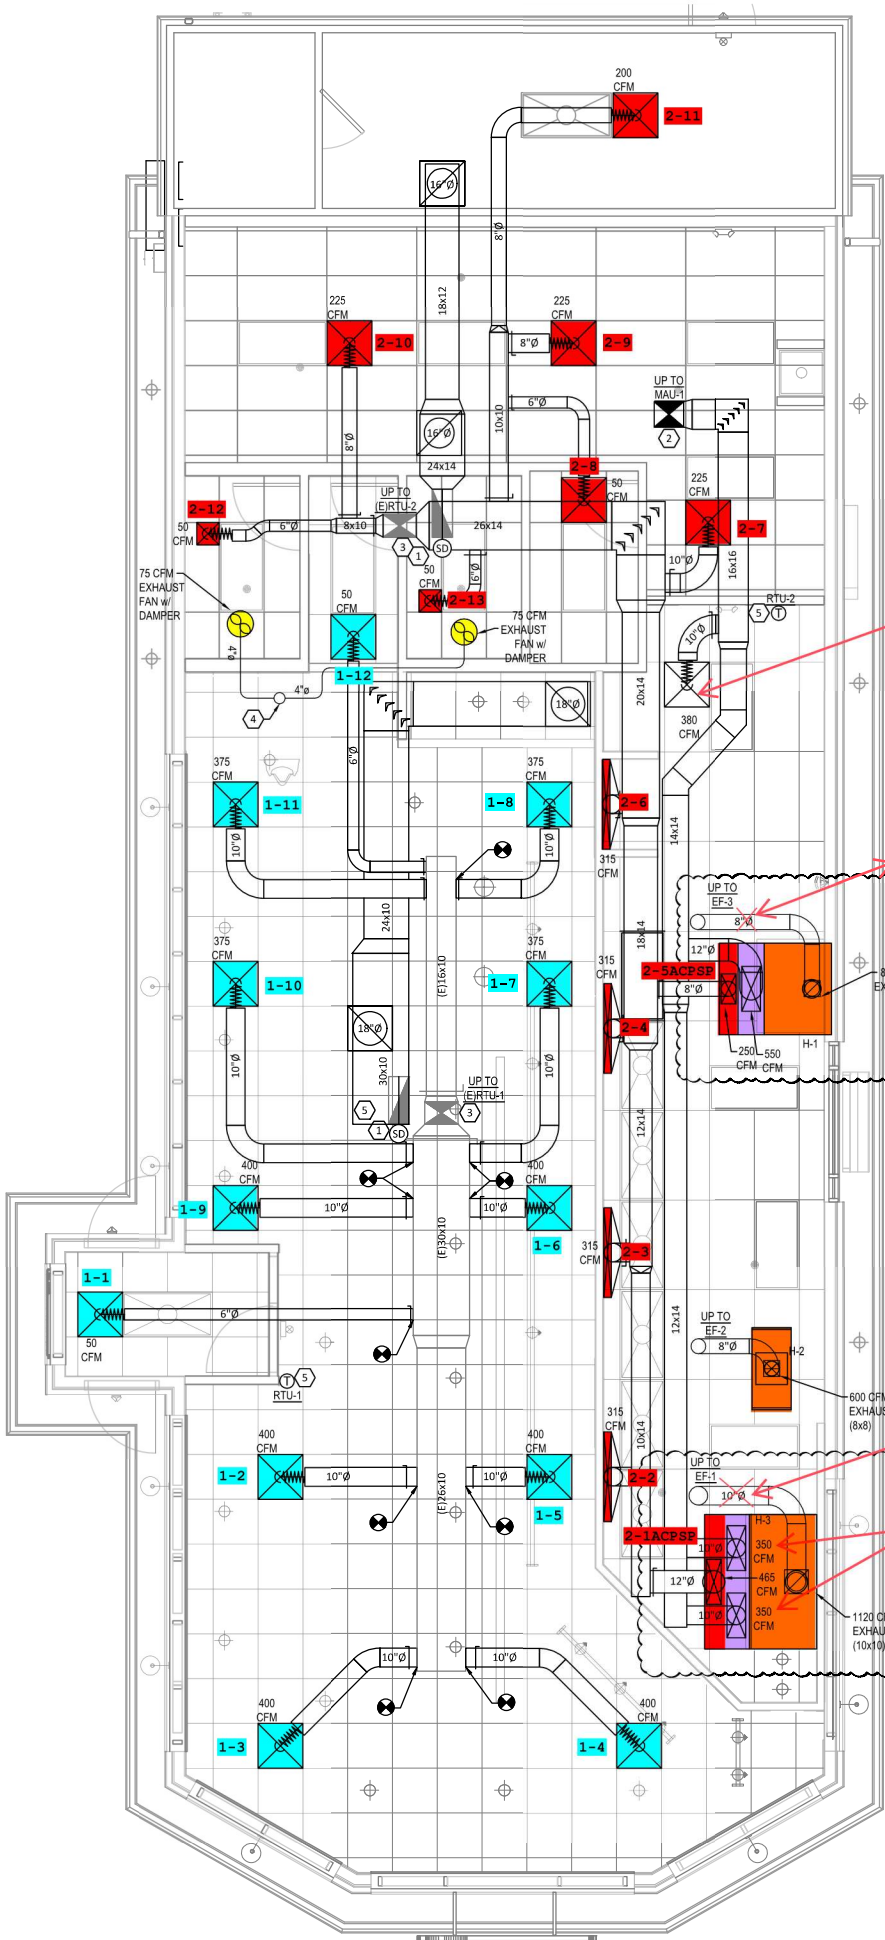
HVAC PLAN NOTES

Recommended this be perforated. At times they install too close to hood & then causes performance issues if 4way. They dont always install exact location shown on prints, so fail safe.

Recommended grease duct size for performance & sound ratings.

- PROVIDE 4" X 48" LINEAR DIFFUSERS.
- REFER TO CAPTIVEAIRE SHOP DRAWINGS FOR EQUIPMENT SPECIFICATIONS.
- EXHAUST FANS BY NUTRONE OR EQUIVALENT. SINGLE PORT IN-LINE VENTILATOR TYPE. PENETRATION IF FIELD CONDITIONS PERMITTED.
