Report: TAB Report
Function: Test, Adjust, & Balance
Date: 10/22/2025
Completed By: National TAB

PROJECT
10-20-25 QT #0473 CHANDLER, AZ

Project: 10-20-25 QT #0473 CHANDLER, AZ

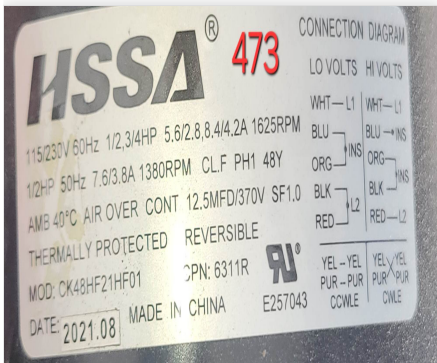
Project Issue File Details

Issue Name : EF1 RUNNING TOO HIGH
Description : EF1 speed controller is turned as low as it will go, still running too high. Building pressure is fine. Amperage @ 8+ amps suggests Motor is running at 0.75HP instead of 0.5. Should be running at 0.5HP and w/i 5.6FLA range (as shown on motor, not unit).
Created By : National TAB **Assigned To :** National TAB - Dan Hertenstein
Status : Closed
Priority : Low **Asset Tag :**
Originated Date : 10/23/2025 - Christine Weale - National TAB

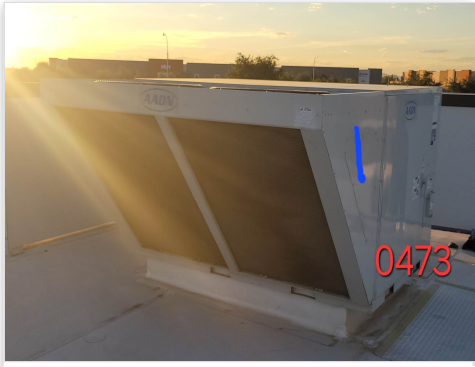
Unit Data - PHOTO LOG

Unit Data	
	Actual
MFG	AAON
Serial Num	201812-ANEK18139
Model Num	RN-013-8-0-EA0A-152
Num OA Filters 1	1
OA Filter Size 1	45X22
Num Final Filter 1	2
Final Filter Size 1	46X19.5X2

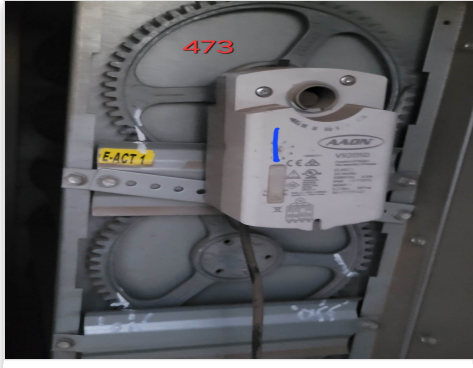
Test Data - PHOTO LOG

Test Data		
	Design	Actual
SF CFM	4200	4510
SF RPM	-	37.98 HZ
OA CFM (Hoods On)	800	798
OA CFM (Hoods Off)	350	332
RL Voltage	-	111.0
RL Amperage	-	8.0
VFD Max SetPt	-	63.3
VFD Min SetPt	-	24.0
OA Damper Position (Hoods On)	-	46.0
OA Damper Position (Hoods Off)	-	0.0

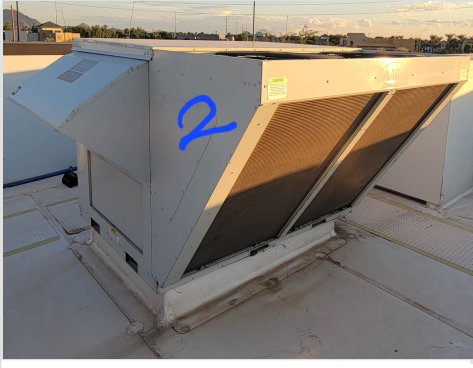
Unit Data - PHOTO LOG

Unit Data	
	Actual
MFG	AAON
Serial Num	201812-ANEK18137
Model Num	RN-013-8-0-EA0A-152
Num OA Filters 1	1
OA Filter Size 1	45X22
Num Final Filter 1	2
Final Filter Size 1	46X19.5X2

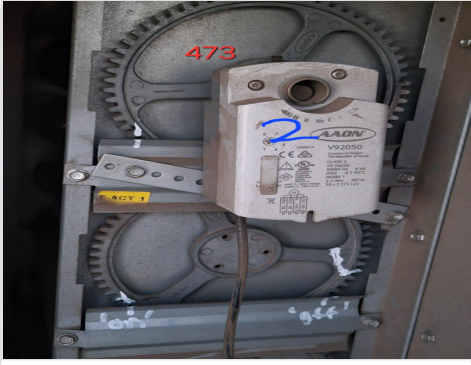
Test Data - PHOTO LOG

Test Data		
	Design	Actual
SF CFM	4200	4651
SF RPM	-	36.6 HZ
OA CFM (Hoods On)	800	832
OA CFM (Hoods Off)	350	323
RL Voltage	-	102.5
RL Amperage	-	7.6
VFD Max SetPt	-	61.0
VFD Min SetPt	-	24.0
OA Damper Position (Hoods On)	-	46.0
OA Damper Position (Hoods Off)	-	0.0

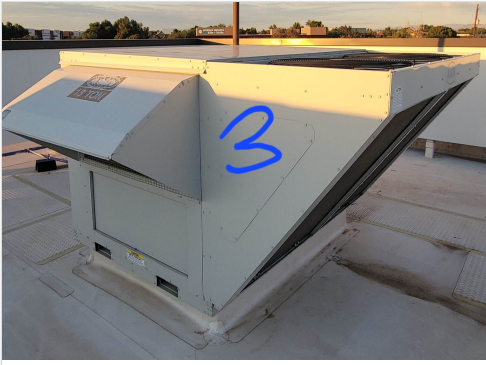
Unit Data - PHOTO LOG

Unit Data	
	Actual
MFG	AAON
Serial Num	201812-ANEK18138
Model Num	RN-013-8-0-EA0A-152
Num OA Filters 1	1
OA Filter Size 1	45X22
Num Final Filter 1	2
Final Filter Size 1	46X19.5X2

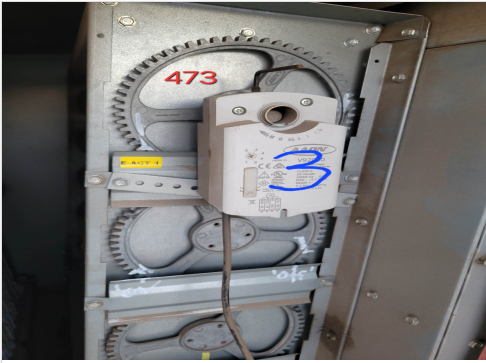
Test Data - PHOTO LOG

Test Data		
	Design	Actual
SF CFM	4200	4330
SF RPM	-	45 HZ
OA CFM (Hoods On)	800	866
OA CFM (Hoods Off)	350	353
RL Voltage	-	155.5
RL Amperage	-	9.15
VFD Max SetPt	-	75
VFD Min SetPt	-	24
OA Damper Position (Hoods On)	-	46.0
OA Damper Position (Hoods Off)	-	0.0

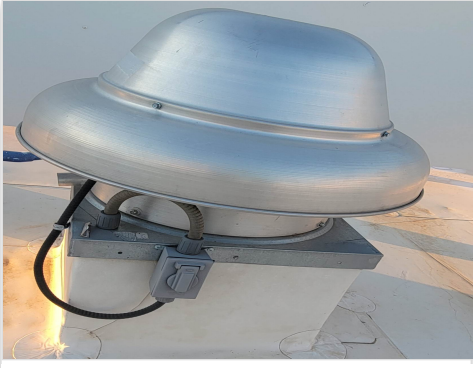
Unit Data - PHOTO LOG

Unit Data		
	Design	Actual
MFG	NA	CAPTIVEAIRE
Model Num	NA	DR50HFA
Serial Num	-	3624745
Type	-	DOWNBLAST
Configuration	-	VERTICAL

[1] UNABLE TO REDUCE AIRFLOW. OVEN GRILLE SLIGHTLY ABOVE DESIGN, UNABLE TO ACCESS DAMPER. NOT ANTICIPATED TO CAUSE AN ISSUE.

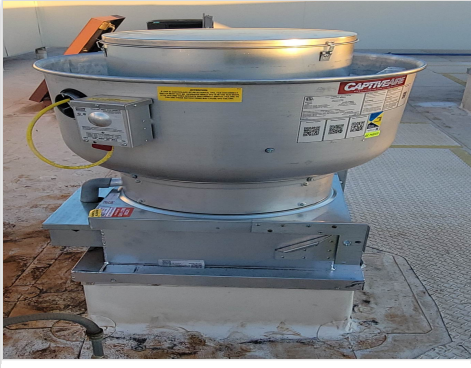
Unit Data - PHOTO LOG

Unit Data		
	Design	Actual
MFG	NA	CAPTIVEAIRE
Model Num	NA	DU50HFA
Serial Num	-	7660161
Type	UPBLAST	UPBLAST
Configuration	VERTICAL	VERTICAL

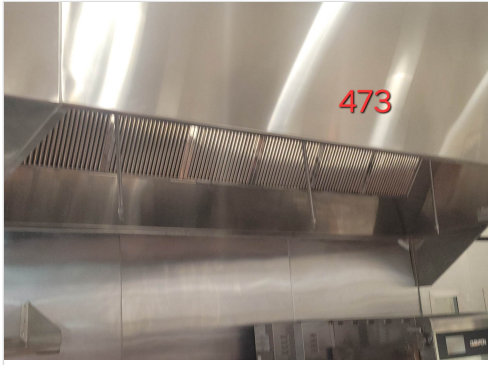
Unit Data - PHOTO LOG

Unit Data		
	Design	Actual
MFG	CAPTIVEAIRE	CAPTIVEAIRE
Model Num	6030ND-2-F	6030ND-2-F
Job / Serial Num	-	7660161
Type	-	TYPE I CANOPY
Hood length	-	108"
Hood Width	-	60"

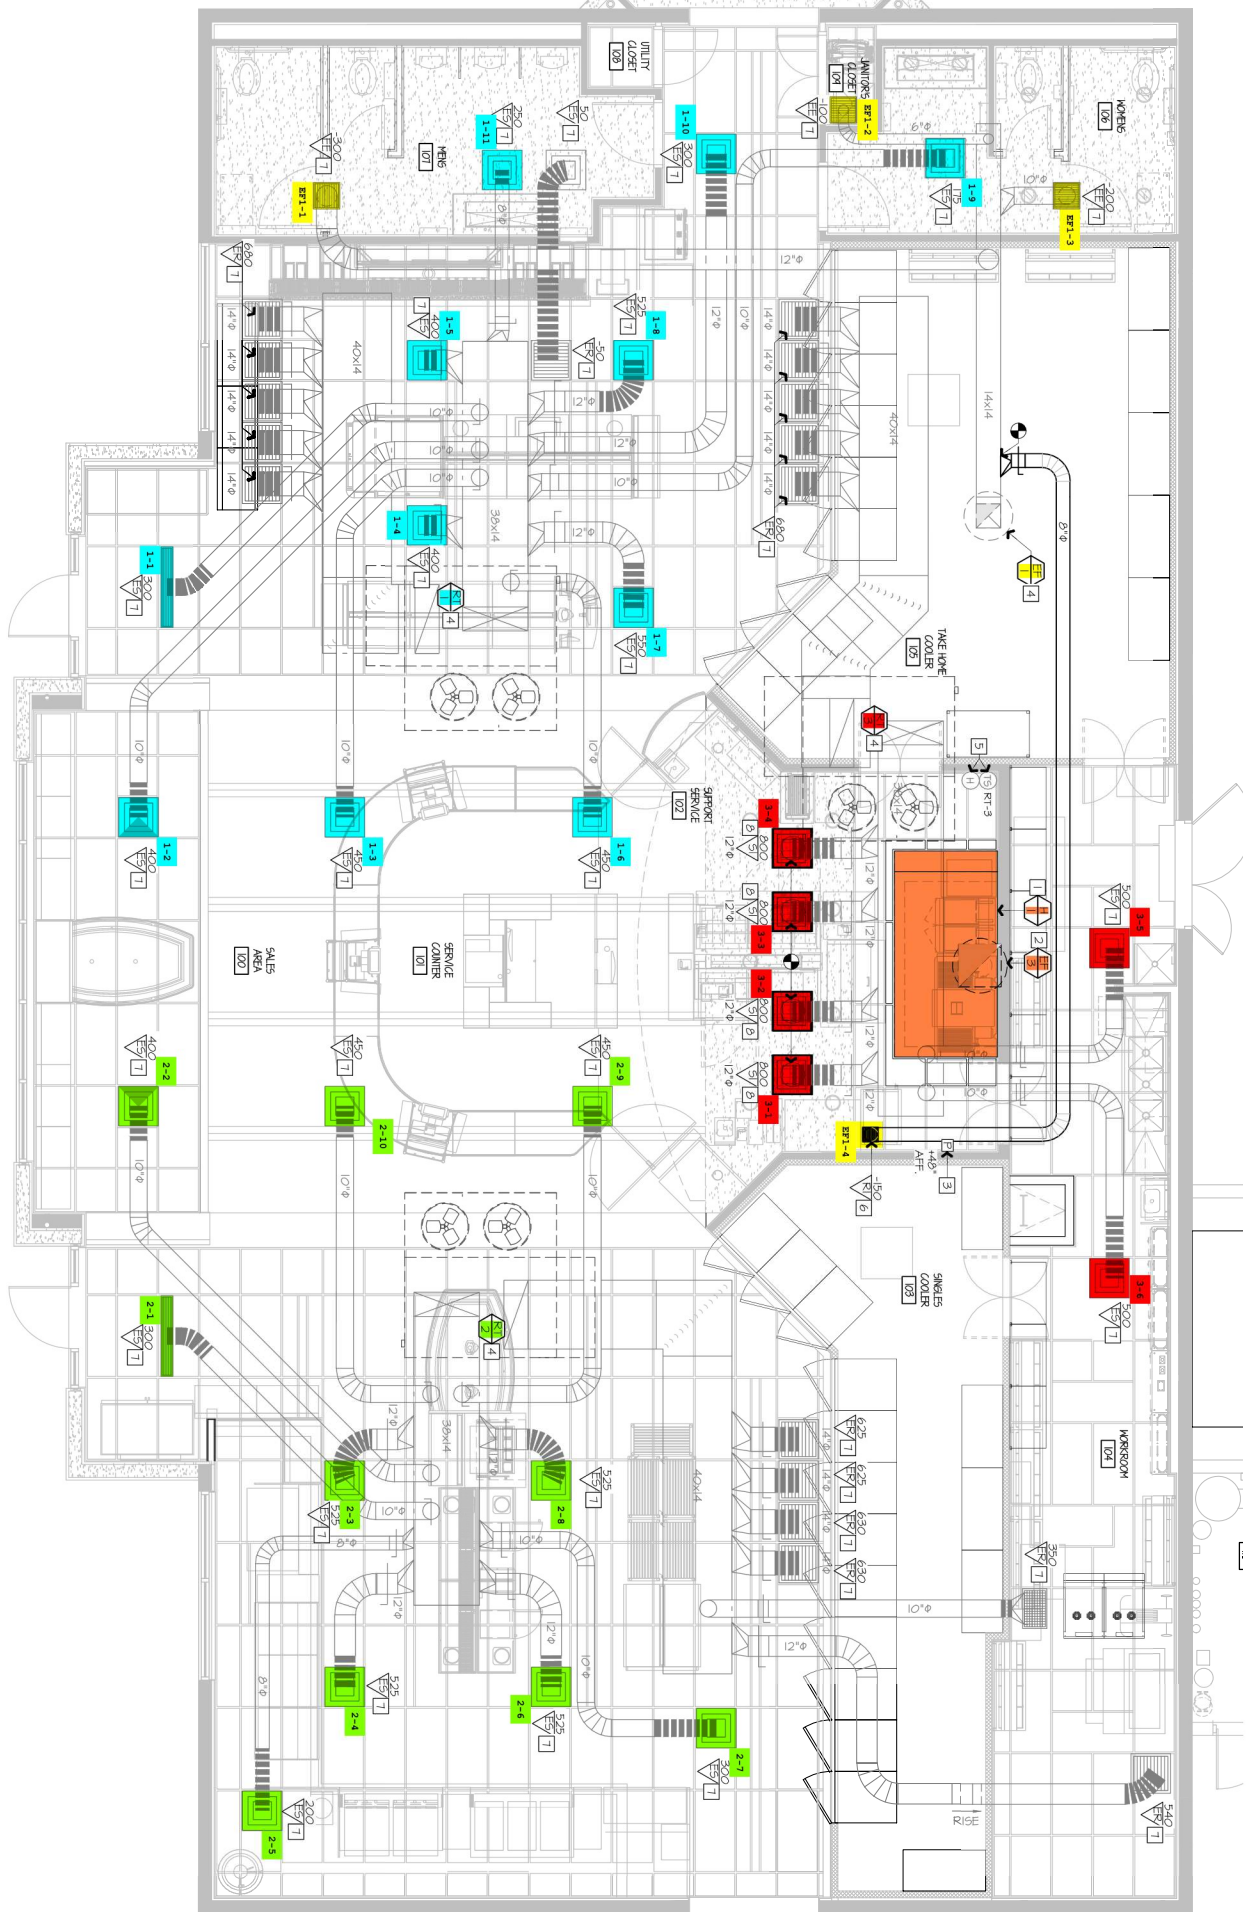
GRD doesn't match actual building, there are 3 8" diameter circular diffusers on each side of the sales area (which means 1 more on each side than shown). 2 diffusers on each side are covered by TVs.
