**Report: TAB REPORT**  
**Function: Test, Adjust, & Balance**  
**Date: 03/15/2024**

## 03-11-24 WAWA #5801 - FAIRHOPE, AL

18968 GREENO RD

FAIRHOPE, AL 36532

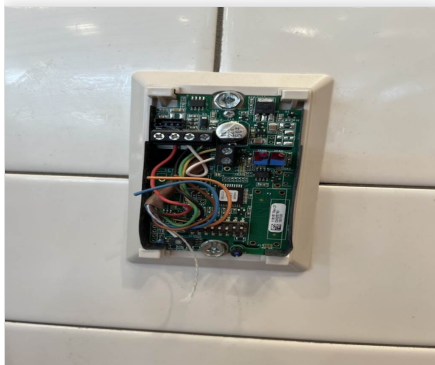
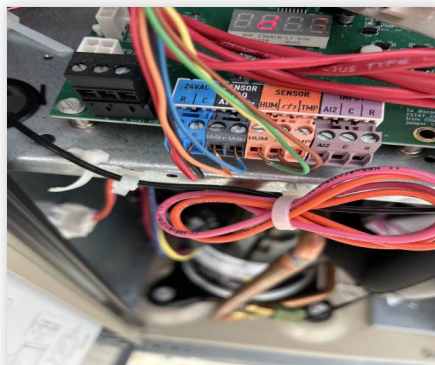
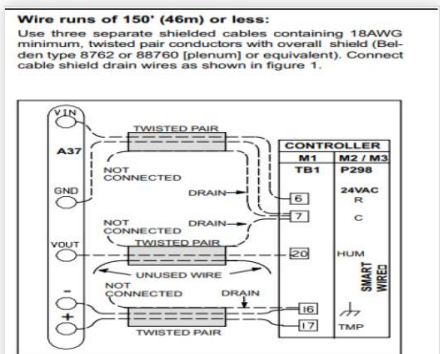
sensor\_wiring  
03/13/2024

**Issue Name :** Lennox sensor wiring  
**Description :** Lennox manual shows 3 separate shielded twisted pairs to be ran for the temp/humidity sensors. However, all 6 conductors are run in a single non-shielded cable. Link to manual: [https://www.allied-commercial.com/AlliedCommercial/landing/e-series/product-literature/accessories/E-Series\\_Temperature\\_Humidity\\_Combos\\_Kit.pdf](https://www.allied-commercial.com/AlliedCommercial/landing/e-series/product-literature/accessories/E-Series_Temperature_Humidity_Combos_Kit.pdf)  
**Created By :** National TAB      **Assigned To :** National TAB - Will Turnbough  
**Status :** Open  
**Priority :** Medium      **Asset Tag :** RTU1  
**Originated Date :** 03/13/2024 - Will Turnbough - National TAB

2 conductor shielded cable has one wire landed to Vin, one to GND, and the shield wire is not connected. Fail

For second shielded cable, one wire is landed to Vout and the shield wire is not connected. Fail

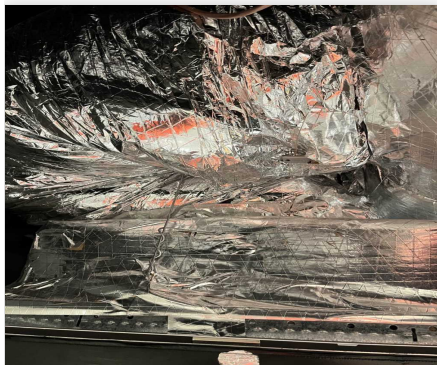
0A027780\_7B67\_4319\_AF..  
03/13/2024

**Issue Name :** Return grille R1 on RTU-2 is low on flow  
**Description :** Restrictive ductwork preventing return R-1 from reaching design flow. Total supply and return flow is within tolerance. Recommend straightening ductwork to improve unit performance, but return trip not necessary to re-measure airflow

RTU2 R-1 restrictive ductwork preventing flow, RTU 3 returns all reading ~90% of design.

Notes:  
Restrictive ductwork on R-1. Unable to hit design flow.
