**Report: TAB REPORT**  
**Function: Test, Adjust, & Balance**  
**Date: 03/15/2024**

## 03-11-24 WAWA #5801 - FAIRHOPE, AL

# National TAB

**Issue Name :** Lennox sensor wiring  
**Description :** Lennox manual shows 3 separate shielded twisted pairs to be ran for the temp/humidity sensors. However, all 6 conductors are run in a single non-shielded cable. Link to manual: [https://www.allied-commercial.com/AlliedCommercial/landing/e-series/product-literature/accessories/E-Series\\_Temperature\\_Humidity\\_Combo\\_Kit.pdf](https://www.allied-commercial.com/AlliedCommercial/landing/e-series/product-literature/accessories/E-Series_Temperature_Humidity_Combo_Kit.pdf)  
**Created By :** National TAB      **Assigned To :** National TAB - Will Turnbough  
**Status :** Open  
**Priority :** Medium      **Asset Tag :** RTU1  
**Originated Date :** 03/13/2024 - Will Turnbough - National TAB

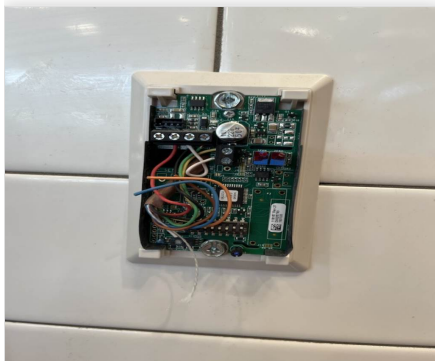
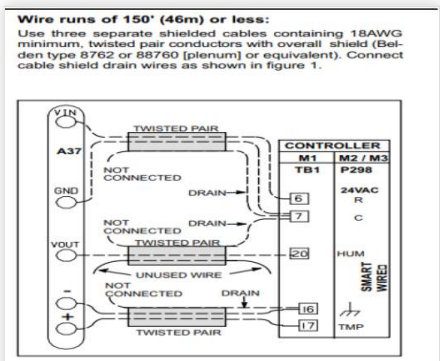
sensor\_wiring  
03/13/2024

2 conductor shielded cable has one wire landed to Vin, one to GND, and the shield wire is not connected. Fail

For second shielded cable, one wire is landed to Vout and the shield wire is not connected. Fail
