Report: TAB REPORT
Function: Test, Adjust, & Balance
Date: 03/15/2024

03-11-24 WAWA #5801 - FAIRHOPE, AL

Section	Page #
Summary	3
Checklist Data	4
AHU/RTU	20
FAN - Exhaust	26
GRD Layout	29

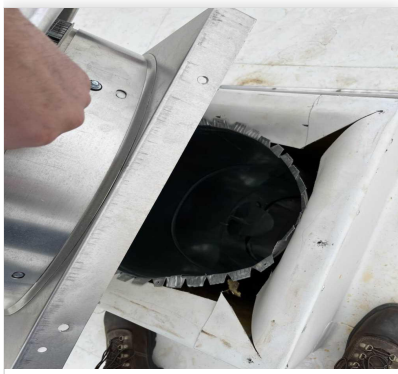
OBED512A_4AD2_4FC5_89..
03/11/2024

Speed controller installed and functional (if applicable)?

Fail

Speed controller raises amperage on ef1 while slowing down.

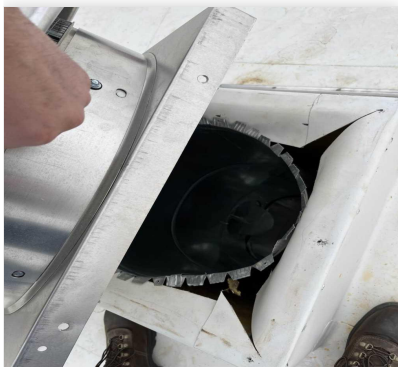
95F3B5C3_8E89_4919_94..
03/11/2024

4.5/3.2

Back draft damper installed and can it fully open?

Fail

Damper not installed on ef-1
