Report: TAB REPORT
Function: Test, Adjust, & Balance
Date: 12/12/2024
Completed By: National TAB

12-09-24 CHIPOTLE #5052 MONTICELLO, MN

Chipotle Mexican Grill
610 Newport Center Drive, Suite 1100
Newport Beach, CA 92660

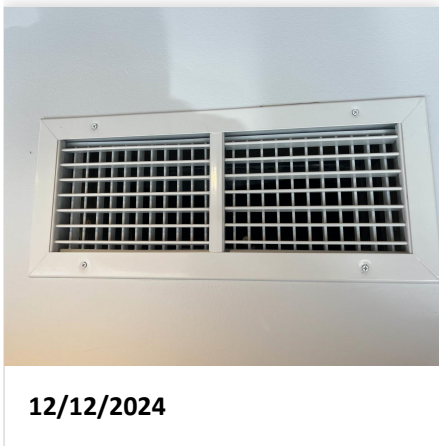
Issue Name : INFO ONLY: Grilles 2-1 and 2-2 Missing Dampers / 2-7 Diffuser Missing
Description : Grilles 2-1 and 2-2 are to have OBD dampers installed per schedule. These are not installed. Unable to dampen grilles and push air to diffuser 2-3 as result. 2-1 and 2-2 slightly above design, 2-3 slightly below. Not anticipated to cause any issues. Additionally, diffuser 2-7 still needs to be installed.

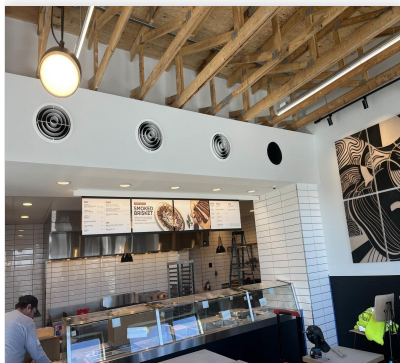
12/12/2024

All diffusers and grilles are installed and match design?	No
---	----

Diffuser 2-7 not yet installed. Waiting for shipment.

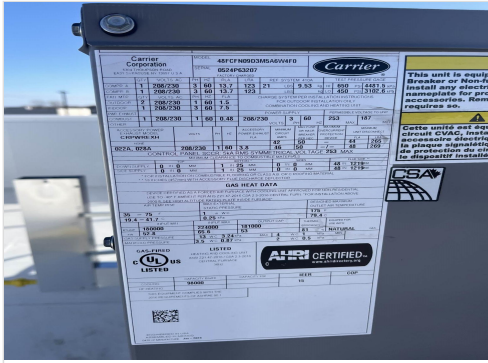
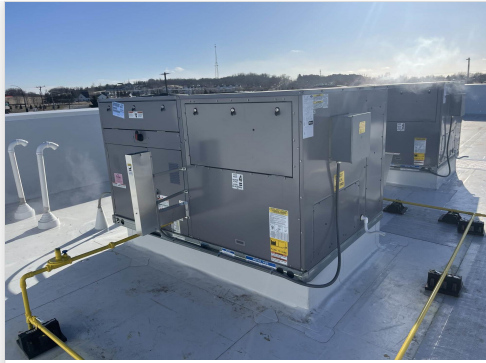
Unit Data - PHOTO LOG

Unit Data		
	Design	Actual
MFG	CARRIER	CARRIER
Serial Num	-	0524P63207
Model Num	48FCFN09D3M5	48FCFN09D3M5
Type	RTU	RTU
Configuration	VERTICAL	VERTICAL
Num OA Filters 1	-	1
OA Filter Size 1	-	35X19.5
Num Final Filter 1	-	4
Final Filter Size 1	-	20X20X2

Test Data		
	Design	Actual
SF CFM	3400	3406
SF RPM	-	1838
RA CFM	2900	2875
OA CFM	500	531
RL Voltage	-	206/206/206
RL Amperage	-	4.9/5.0/4.8
SF Rotation	-	CORRECT
SF System SetPt	-	7.8 VDC
RA Damper Position	-	MECHANICALLY LINKED
Min OA Damper Position	-	3.35 V (16%)
Min OA Damper Type	-	ECONOMIZER
OA Enthalpy Setpt	-	ES5

General	
	Actual
Fan Rotation Correct	YES
Unit Filters Clean	YES, CONSTRUCTION FILTERS INSTALLED
Condensate Drain Installed	YES

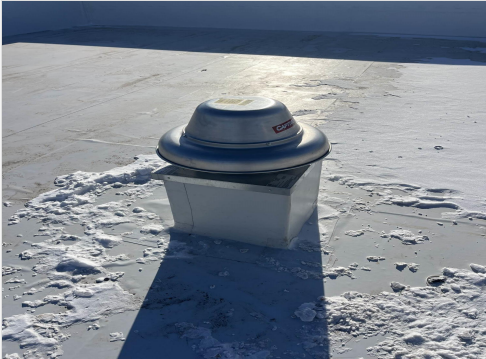
Unit Data - PHOTO LOG

Unit Data		
	Design	Actual
MFG	CAPTIVEAIRE	CAPTIVEAIRE
Model Num	DR12HFA	DR12HFA
Serial Num	-	6861468
Type	DOWNBLAST	DOWNBLAST
Configuration	VERTICAL	VERTICAL

Test Data		
	Design	Actual
CFM	150	144
Fan RPM	-	890
Fan Rotation	-	CCW, CORRECT
Motor RPM	-	890
System SetPt	-	48%
RL Voltage	-	NR
RL Amperage	-	NR
Total ESP	0.60"	0.19"
Fan Inlet SP	-	-0.19"
Fan Discharge SP	-	ATM

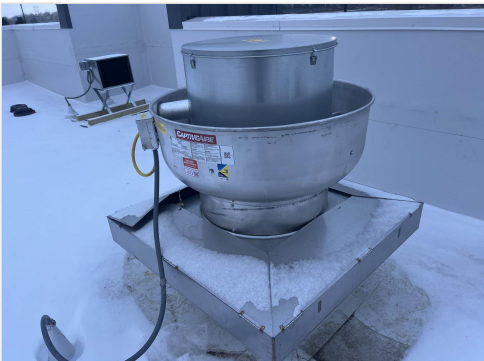
Unit Data - PHOTO LOG

Unit Data		
	Design	Actual
MFG	CAPTIVEAIRE	CAPTIVEAIRE
Model Num	DU180HFA	DU180HFA
Serial Num	-	6861468
Type	UPBLAST	UPBLAST
Configuration	VERTICAL	VERTICAL

Test Data		
	Design	Actual
CFM	2550	2568
Fan RPM	-	1100
Fan Rotation	-	CCW, CORRECT
Motor RPM	-	1100
System SetPt	-	56.4 HZ
RL Voltage	-	122 @VFD
RL Amperage	-	5.4 @ VFD
Total ESP	1.2	0.81"
Fan Inlet SP	-	-0.81"
Fan Discharge SP	-	ATM

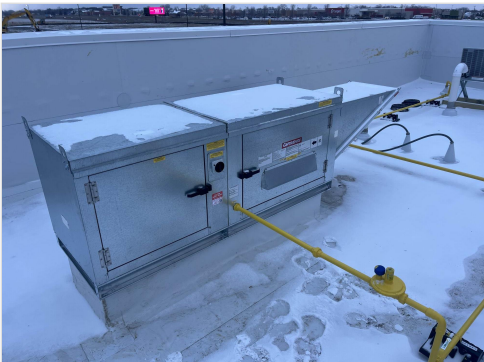
Unit Data - PHOTO LOG

Unit Data		
	Design	Actual
MFG	CAPTIVEAIRE	CAPTIVEAIRE
Model Num	A1-D.250-15D	A1-D.250-15D
Serial Num	-	6861468
Type	MAU	MAU
Configuration	VERTICAL	VERTICAL

Test Data		
	Design	Actual
CFM	1300	1348
SF RPM	-	1546
Motor RPM	-	1546
SF System SetPt	-	53.3 HZ
RL Voltage	-	149 @ VFD
RL Amperage	-	2.6 @ VFD
Total ESP	-	0.52"
Fan Discharge SP	-	0.52"

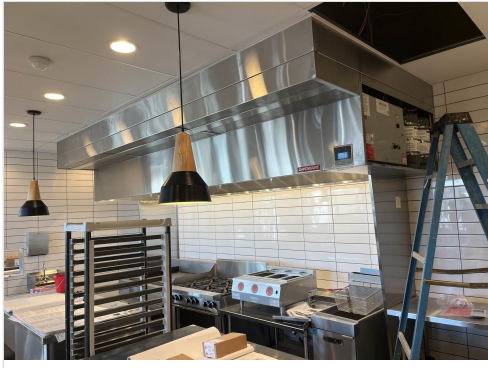
Unit Data - PHOTO LOG

Unit Data		
	Design	Actual
MFG	CAPTIVEAIRE	CAPTIVEAIRE
Model Num	5424 ND-2-ACPSP-F	5424 ND-2-ACPSP-F
Job / Serial Num	-	6861468
Type	TYPE I CANOPY	TYPE I CANOPY
Hood length	153"	153"
Hood Width	54"	54"
Supply Plenum Type	-	ACPSP
Supply Plenum Width	9"	9"
Supply Plenum Length	165"	165"

Test Data Exhaust		
	Design	Actual
Filter Type	CAPTRATE	CAPTRATE SOLO
Filter Size 1	16x16	16X16
Filter Qty 1	9	9
Filter AK factor size 1	1.62	1.62
Filter Total AK Area	14.58	14.58
Filter1 FPM	-	162
Filter2 FPM	-	167
Filter3 FPM	-	178
Filter4 FPM	-	204
Filter5 FPM	-	197
Filter6 FPM	-	192
Filter7 FPM	-	170
Filter8 FPM	-	162
Filter9 FPM	-	153
Filter Ave FPM(corr)	-	176.11
CFM	1	2568
