Report: TAB REPORT
Function: Test, Adjust, & Balance
Date: 12/12/2024
Completed By: National TAB

12-09-24 CHIPOTLE #5052 MONTICELLO, MN

779 CHELSEA RD EAST

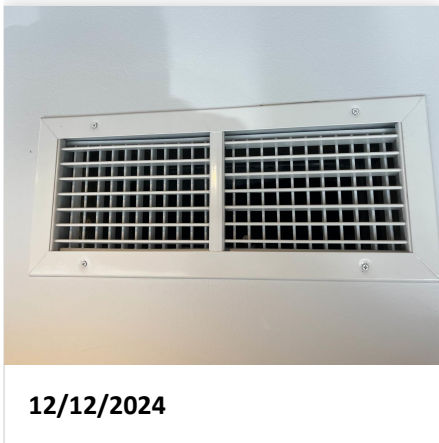
Issue Name : INFO ONLY: Grilles 2-1 and 2-2 Missing Dampers
Description : Grilles 2-1 and 2-2 are to have OBD dampers installed per schedule. These are not installed. Unable to dampen grilles and push air to diffuser 2-3 as result. 2-1 and 2-1 slightly above design, 2-3 slightly below. Not anticipated to cause any issues.

[1] DAMPERS MISSING ON DIFFUSERS 2-1 AND 2-2. NOT ANTICIPATED TO CAUSE ANY ISSUE. UNIT SERVES SINGLE OPEN AREA.

Asset	Notes	Date	Written By
SGRD1	[1] ABOVE DESIGN DUE TO MISSING DAMPER, NOT ANTICIPATED TO CAUSE ISSUE.	12/12/2024	Michael McDonnell
SGRD2	[1] ABOVE DESIGN DUE TO MISSING DAMPER, NOT ANTICIPATED TO CAUSE ISSUE.	12/12/2024	Michael McDonnell
SGRD3	[1] UNABLE TO INCREASE AIRFLOW DUE TO MISSING DAMPERS ON SYSTEM, NOT ANTICIPATED TO CAUSE ANY ISSUE.	12/12/2024	Michael McDonnell
