Report: TAB Report
Function: Test, Adjust, & Balance
Date: 10/22/2025
Completed By: National TAB

PROJECT
10-20-25 QT #1141 SIMPSONVILLE, SC

Project: 10-20-25 QT #1141 SIMPSONVILLE, SC

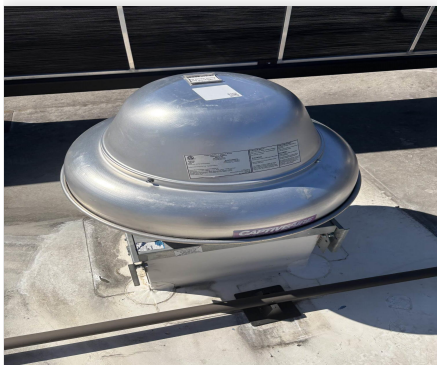
Issue Name : EF-1: Not Operational
Description : EF-1 has power and the motor operates. The electrician and I trouble-shot the problem and believe the speed controller is the issue, recommend replacement.
Created By : National TAB **Assigned To :** National TAB - Dan Hertenstein
Status : Open
Priority : High **Asset Tag :** EF1
Originated Date : 10/24/2025 - Christian Moller - National TAB

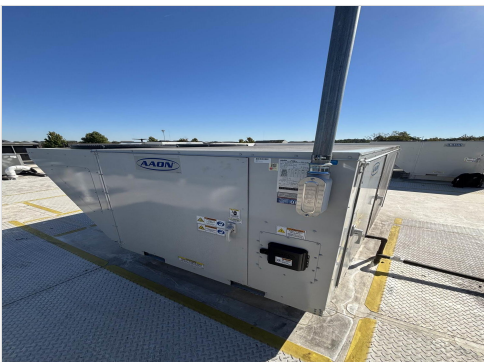
Unit Data - PHOTO LOG

Test Data		
	Design	Actual
SF CFM	4200	4123
OA CFM (Hoods On)	800	863
OA CFM (Hoods Off)	350	342
RL Voltage	-	205/206/206
RL Amperage	-	6.5/6.7/7.0
VFD Max SetPt	-	43.2Hz
VFD Min SetPt	-	24Hz
OA Damper Position (Hoods On)	-	9%
OA Damper Position (Hoods Off)	-	12%

Notes:
[1] DEFLECTION BLADES NOT INSTALLED ON COOKLINE DIFFUSERS.

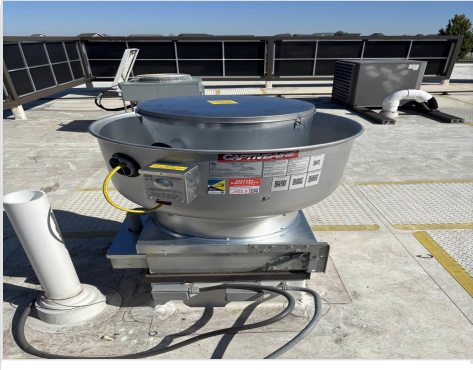
Unit Data - PHOTO LOG

Test Data		
	Design	Actual
CFM	1350	1410
Fan Rotation	-	CCW
System SetPt	-	HMI / 55.8Hz
RL Voltage	-	206
RL Amperage	-	2.7
Total ESP	-	NR
Fan Inlet SP	-	NR
Fan Discharge SP	-	ATM
