Report: TAB Report
Function: Test, Adjust, & Balance
Date: 10/22/2025
Completed By: National TAB

PROJECT
10-20-25 QT #1141 SIMPSONVILLE, SC

Project: 10-20-25 QT #1141 SIMPSONVILLE, SC

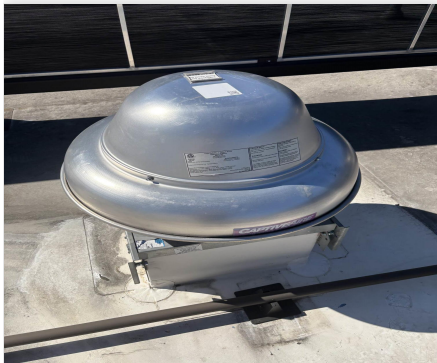
Issue Name : EF-1 not running
Description : EF-1 has power and the motor works. The electricians and I trouble-shot the problem and believe it is the speed controller that is not working.
Created By : National TAB **Assigned To :** National TAB - Dan Hertenstein
Status : Open
Priority : High **Asset Tag :** EF1
Originated Date : 10/24/2025 - Christian Moller - National TAB

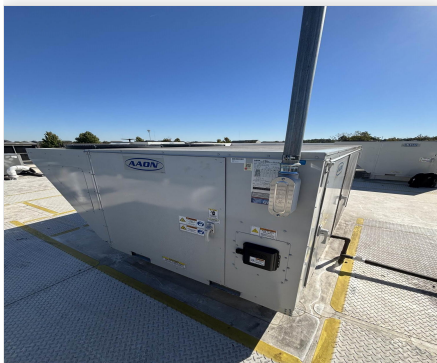
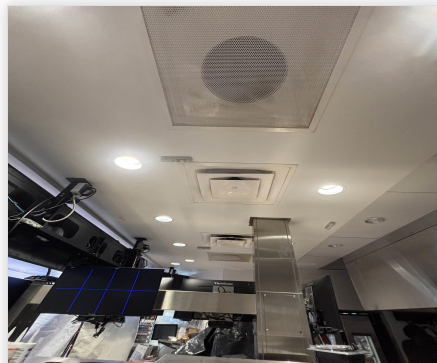
Issue Name : RTU 3 no deflection blades
Description : The tradesman that orders the new cookline diffusers for RTU 3 were not ordered with the deflection blades. If there are drafting issues we will not be able to mitigate them without the blades.
Created By : National TAB **Assigned To :** National TAB - Dan Hertenstein
Status : Open
Priority : High **Asset Tag :** RT-3
Originated Date : 10/24/2025 - Christian Moller - National TAB

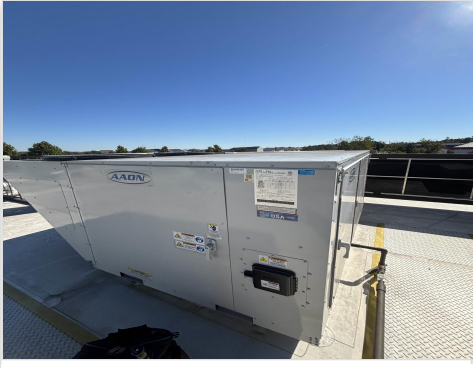
Unit Data - PHOTO LOG

Unit Data		
	Design	Actual
MFG	NA	AAON
Serial Num	-	202112-ANEK23275
Model Num	NA	RN-013-8-0-EA0A-152
Num OA Filters 1	-	1
OA Filter Size 1	-	45X25

Test Data		
	Design	Actual
SF CFM	4200	4095
OA CFM (Hoods On)	800	793
OA CFM (Hoods Off)	350	355
RL Voltage	-	208/209/210
RL Amperage	-	5.1/5.7/7.0
VFD Max SetPt	-	40.2Hz
VFD Min SetPt	-	24Hz
OA Damper Position (Hoods On)	-	40%
OA Damper Position (Hoods Off)	-	35%

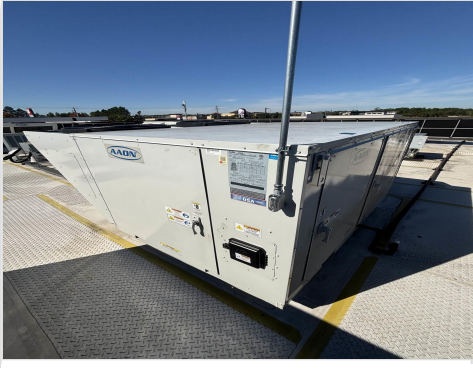
Unit Data - PHOTO LOG

Unit Data		
	Design	Actual
MFG	NA	AAON
Serial Num	-	202112-ANEK23275
Model Num	NA	RN-013-8-0-EA0A-152
Num OA Filters 1	-	1
OA Filter Size 1	-	45X25

Test Data		
	Design	Actual
SF CFM	4200	4081
OA CFM (Hoods On)	800	744
OA CFM (Hoods Off)	350	348
RL Voltage	-	205/206/208
RL Amperage	-	5.1/5.2/5.8
VFD Max SetPt	-	38.4Hz
VFD Min SetPt	-	24Hz
OA Damper Position (Hoods On)	-	40%
OA Damper Position (Hoods Off)	-	35%

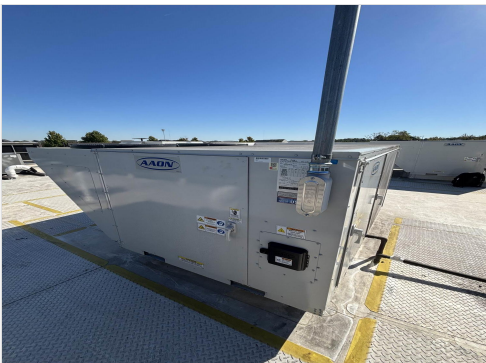
Unit Data - PHOTO LOG

Unit Data		
	Design	Actual
MFG	NA	AAON
Serial Num	-	202112-ANEK23276
Model Num	NA	RN-013-8-0-EA0A-152
Num OA Filters 1	-	1
OA Filter Size 1	-	45X25

Test Data		
	Design	Actual
SF CFM	4200	4123
OA CFM (Hoods On)	800	863
OA CFM (Hoods Off)	350	342
RL Voltage	-	205/206/206
RL Amperage	-	6.5/6.7/7.0
VFD Max SetPt	-	43.2Hz
VFD Min SetPt	-	24Hz
OA Damper Position (Hoods On)	-	9%
OA Damper Position (Hoods Off)	-	12%

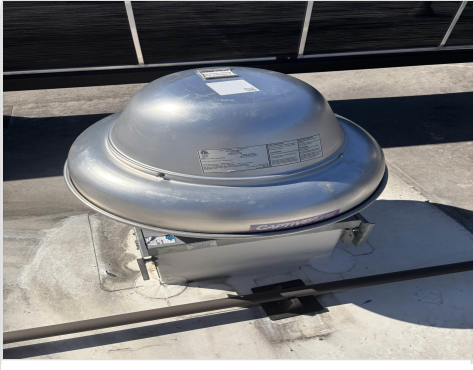
Unit Data - PHOTO LOG

Fan is not running, has power, we believe the speed controller is not working.

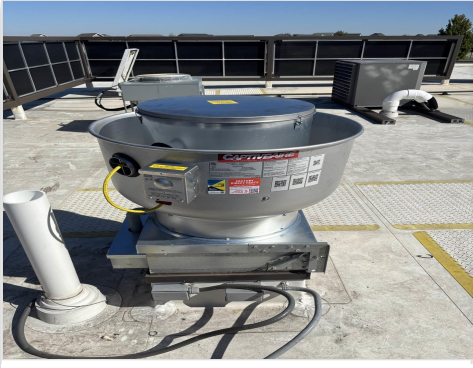
Unit Data - PHOTO LOG

Unit Data		
	Design	Actual
MFG	NA	CAPTIVEAIRE
Model Num	NA	DU50HFA
Serial Num	-	7657323
Type	UPBLAST	UPBLAST
Configuration	VERTICAL	VERTICAL

Test Data		
	Design	Actual
CFM	1350	1410
Fan Rotation	-	CCW
System SetPt	-	HMI / 55.8Hz
RL Voltage	-	206
RL Amperage	-	2.7
Total ESP	-	NR
Fan Inlet SP	-	NR
Fan Discharge SP	-	ATM

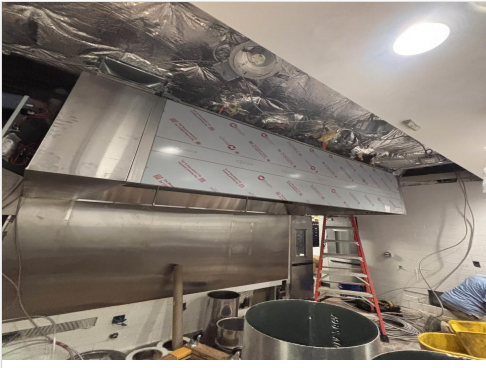
Unit Data - PHOTO LOG

Unit Data		
	Design	Actual
MFG	CAPTIVEAIRE	CAPTIVEAIRE
Model Num	6030ND-2-F	6030ND-2-F
Job / Serial Num	-	7657323
Type	-	TYPE I CANOPY
Hood length	-	122"
Hood Width	-	60"

Test Data Exhaust		
	Design	Actual
Filter Type	-	BAFFLE FILTERS
Filter Size 1	-	16X20
Filter Qty 1	-	6
Filter AK factor size 1	-	2.08
Filter Total AK Area	-	12.48
Filter1 FPM	-	106
Filter2 FPM	-	106
Filter3 FPM	-	124
Filter4 FPM	-	124
Filter5 FPM	-	112
Filter6 FPM	-	109
Filter Ave FPM(corr)	-	113
CFM	1350	1410

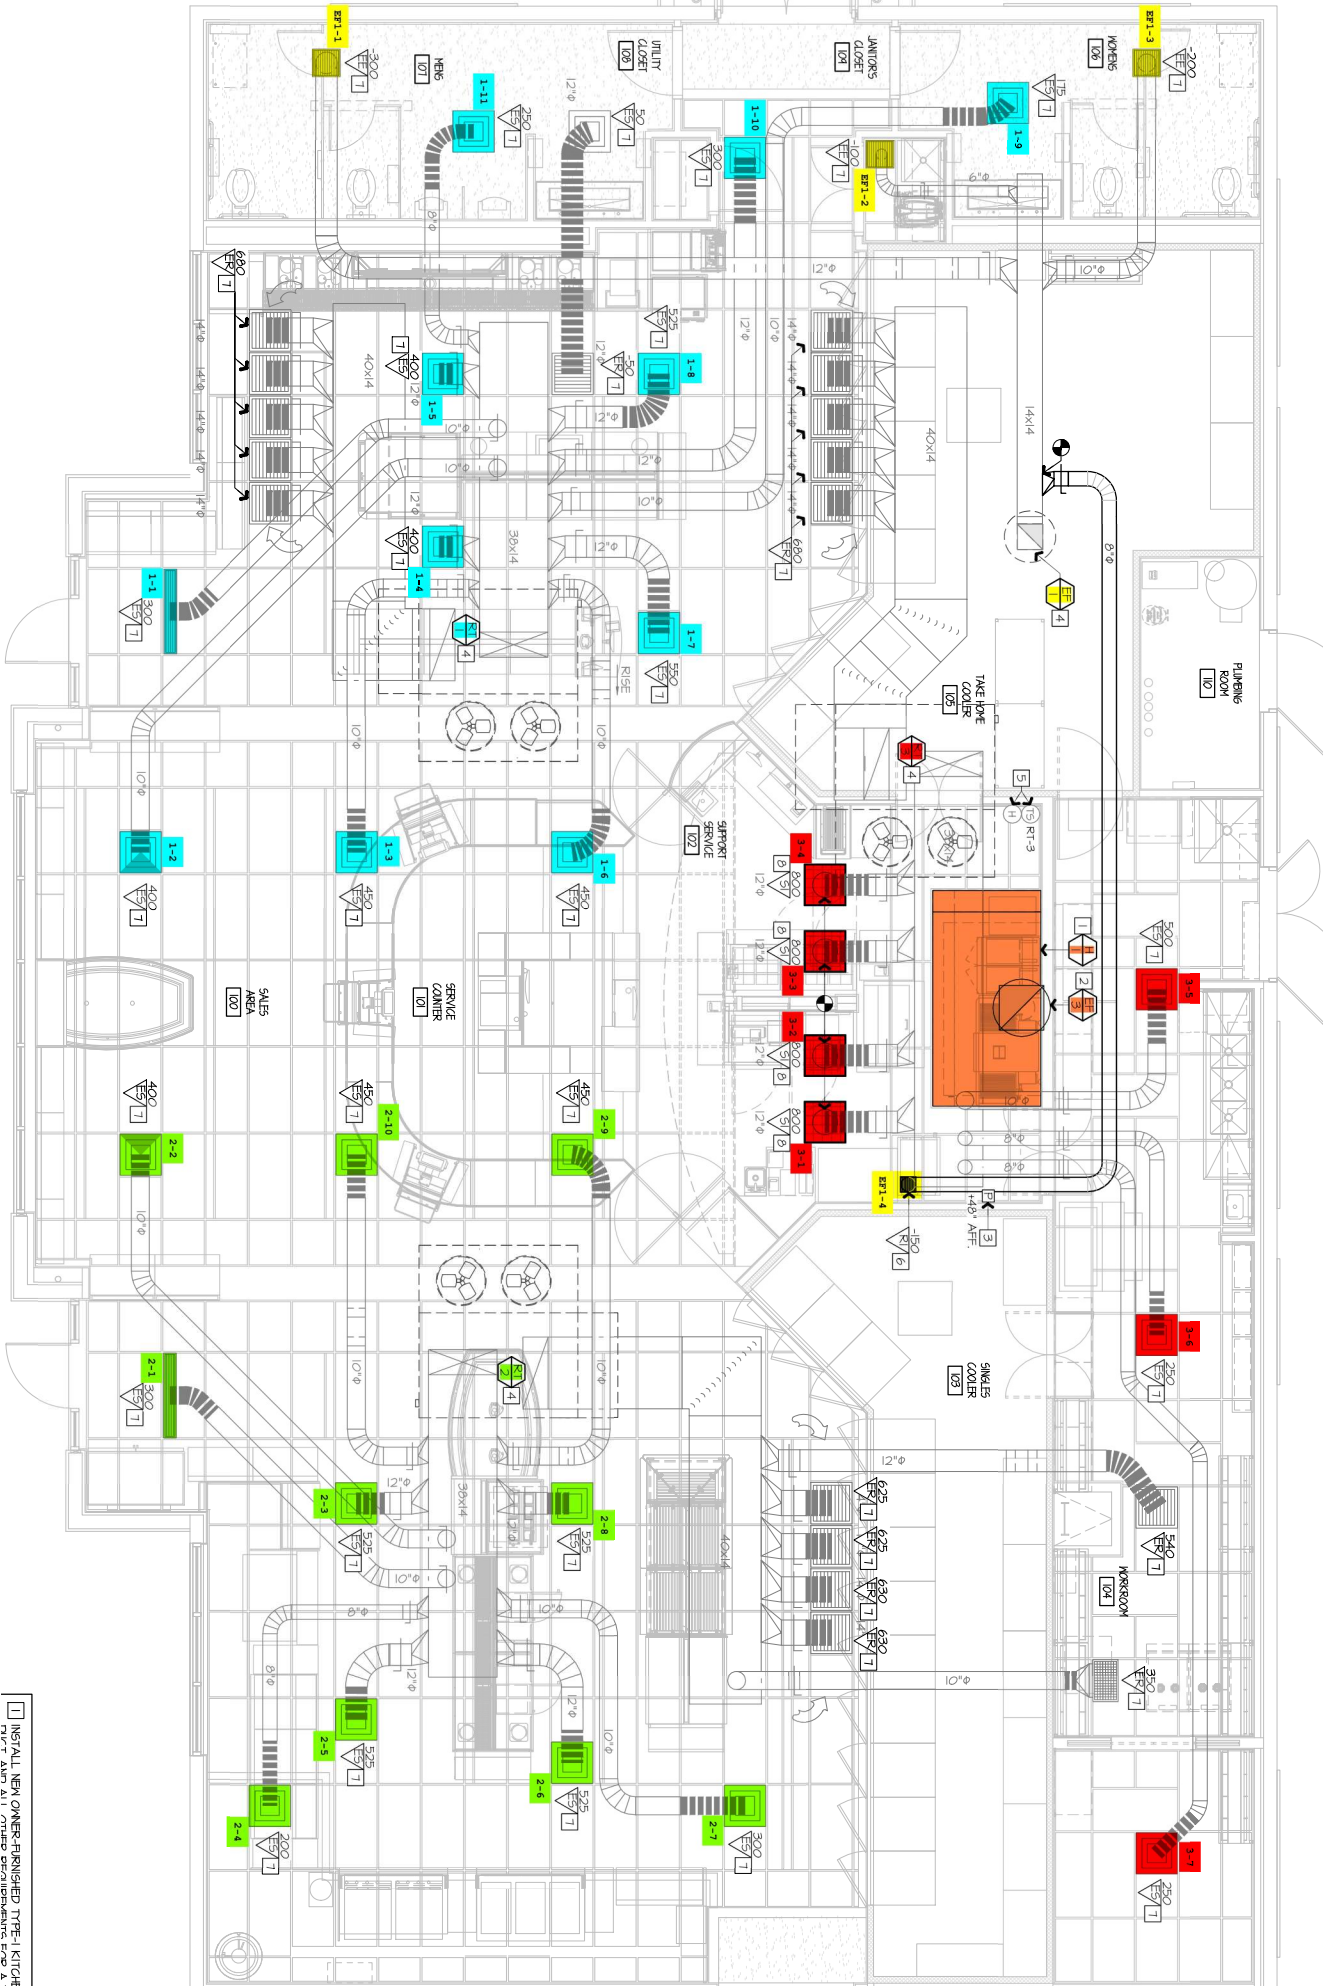
10/24/2025

INSTALL NEW OWNER-FINISHED TYPE I KITCHEN HOOD EXHAUST SYSTEM
 RISE AND ALL OTHER DIMENSIONS FOR A TYPE I SYSTEM
