Report: TAB Report
Function: Test, Adjust, & Balance
Date: 05/28/2024

PROJECT
05-20-24 CARMAX #7110 - DORAL, FL

Project: 05-20-24 CARMAX #7110 - DORAL, FL

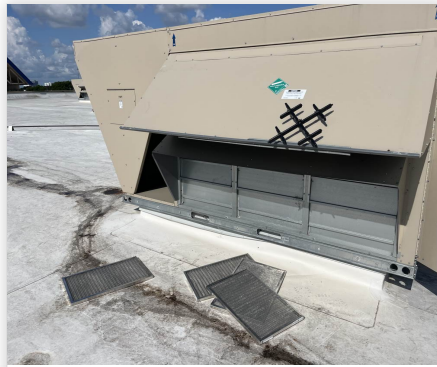
IMG_3058
05/22/2024

Issue Name : RTU 1 - High Airflow
Description : Current airflow measured at 17774CFM out of 10000CFM design (177%). Outside air filters were not installed in the RTU. Unable to adjust VFD, error messages given when any parameter was changed. Reducing the airflow via just the VFD also would prevent the unit from modulating speed, as only ~35Hz would be available. Sheave change recommended.
Created By : National TAB **Assigned To :** National TAB - Stephen Tassinaro
Status : Open
Priority : High **Asset Tag :**
Originated Date : 05/22/2024 - Stephen Tassinaro - National TAB

Issue Name : RTU 1 - OA Filters Incorrectly Installed
Description : The outside air filters were not correctly installed on RTU-1. All filters fell out of the unit and onto the rooftop when unit was tested in high speed.
Created By : National TAB **Assigned To :** National TAB - Stephen Tassinaro
Status : Open
Priority : High **Asset Tag :**
Originated Date : 05/22/2024 - Stephen Tassinaro - National TAB

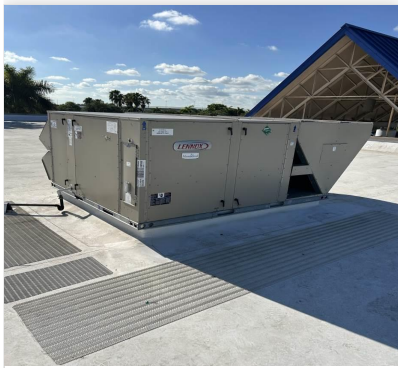
RTU_4
05/28/2024

Test Data		
	Design	Actual
SF CFM	9000	8329
SF RPM	-	973
RA CFM	6200	5569
OA CFM	2800	2760
RL Voltage	-	482/483/480
RL Amperage	-	8.7 VFD
SF Rotation	-	CORRECT
RA Damper Position	-	52%
Min OA Damper Position	-	48%
Min OA Damper Type	-	ECONOMIZER
OA Enthalpy Setpt	-

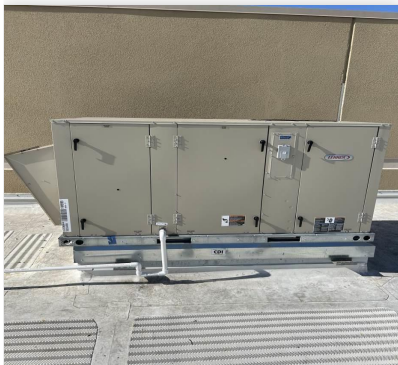
RTU_8
05/28/2024

Test Data		
	Design	Actual
SF CFM	2250	2175
SF RPM	MSAV	79% MSAV
RA CFM	2010	1930
OA CFM	240	245
RL Voltage	-	484/484/485
RL Amperage	-	1.3/1.3/1.3
SF Rotation	-	CORRECT
RA Damper Position	-	70%
Min OA Damper Position	-	30%
Min OA Damper Type	-	ECONOMIZER

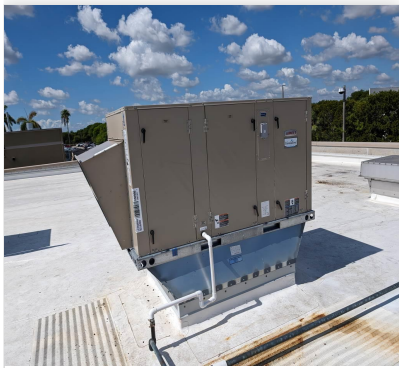
RTU_13
05/28/2024

Test Data		
	Design	Actual
SF CFM	1150	1156
SF RPM	-	74% MSAV
RA CFM	1030	1043
OA CFM	120	113
RL Voltage	-	209
RL Amperage	-	4.2
SF Rotation	-	CORRECT
RA Damper Position	-	80%
Min OA Damper Position	-	20%
Min OA Damper Type	-	ECONOMIZER
