Report: TAB REPORT
Function: Test, Adjust, & Balance
Date: 06/26/2023

PROJECT
06-19-23 CULVERS - COLUMBUS, GA

Issue List

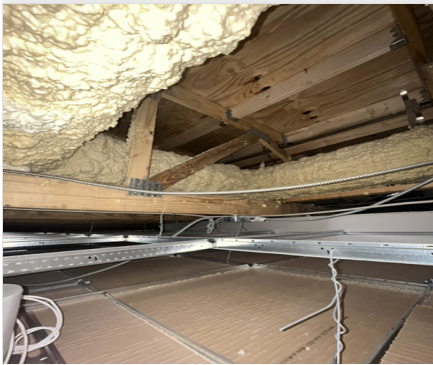
SprayFoamInsulation.j..
06/21/2023

Issue Name : INCORRECT DAMPERS INSTALLED
Description : MSET CALLS FOR VOLUME DAMPERS AT SUPPLY TAKEOFFS, INSTEAD DAMPERS WERE INSTALLED AT FACES OF DIFFUSERS. SEE MSET M201 DETAIL C6. EXISTENCE OF BRANCH DAMPERS COULD NOT BE VERIFIED DUE TO SPRAY FOAM INSULATION ON DUCT. THE FACE DAMPERS CAUSE EXCESSIVE NOISE AT SEVERAL DIFFUSERS.
Created By : National TAB **Assigned To :** National TAB - William Patton
Status : Open
Originated Date : 06/21/2023 - William Patton - National TAB

- **06/22/2023 National TAB - William Patton**
 - RECOMMENDED TO INSTALL VOLUME DAMPERS FOR THE DIFFUSERS AT THE TAKEOFFS. IT IS ALSO RECOMMENDED TO INSTALL BRANCH DAMPERS. NTAB WAS UNABLE TO SEE OR USE ANY BRANCH DAMPERS DUE TO SPRAY INSULATION ON THE DUCTWORK.

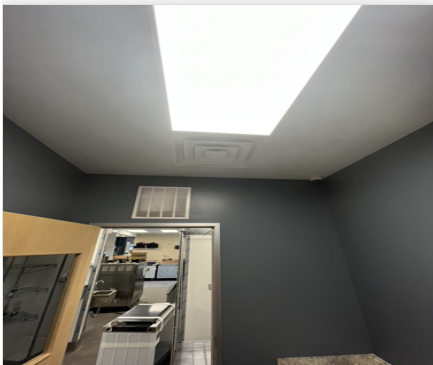
OfficeDiffuser
06/21/2023

Issue Name : OFFICE DIFFUSER DUCTWORK
Description : OFFICE SUPPLY DIFFUSER IS DUCTED TO RTU2 INSTEAD OF RTU1. MSET M101 CALLS FOR THAT DIFFUSER TO BE DUCTED TO TO RTU1. PER MECHANICAL THE TRUSS WORK MAKES DUCTING TO RTU1 IMPOSSIBLE. THIS MAY LEAD TO UNCOMFORTABLE TEMPERATURES IN OFFICE AS THE KITCHEN CALLS HAS A DEMAND FOR COOLING WIEN THE OFFICE IS ALREADY COLD.
Created By : National TAB **Assigned To :** National TAB - William Patton
Status : Open
Originated Date : 06/21/2023 - William Patton - National TAB

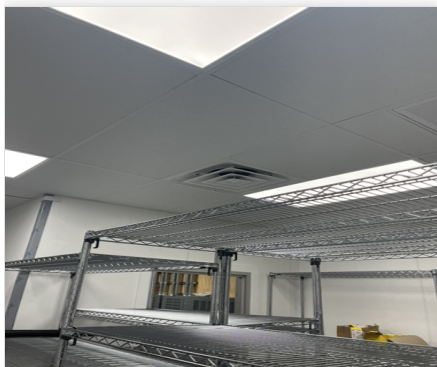
LowFlowDiffuser
06/22/2023

Issue Name : RTU 2 DIFFUSER 15 LOW FLOW
Description : DIFFUSER 15 (DRY GOODS) IS 351 CFM. DESIGN IS 600CFM. AFTER SEVERAL FULL PASSES TOTAL INCREASE IN FLOW TO THIS DIFFUSER WAS 63 CFM, WITH ALL OTHER DIFFUSERS FALLING WITHIN DESIGN. AFTER INSPECTION TECHNICIAN COULD NOT DIAGNOSE WHAT IS CAUSING RESTRICTION. RECOMMEND MECHANICAL CONTRACTOR INVESTIGATES DUCTWORK AND VOLUME DAMPER FOR ANY ISSUES.
