**Report: PRELIM TAB REPORT  
Function: Test, Adjust, & Balance  
Date: 06/15/2023**

**PROJECT  
06-19-23 CULVERS - COLUMBUS, GA**

## Issue List

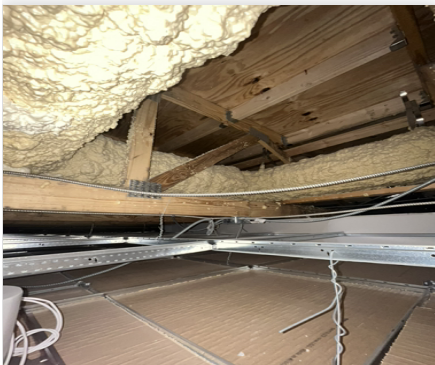
SprayFoamInsulation.j..  
06/21/2023

**Issue Name :** INCORRECT DAMPERS INSTALLED  
**Description :** MSET CALLS FOR VOLUME DAMPERS AT SUPPLY TAKEOFFS. AND BRANCH DAMPERS. SEE MSET M201 DETAIL C6. IN NECK FACE ADJUSTED DAMPERS WERE INSTALLED INSTEAD. EXISTENCE OF BRANCH DAMPERS COULD NOT BE VERIFIED DUE TO SPRAY FOAM INSULATION ON DUCT. THE FACE DAMPERS CAUSE EXCESSIVE NOISE AT SEVERAL DIFFUSERS.  
**Created By :** National TAB                      **Assigned To :** National TAB - William Patton  
**Status :** Open  
**Originated Date :** 06/21/2023 - William Patton - National TAB

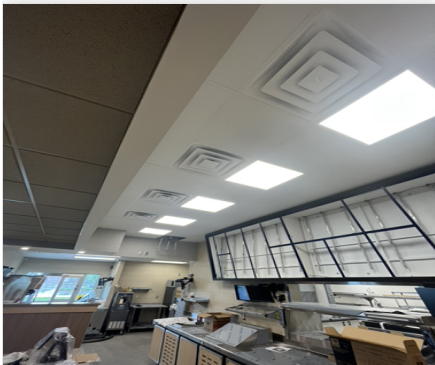
**LowLineDiffusers**  
06/21/2023

**Description :** AS A RESULT OF INCORRECT DAMPERS BEING INSTALLED AND THE DUCTWORK LAYOUT DIFFERING FROM THAT SHOWN ON THE MSET THERE ARE 4 DIFFUSERS THAT ARE BELOW DESIGN. SEVERAL FULL PASSES WERE MADE TO ATTEMPT TO RESOLVE THIS BUT WERE UNSUCCESSFUL. SPACE IS COMFORTABLE AS IS. RECOMMEND INSTALLING CORRECT VOLUME DAMPERS FOR INDIVIDUAL DIFFUSERS AND BRANCHES TO RESOLVE.
