Report: TAB REPORT
Function: Test, Adjust, & Balance
Date: 06/26/2023

PROJECT
06-19-23 CULVERS - COLUMBUS, GA

Project: 06-19-23 CULVERS - COLUMBUS, GA

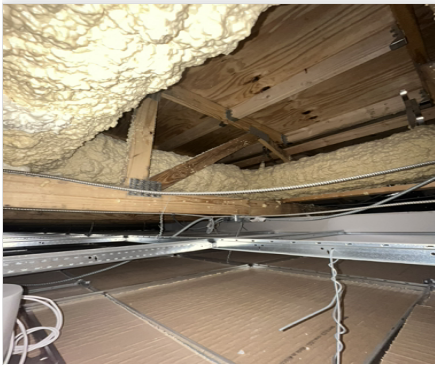
SprayFoamInsulation.j..
06/21/2023

Issue Name : INCORRECT DAMPERS INSTALLED
Description : MSET CALLS FOR VOLUME DAMPERS AT SUPPLY TAKEOFFS, INSTEAD DAMPERS WERE INSTALLED AT FACES OF DIFFUSERS. SEE MSET M201 DETAIL C6. EXISTENCE OF BRANCH DAMPERS COULD NOT BE VERIFIED DUE TO SPRAY FOAM INSULATION ON DUCT. THE FACE DAMPERS CAUSE EXCESSIVE NOISE AT SEVERAL DIFFUSERS.
Created By : National TAB **Assigned To :** National TAB - William Patton
Status : Open
Originated Date : 06/21/2023 - William Patton - National TAB

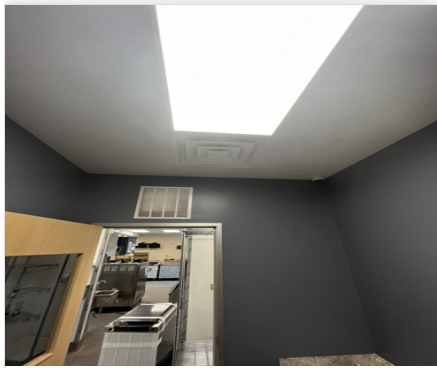
OfficeDiffuser
06/21/2023

Issue Name : OFFICE DIFFUSER DUCTWORK
Description : OFFICE SUPPLY DIFFUSER IS DUCTED TO RTU2 INSTEAD OF RTU1. MSET M101 CALLS FOR THAT DIFFUSER TO BE DUCTED TO TO RTU1. PER MECHANICAL THE TRUSS WORK MAKES DUCTING TO RTU1 IMPOSSIBLE. THIS MAY LEAD TO UNCOMFORTABLE TEMPERATURES IN OFFICE AS THE KITCHEN CALLS HAS A DEMAND FOR COOLING WIEN THE OFFICE IS ALREADY COLD.
Created By : National TAB **Assigned To :** National TAB - William Patton
Status : Open
Originated Date : 06/21/2023 - William Patton - National TAB

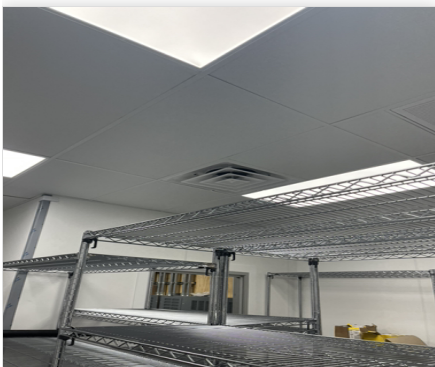
LowFlowDiffuser
06/22/2023

Issue Name : RTU 2 DIFFUSER 15 LOW FLOW
Description : DIFFUSER 15 (DRY GOODS) IS 351 CFM. DESIGN IS 600CFM. AFTER SEVERAL FULL PASSES TOTAL INCREASE IN FLOW TO THIS DIFFUSER WAS 63 CFM, WITH ALL OTHER DIFFUSERS FALLING WITHIN DESIGN. AFTER INSPECTION TECHNICIAN COULD NOT DIAGNOSE WHAT IS CAUSING RESTRICTION. RECOMMEND MECHANICAL CONTRACTOR INVESTIGATES DUCTWORK AND VOLUME DAMPER FOR ANY ISSUES.
