Report: TAB REPORT
Function: Test, Adjust, & Balance
Date: 06/26/2023

PROJECT
06-19-23 CULVERS - COLUMBUS, GA

6859 MIDLAND COMMONS BLVD

COLUMBUS, GA 31909

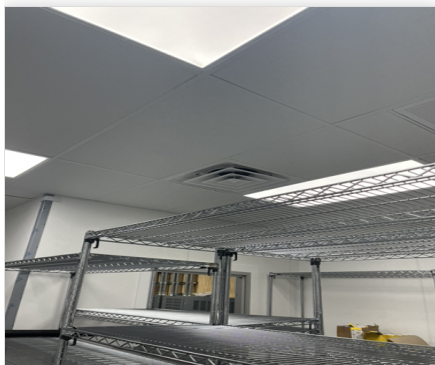
LowFlowDiffuser
06/22/2023

Issue Name : RTU 2 DIFFUSER 15 LOW FLOW
Description : DIFFUSER 15 (DRY GOODS) IS 351 CFM. DESIGN IS 600CFM. AFTER SEVERAL FULL PASSES TOTAL INCREASE IN FLOW TO THIS DIFFUSER WAS 63 CFM, WITH ALL OTHER DIFFUSERS FALLING WITHIN DESIGN. AFTER INSPECTION TECHNICIAN COULD NOT DIAGNOSE WHAT IS CAUSING RESTRICTION. RECOMMEND MECHANICAL CONTRACTOR INVESTIGATES DUCTWORK AND VOLUME DAMPER FOR ANY ISSUES.

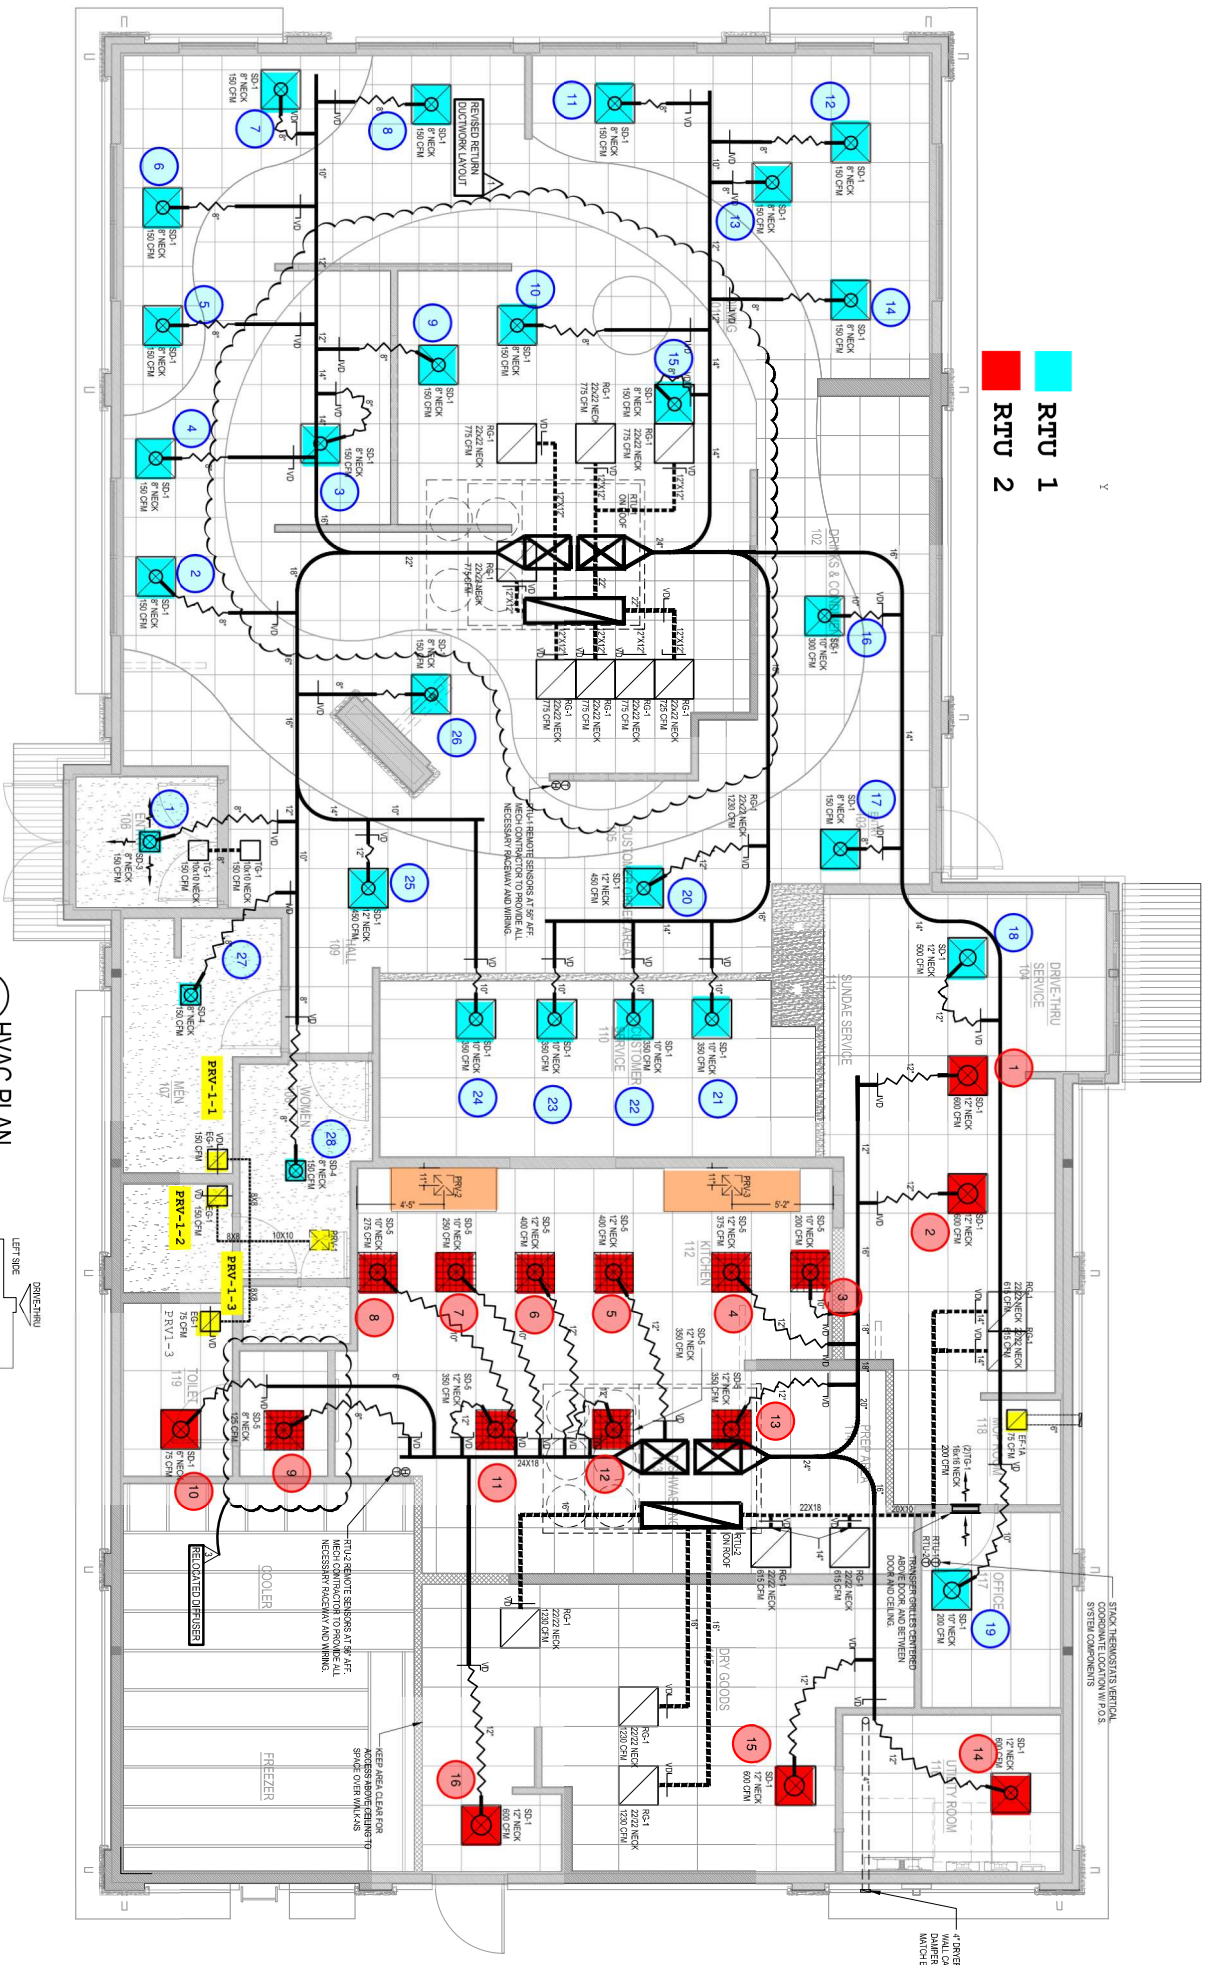
HVAC DUCT PLAN

■ RTU 1
■ RTU 2
