**Report: TAB REPORT  
Function: Test, Adjust, & Balance  
Date: 06/26/2023**

**PROJECT  
06-19-23 CULVERS - COLUMBUS, GA**

6859 MIDLAND COMMONS BLVD

COLUMBUS, GA 31909

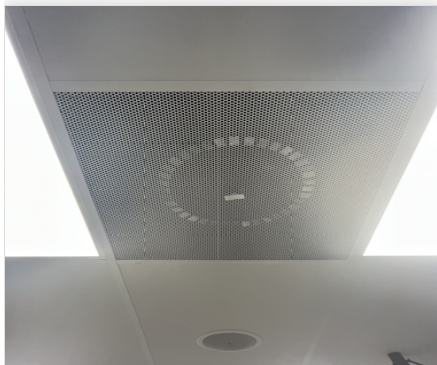
**LineDiffusers**  
06/22/2023

**Issue Name :** HOOD CAPTURE  
**Description :** WITH HOOD AT DESIGN FLOW AND LINE DIFFUSERS IN DESIGN AIRFLOW CAUSES HOODS TO FAIL TO FULLY CAPTURE. TECHNICIAN VERIFIED WITH KITCHEN UNITS OFF AND REAR DOOR OPEN THE HOODS CAPTURED CORRECTLY. DUCTWORK NOT INSTALLED PER DESIGN. SEE MSET PAGE M201 DETAIL C6. DIFFUSERS ARE MISSING RIGID 90 AND 12" RIGID DUCT RUN. RETURN STYLE DIFFUSERS ARE INSTALLED INSTEAD OF SUPPLY. RECOMMEND MECHANICAL CONTRACTOR INSTALLS DUCT PER DESIGN.

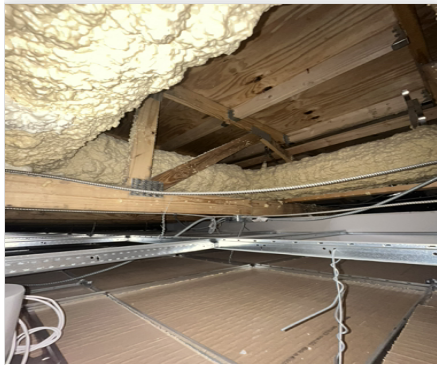
**SprayFoamInsulation.j..**  
**06/21/2023**

**Issue Name :** INCORRECT DAMPERS INSTALLED  
**Description :** MSET CALLS FOR VOLUME DAMPERS AT SUPPLY TAKEOFFS, INSTEAD DAMPERS WERE INSTALLED AT FACES OF DIFFUSERS. SEE MSET M201 DETAIL C6. EXISTENCE OF BRANCH DAMPERS COULD NOT BE VERIFIED DUE TO SPRAY FOAM INSULATION ON DUCT. THE FACE DAMPERS CAUSE EXCESSIVE NOISE AT SEVERAL DIFFUSERS.  
**Created By :** National TAB                      **Assigned To :** National TAB - William Patton  
**Status :** Open  
**Originated Date :** 06/21/2023 - William Patton - National TAB

- **06/22/2023 National TAB - William Patton**
  - RECOMMENDED TO INSTALL VOLUME DAMPERS FOR THE DIFFUSERS AT THE TAKEOFFS. IT IS ALSO RECOMMENDED TO INSTALL BRANCH DAMPERS. NTAB WAS UNABLE TO SEE OR USE ANY BRANCH DAMPERS DUE TO SPRAY INSULATION ON THE DUCTWORK.

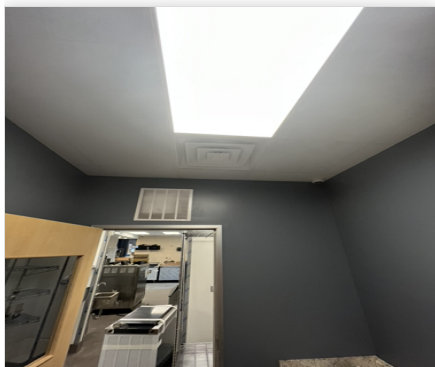
**OfficeDiffuser**  
06/21/2023

**Issue Name :** OFFICE DIFFUSER DUCTWORK  
**Description :** OFFICE SUPPLY DIFFUSER IS DUCTED TO RTU2 INSTEAD OF RTU1. MSET M101 CALLS FOR THAT DIFFUSER TO BE DUCTED TO TO RTU1. PER MECHANICAL THE TRUSS WORK MAKES DUCTING TO RTU1 IMPOSSIBLE. THIS MAY LEAD TO UNCOMFORTABLE TEMPERATURES IN OFFICE AS THE KITCHEN CALLS HAS A DEMAND FOR COOLING WIEN THE OFFICE IS ALREADY COLD.  
**Created By :** National TAB                      **Assigned To :** National TAB - William Patton  
**Status :** Open  
**Originated Date :** 06/21/2023 - William Patton - National TAB

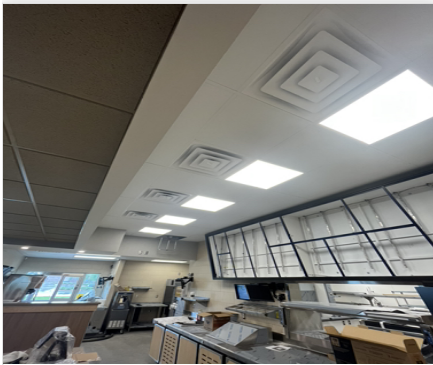
**LowLineDiffusers  
06/21/2023**

**Issue Name :** RTU 1 LOW DIFFUSERS  
**Description :** AS A RESULT OF INCORRECT DAMPERS BEING INSTALLED AND THE DUCTWORK LAYOUT DIFFERING FROM THAT SHOWN ON THE MSET THERE ARE 4 DIFFUSERS THAT ARE BELOW DESIGN. SEVERAL FULL PASSES WERE MADE TO ATTEMPT TO RESOLVE THIS BUT WERE UNSUCCESSFUL. SPACE IS COMFORTABLE AS IS.  
**Created By :** National TAB                      **Assigned To :** National TAB - William Patton  
**Status :** Open  
**Originated Date :** 06/21/2023 - William Patton - National TAB

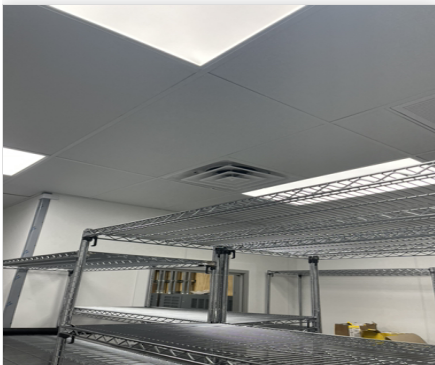
**LowFlowDiffuser**  
06/22/2023

**Issue Name :** RTU 2 DIFFUSER 15 LOW FLOW  
**Description :** DIFFUSER 15 (DRY GOODS) IS 351 CFM. DESIGN IS 600CFM. AFTER SEVERAL FULL PASSES TOTAL INCREASE IN FLOW TO THIS DIFFUSER WAS 63 CFM, WITH ALL OTHER DIFFUSERS FALLING WITHIN DESIGN. AFTER INSPECTION TECHNICIAN COULD NOT DIAGNOSE WHAT IS CAUSING RESTRICTION. RECOMMEND MECHANICAL CONTRACTOR INVESTIGATES DUCTWORK AND VOLUME DAMPER FOR ANY ISSUES.
