Report: PRELIM TAB REPORT
Function: Test, Adjust, & Balance
Date: 06/15/2023

PROJECT
06-19-23 CULVERS - COLUMBUS, GA

6859 MIDLAND COMMONS BLVD

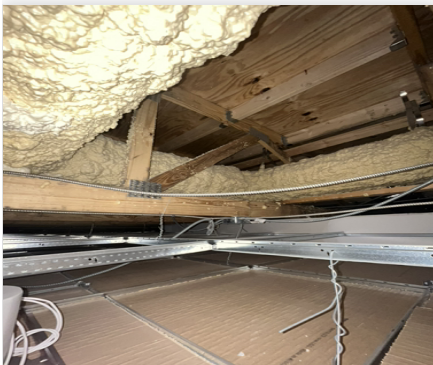
Issue Name : INCORRECT DAMPERS INSTALLED
Description : MSET CALLS FOR VOLUME DAMPERS AT SUPPLY TAKEOFFS, INSTEAD DAMPERS WERE INSTALLED AT FACES OF DIFFUSERS. SEE MSET M201 DETAIL C6. EXISTENCE OF BRANCH DAMPERS COULD NOT BE VERIFIED DUE TO SPRAY FOAM INSULATION ON DUCT. THE FACE DAMPERS CAUSE EXCESSIVE NOISE AT SEVERAL DIFFUSERS.

SprayFoamInsulation.j..
06/21/2023

- **06/22/2023 National TAB - William Patton**
 - RECOMMENDED TO INSTALL VOLUME DAMPERS FOR THE DIFFUSERS AT THE TAKEOFFS. IT IS ALSO RECOMMENDED TO INSTALL BRANCH DAMPERS. NTAB WAS UNABLE TO SEE OR USE ANY BRANCH DAMPERS DUE TO SPRAY INSULATION ON THE DUCTWORK.

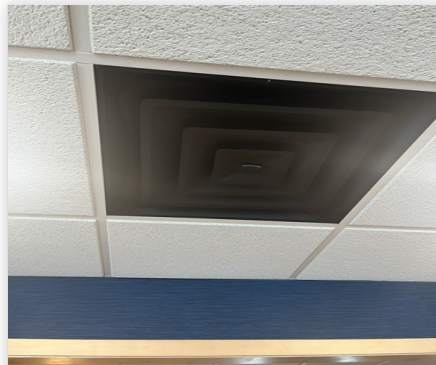
InNeckFaceDamper
06/21/2023

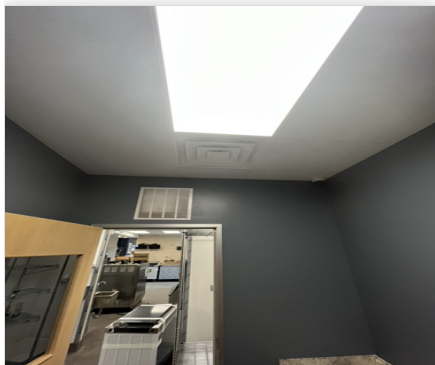
Issue Name : OFFICE DIFFUSER DUCTWORK
Description : OFFICE SUPPLY DIFFUSER IS DUCTED TO RTU2 INSTEAD OF RTU1. MSET M101 CALLS FOR THAT DIFFUSER TO BE DUCTED TO TO RTU1. PER MECHANICAL THE TRUSS WORK MAKES DUCTING TO RTU1 IMPOSSIBLE. THIS MAY LEAD TO UNCOMFORTABLE TEMPERATURES IN OFFICE AS THE KITCHEN CALLS HAS A DEMAND FOR COOLING WIEN THE OFFICE IS ALREADY COLD.

OfficeDiffuser
06/21/2023

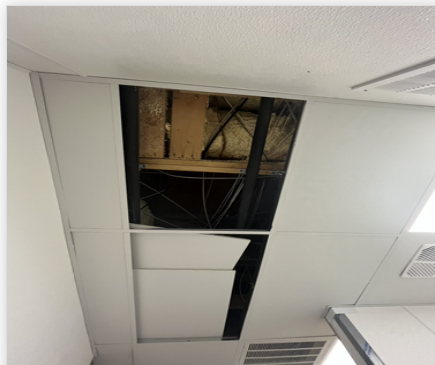
Trusses
06/21/2023

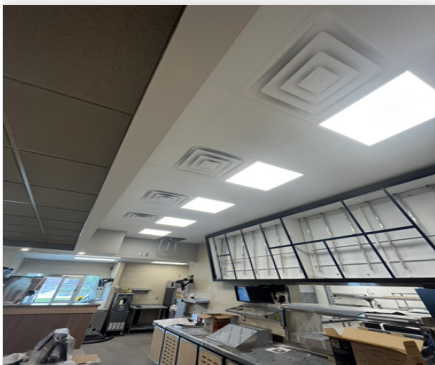
Description : AS A RESULT OF INCORRECT DAMPERS BEING INSTALLED AND THE DUCTWORK LAYOUT DIFFERING FROM THAT SHOWN ON THE MSET THERE ARE 4 DIFFUSERS THAT ARE BELOW DESIGN. SEVERAL FULL PASSES WERE MADE TO ATTEMPT TO RESOLVE THIS BUT WERE UNSUCCESSFUL. SPACE IS COMFORTABLE AS IS.

LowLineDiffusers
06/21/2023

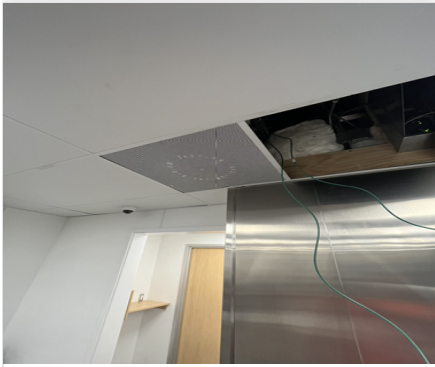
Issue Name : RTU2 & RESTROOM EXHAUST MISSING DAMPERS
Description : BACK OF HOUSE IS MISSING 8 DAMPERS. ALL RESTROOM EXHAUST DIFFUSERS ARE MISSING DAMPERS.
Created By : National TAB **Assigned To :** National TAB - William Patton
Status : Closed
Originated Date : 06/21/2023 - William Patton - National TAB

SGRD8
06/21/2023

- **06/21/2023 National TAB - William Patton**
 - MECHANICAL CONTRACTOR INSTALLED MISSING DAMPERS.
