Report: TAB REPORT
Function: Test, Adjust, & Balance
Date: 06/26/2023

PROJECT
06-19-23 CULVERS - COLUMBUS, GA

6859 MIDLAND COMMONS BLVD

COLUMBUS, GA 31909

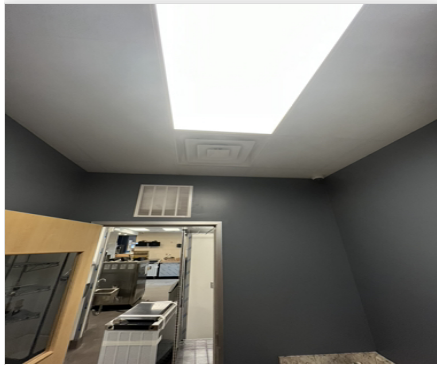
OfficeDiffuser
06/21/2023

Issue Name : Office Diffuser Ductwork
Description : Office supply diffuser is ducted to rtu2 instead of rtu1. MSET M101 calls for that diffuser to be ducted to rtu1. Per the MC the truss work makes ducting to rtu1 impossible. This may lead to uncomfortable temperatures in the office as the kitchen has a different demand for heat/cool than the office.
Created By : National TAB **Assigned To :** National TAB - William Patton
Status : Open
Originated Date : 06/21/2023 - William Patton - National TAB

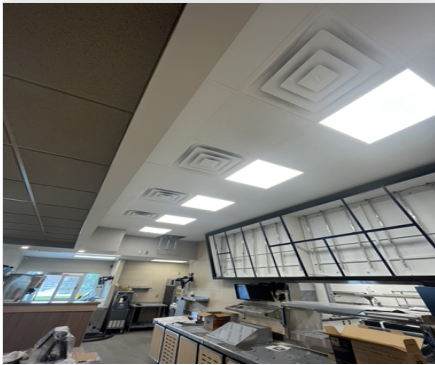
LowLineDiffusers
06/21/2023

Issue Name : RTU 1 Low Diffusers
Description : As a result of incorrect dampers being installed and the ductwork layout differing from that shown on the MSET there are 4 diffusers that are below design. Several full passes were made to attempt to resolve this but were unsuccessful. Space is comfortable as is.
Created By : National TAB **Assigned To :** National TAB - William Patton
Status : Open
Originated Date : 06/21/2023 - William Patton - National TAB

- **06/22/2023 National TAB - William Patton**
 - RECOMMENDED TO INSTALL VOLUME DAMPERS FOR THE DIFFUSERS AT THE TAKEOFFS. IT IS ALSO RECOMMENDED TO INSTALL BRANCH DAMPERS. NTAB WAS UNABLE TO SEE OR USE ANY BRANCH DAMPERS DUE TO SPRAY INSULATION ON THE DUCTWORK.

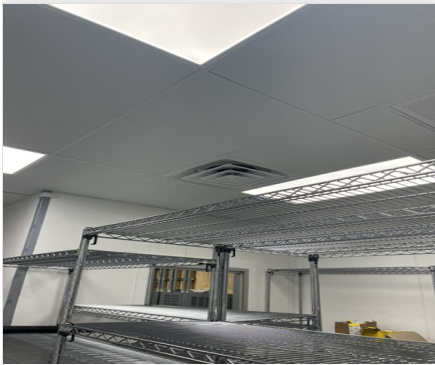
LowFlowDiffuser
06/22/2023

Issue Name : RTU 2 Diffuser 15 Low Flow
Description : Diffuser 15 (dry goods) is 351/600cfm. After several full passes, total increase in flow to this diffuser was 63 cfm, with all other diffusers falling within design. After inspection technician could not diagnose what is causing restriction. Recommend mechanical contractor investigates ductwork and volume damper for any issues.
