Report: TAB Report
Function: Test, Adjust, & Balance
Date: 05/31/2024

PROJECT
06-03-24 WAWA #5434 PALATKA, FL

Project: 06-03-24 WAWA #5434 PALATKA, FL

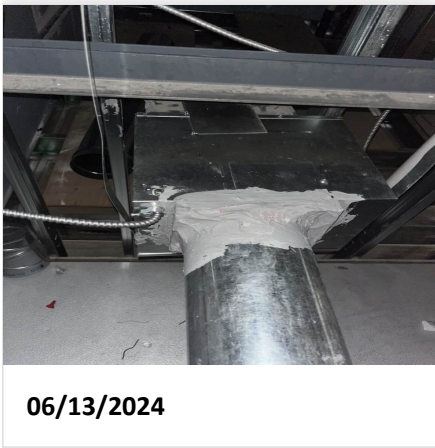
Issue Name : EF 2 Not Running
Description : EF 2 serving the Water Service Room, was not running at the time of balance. This fan was not balanced. The operation of this fan will not effect the balance or comfort of the rest of the store.
Created By : National TAB **Assigned To :** National TAB - Will Turnbough
Status : Open
Priority : High **Asset Tag :**
Originated Date : 06/13/2024 - Stephen Tassinaro - National TAB

- **08/09/2024 National TAB - Mark Johnson**
 - Fan is now operational. Exhaust flow was measured to be 128 CFM (213% of design) and cannot be adjusted as the fan is single-speed.
-

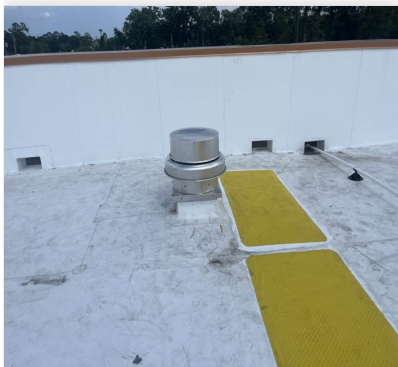
NO SPEED CONTROLLER ON EF-2

EF-2 NO SPEED CONTROLLER. EF-1 BALANCED WITHIN 5%.

Notes:
NO SPEED CONTROLLER LOCATED.
