Report: TAB Report

Function: Test, Adjust, & Balance

06-09-25 WAWA #6305 WAYCROSS, GA

Project: 06-09-25 WAWA #6305 WAYCROSS, GA

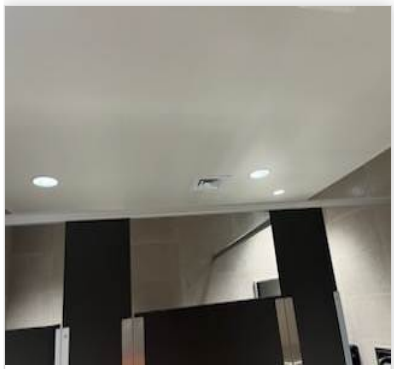
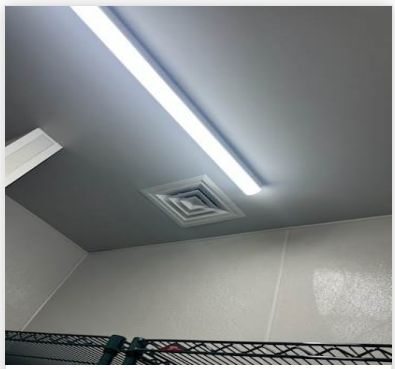
Issue Name : EF1-1and EF4-4 have wrong diffuser type installed

Description : Currently installed are CD-4 supply diffusers when GRD calls for G-3 exhaust diffusers.

- **09/23/2025 National TAB - Stephen Tassinaro**
  - Unresolved 9/22.
- **06/30/2025 National TAB - Ian Fuller**
  - Issue not resolved as of 6/30. Supply type diffusers still installed.

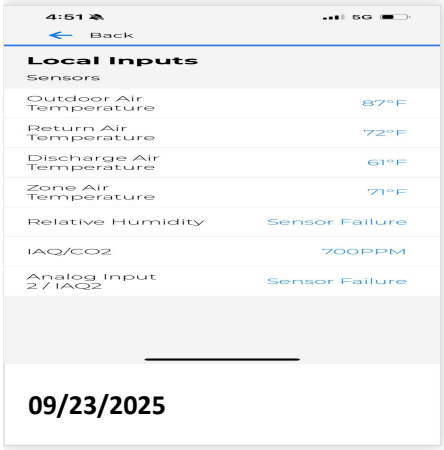
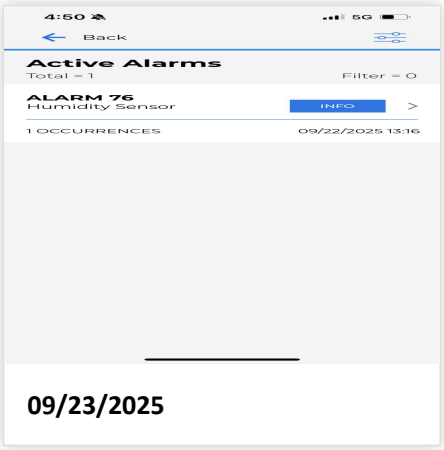
Issue Name : RTU-1 humidity sensor

Description : Humidity sensor is not reading correct humidity. Sensor starts to read at 8% then jumps to around 35% when humidity in the building is around 53 % RH. Humidity sensor wiring is per spec. VERIFY ALL THREE UNITS ARE READING A REALISTIC RELATIVE HUMIDITY IN ORDER TO CLOSE ISSUE.

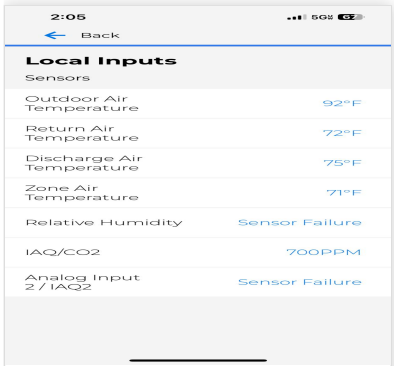
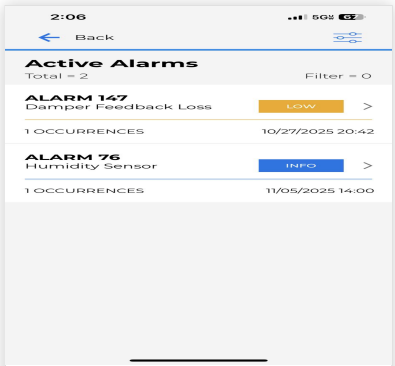
- **11/07/2025 National TAB - Stephen Tassinaro**
  - Sensor still reading between 8% and then sensor failure. Likely a short in the wiring or terminals landed incorrectly.

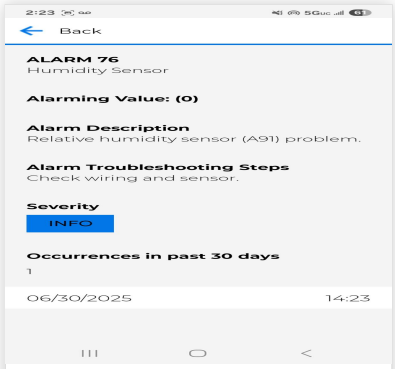
- **06/30/2025 National TAB - Ian Fuller**
  - Issue nit resolved as of 6/30. Core alarm is still present on system.

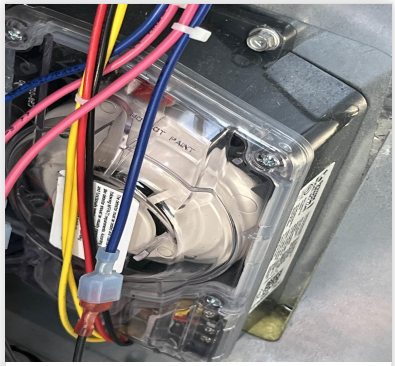
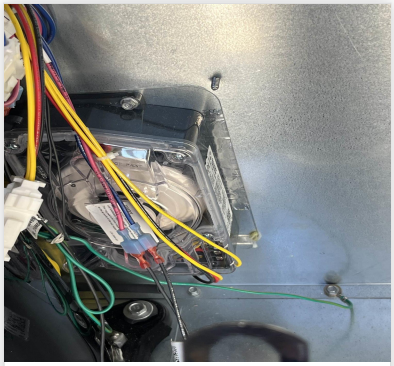
- **11/07/2025 National TAB - Stephen Tassinaro**
  - Dust plugs still installed on return side smoke detector heads.

Issue Name : Smoke detector dust plugs are still in unit
Description : Recommended to remove dust plugs in all units before store operation.

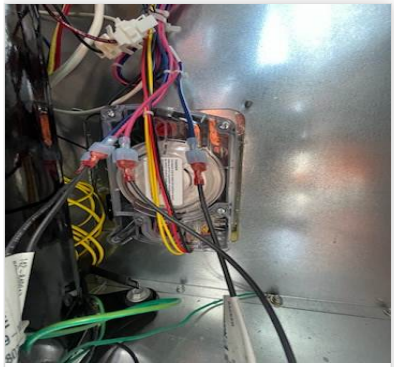
- **06/30/2025 National TAB - Ian Fuller**
  - Issue not resolved as of 6/30.

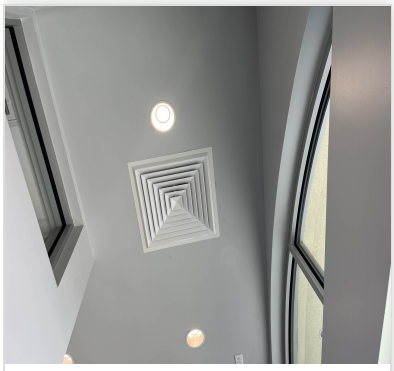
Description : A supply type CD-2 diffuser is installed when the GRD specifies a return type G-2 diffuser is installed. The correct diffuser type needs to be installed.

- **11/07/2025 National TAB - Stephen Tassinaro**
  - Supply type diffuser still installed on vestibule transfer grille.

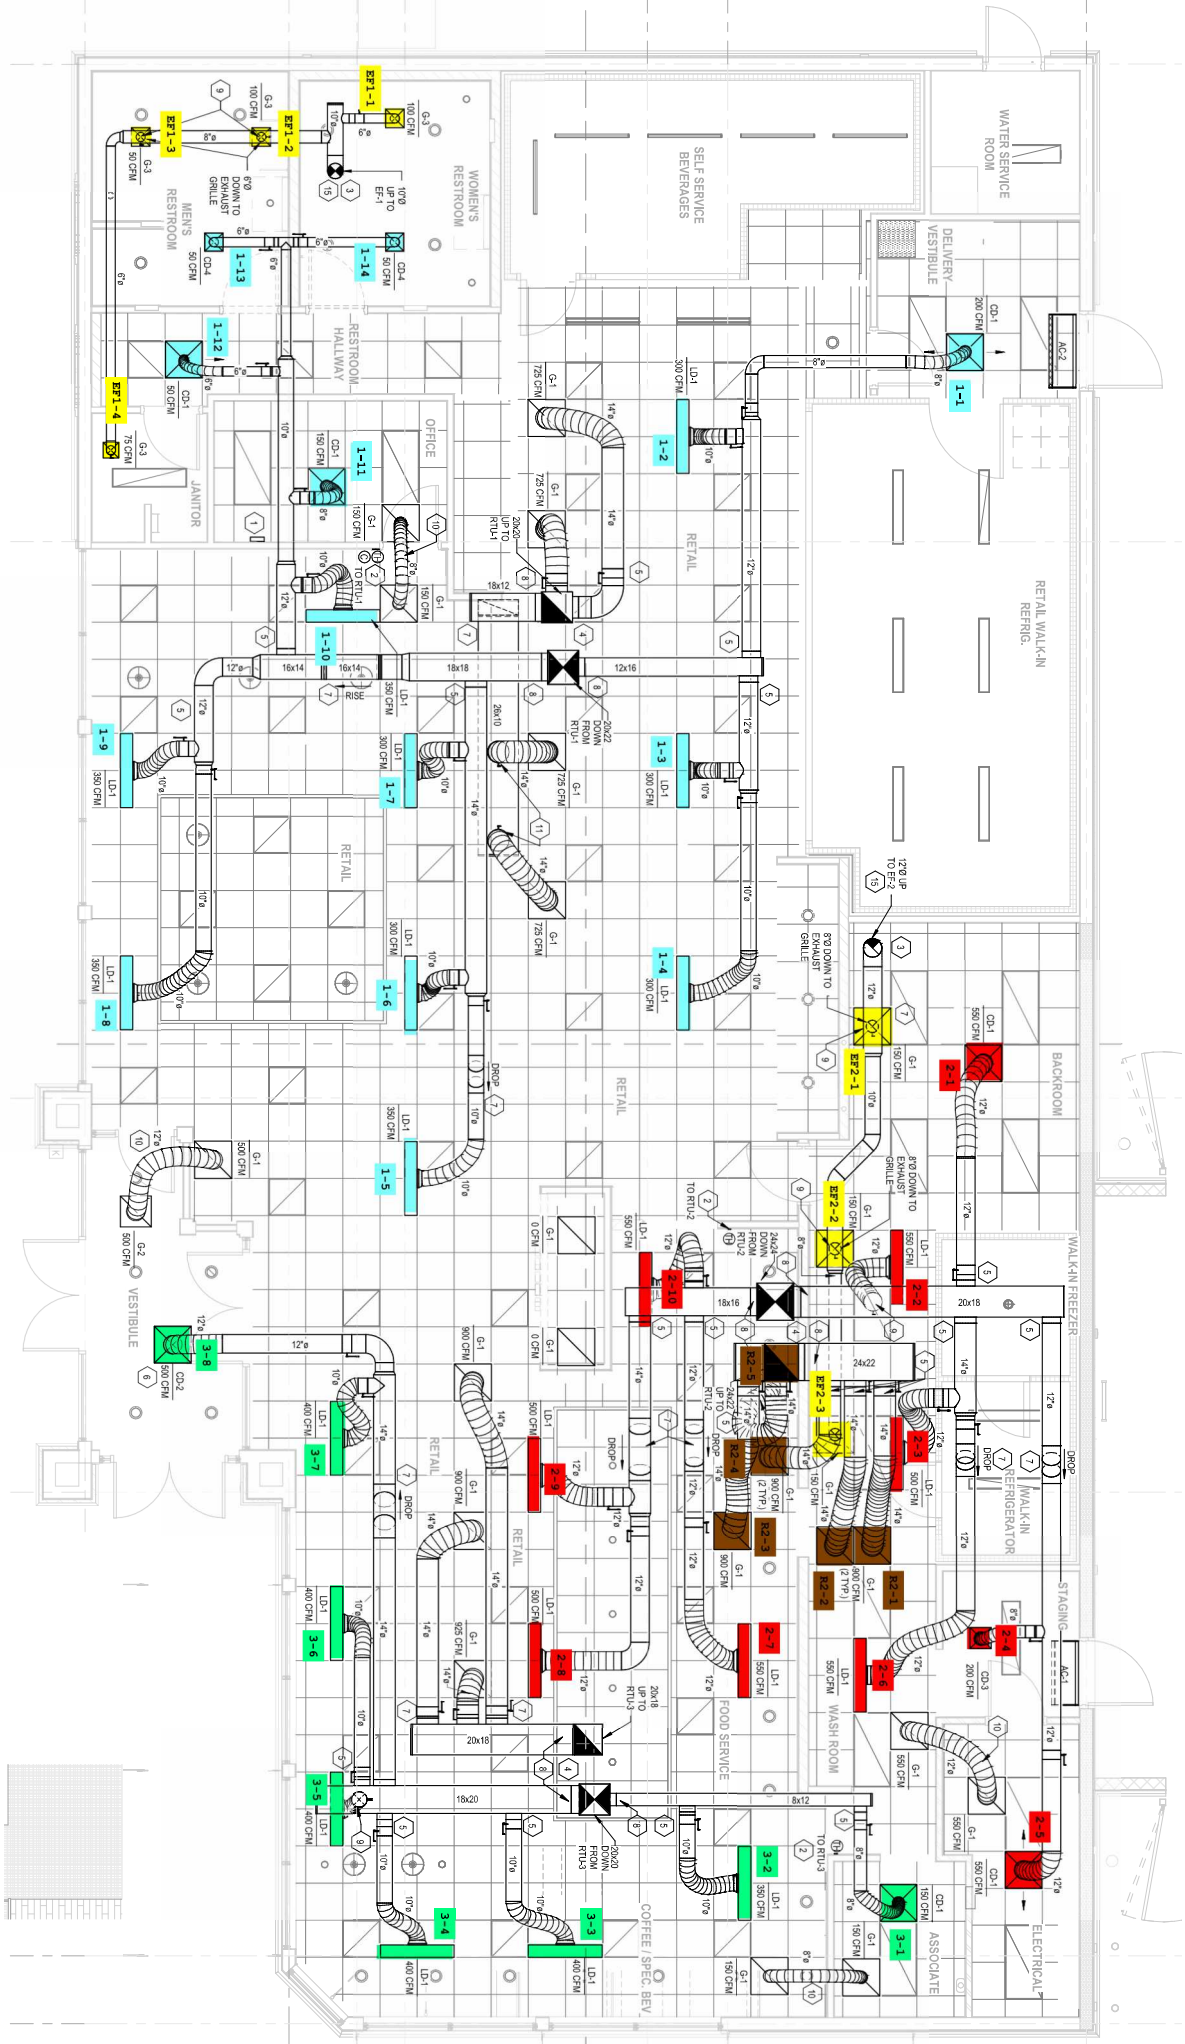
Asset	Notes	Date	Written By
EGRD3	No damper installed. However diffusers were balanced within design without the damper being installed. OK as-is.	09/23/2025	Stephen Tassinaro
