Report: TAB Report

Function: Test, Adjust, & Balance

12-08-25 Freddys - Ada, OK

KT Ventures

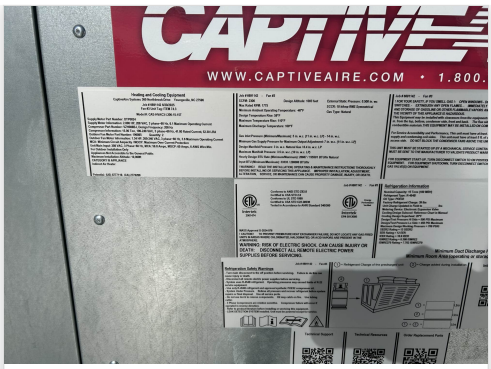
Asset: DOAS2 AREA:KITCHEN

Issue Name :	DOAS-1 severe duct leakage.		
Description :	DOAS-1 severe duct leakage at unit drop. Duct leakage was partly sealed by MC but is not fully sealed. Unit was able to meet design CFM. Airflow is leaking inbetween the space between the unit and roof instead of directly into above ceiling. Fully seal ductwork and schedule rebalancing of DOAS total CFM.		
Created By :	National TAB	**Assigned To :**	National TAB - Dan Hertenstein
Status :	Open		
Priority :	Urgent	**Asset Tag :**	DOAS2
Originated Date :	12/10/2025 - Cody Collett - National TAB

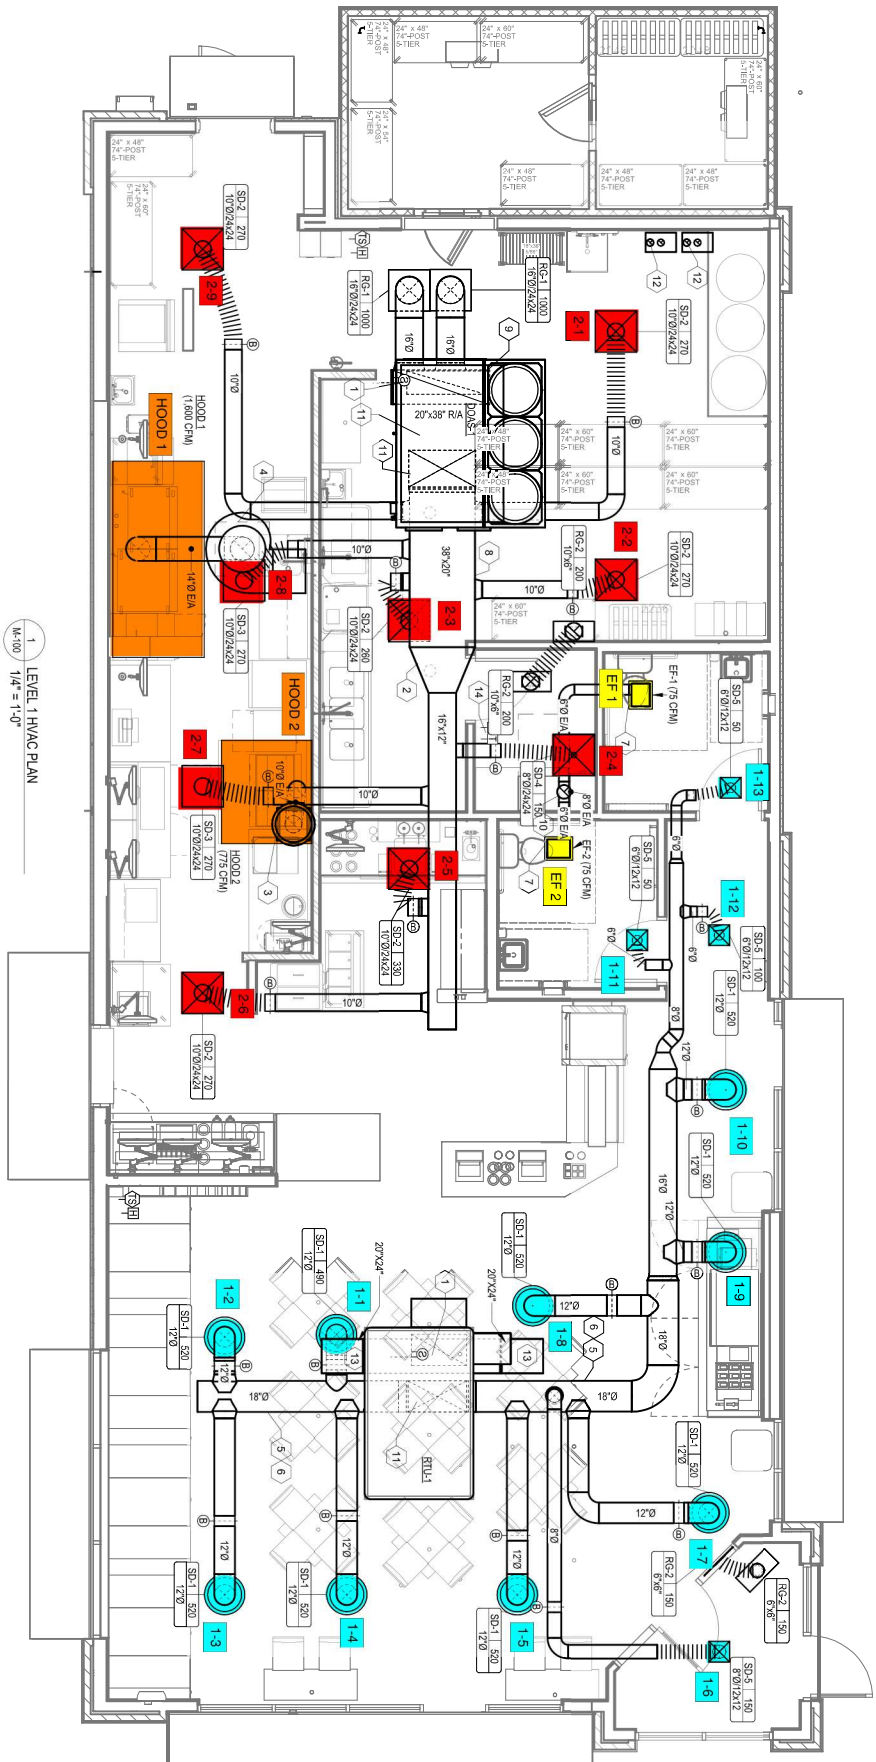
With exception of diffuser 2-7 due to ceiling grid placement.
