Report: TAB REPORT

Function: Test, Adjust, & Balance

Date: 07/16/2025

07-14-25 CHIPOTLE #5446 CHARDON, OH

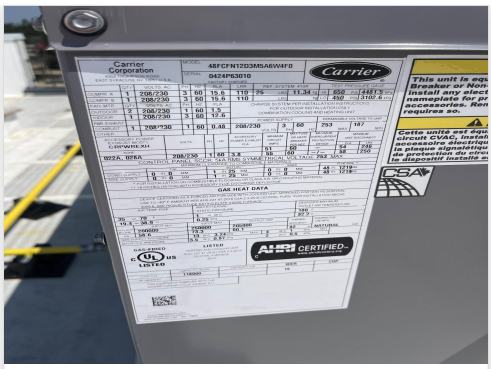
[1] RTU-2 SUPPLY AND RETURN DROPS DEVIATE FROM DESIGN DUE TO TRUSS INSTALLATION. SEVERAL TRANSITIONS AND TURNING VANES INSTALLED IN RETURN. SUPPLY AND RETURN ARE CRAMMED TOGETHER AT DROP. SEE PHOTOS

Slightly elevated dining room noise from RTU-2. Suspect deviations in drop ductwork is contributing to issue. When store is in full operation, not anticipated to be noticeable or cause any issue.

Notes:
[1] DIFFUSERS SUM TO 4000 CFM. RTU SCHEDULE CALLS FOR 4400 CFM. PROPORTIONALLY INCREASED DIFFUSER VALUES TO MATCH RTU SCHEDULE. UNIT OPERATING AT 427 CFM/TON
[2] HIGHER THAN NORMAL NOISE FROM UNIT IN SPACE. SUSPECT INSTALLATION OF RTU DROP IS CAUSE, SEE ISSUE.
