**Report: TAB Report**

**Function: Test, Adjust, & Balance**

## 10-13-25 QT #0839 MABLETON, GA

**Project: 10-13-25 QT #0839 MABLETON, GA**

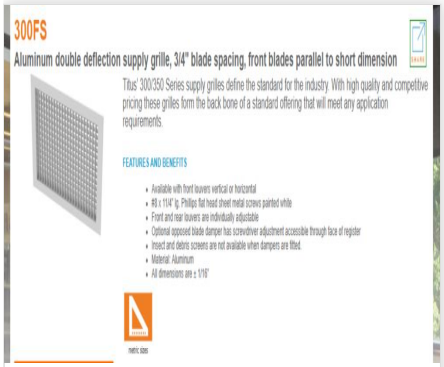
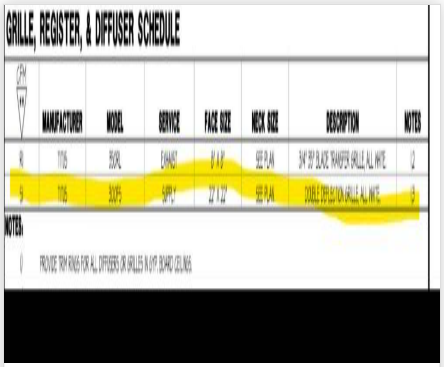
**Issue Name :** DIFFUSERS ARE THE WRONG TYPE
**Description :** The installed diffusers in the kitchen are not the specified model

- **11/12/2025 National TAB - Sagar Patel**
  - Diffusers are still incorrect. Titus diffusers are on back order.

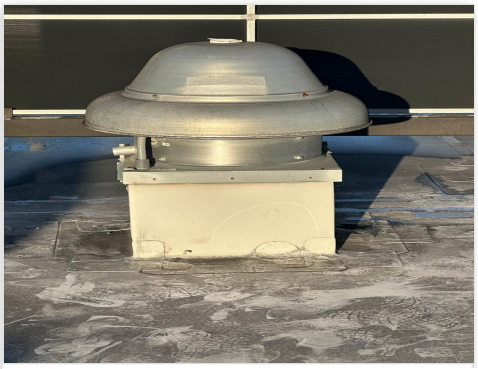
**Asset: EF1** AREA:RR/JANITOR

**Description :** Return grille 1-4 is not installed. Unable to balance EF1 until the return is installed.

- **11/12/2025 National TAB - Sagar Patel**
  - Return grill is not correct and ceiling is exposed.
